Countermeasure Design, Implementation, and Monitoring

Nicole Bartelt | Assistant Waterway Engineer

October 5, 2017

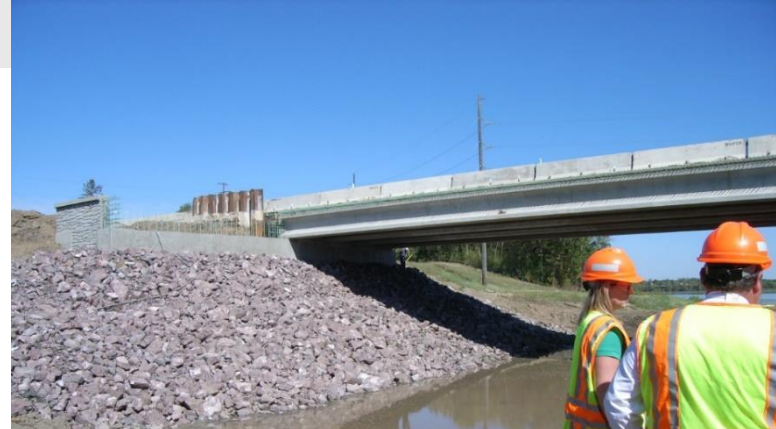
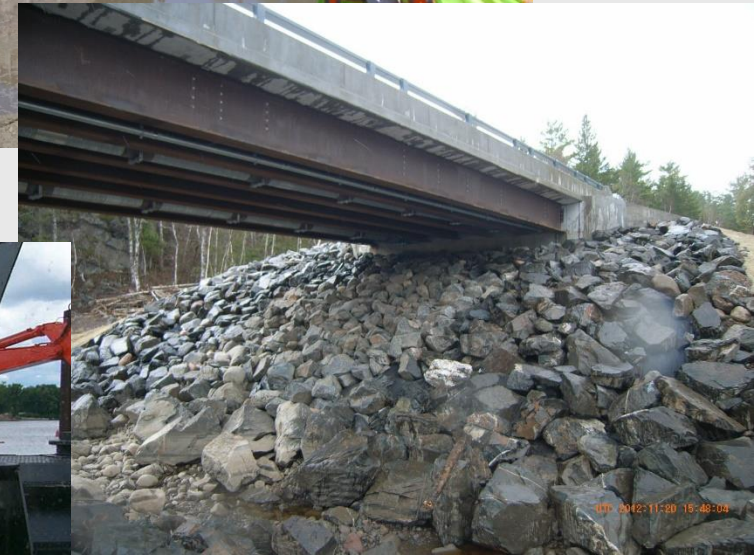
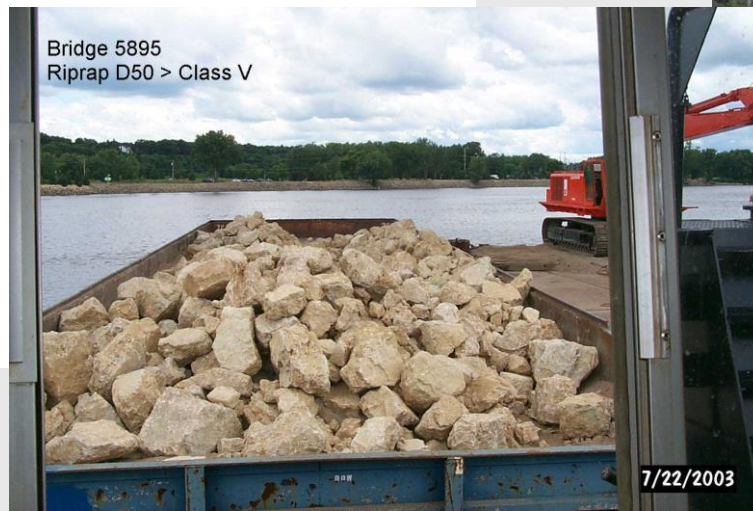
Riprap

- Most common form of countermeasure
- All spillthrough abutments have riprap
- Variety of rock material and quality throughout the state

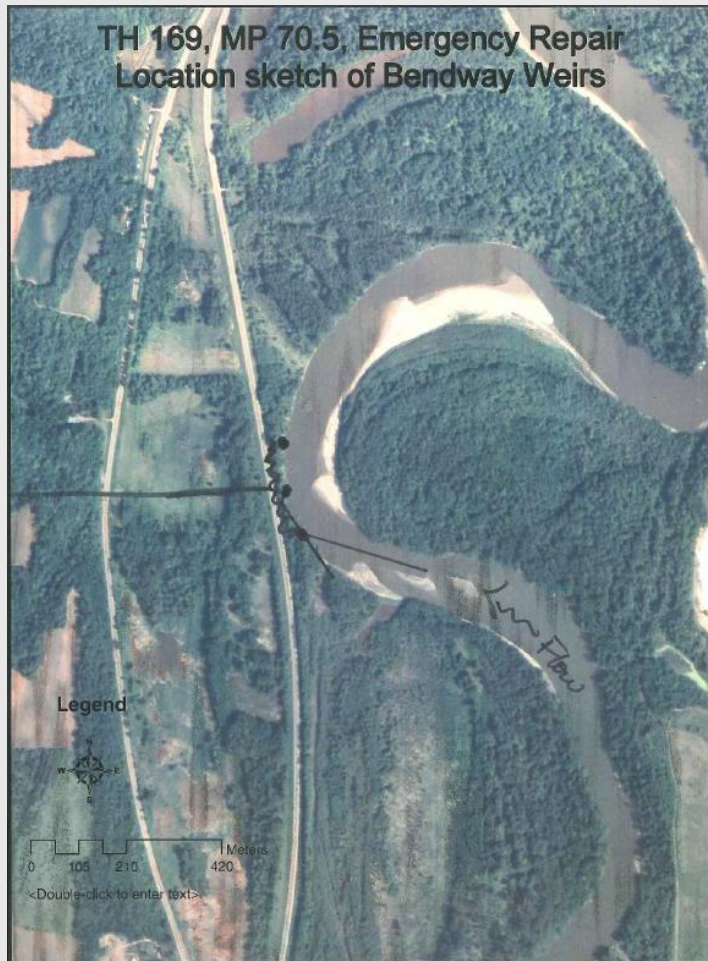
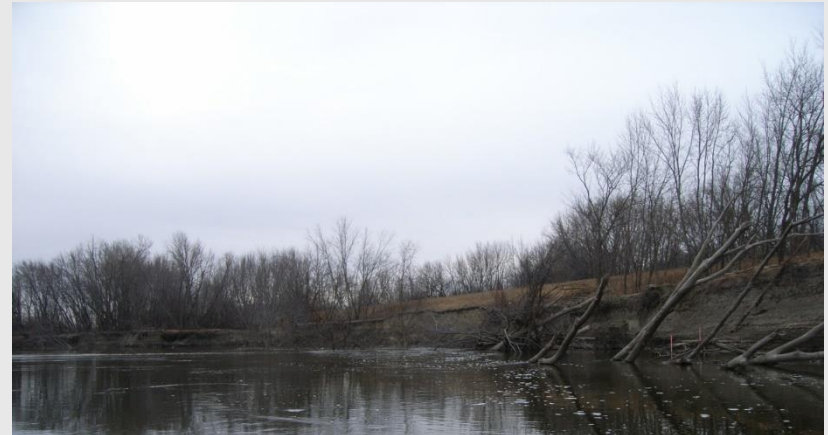
Bendway Weir location

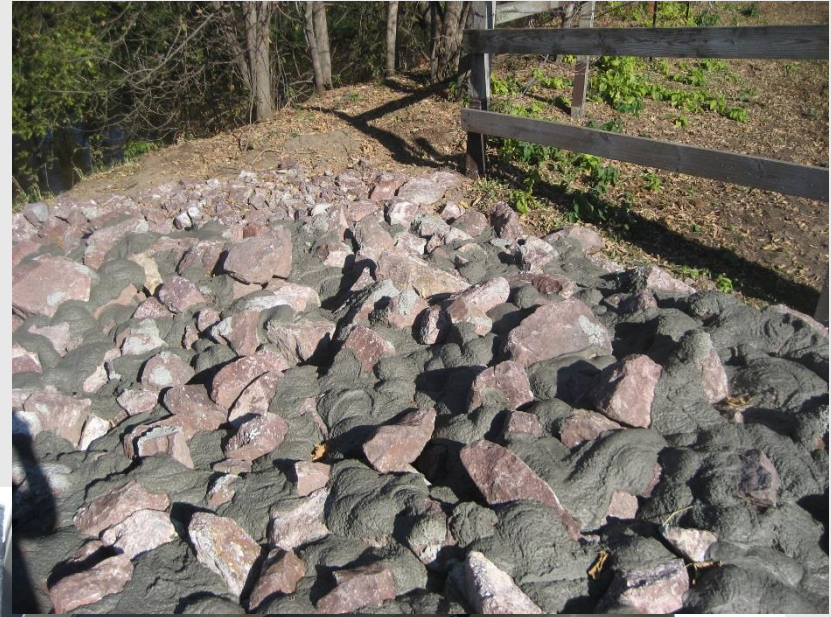
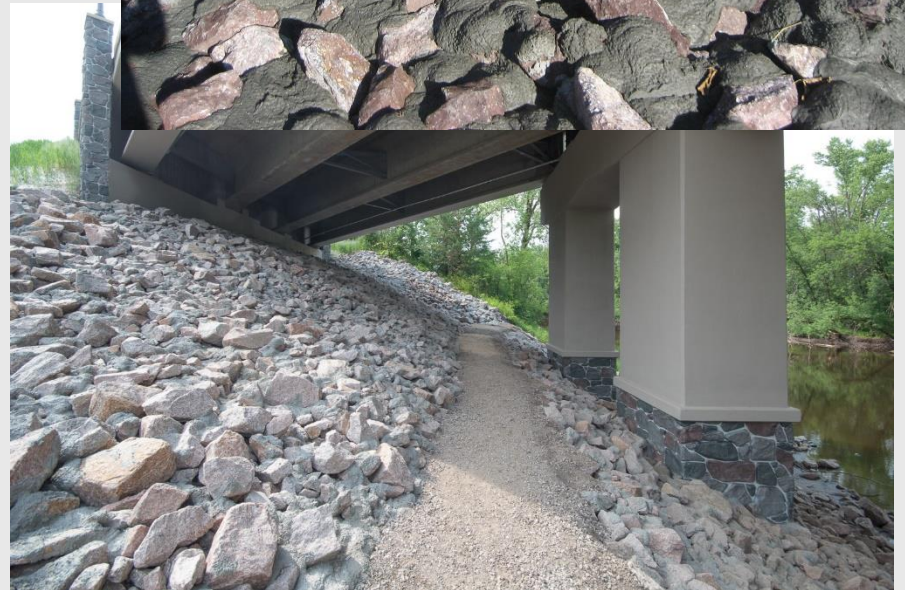
Matrix Riprap

- AKA: Partially grouted riprap
- Renamed to avoid contractor confusion
- Frequent uses:
 - Very high velocity areas
 - Limited or poor riprap
 - Vandalism areas

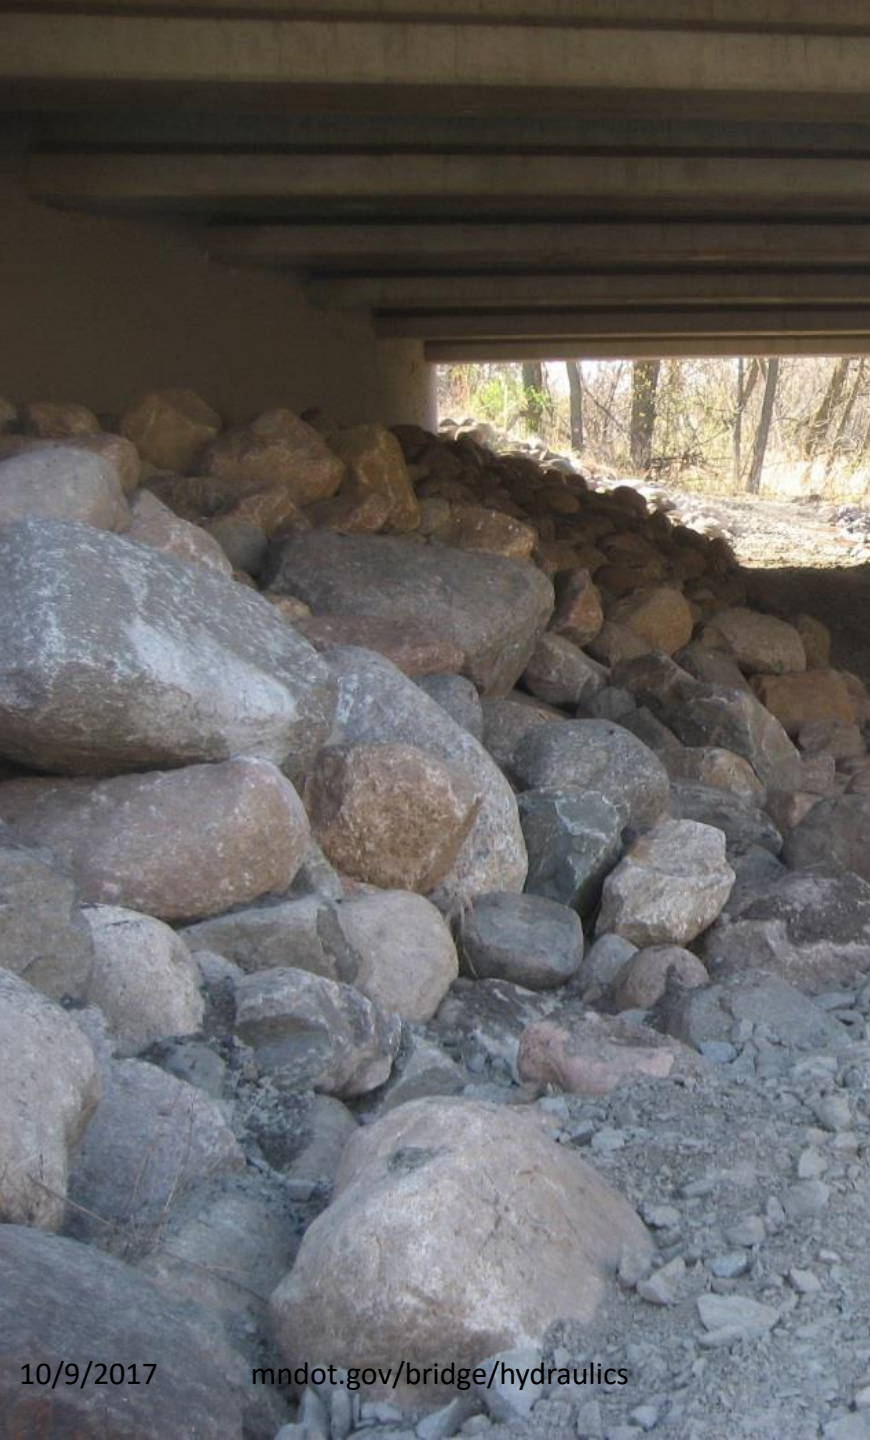
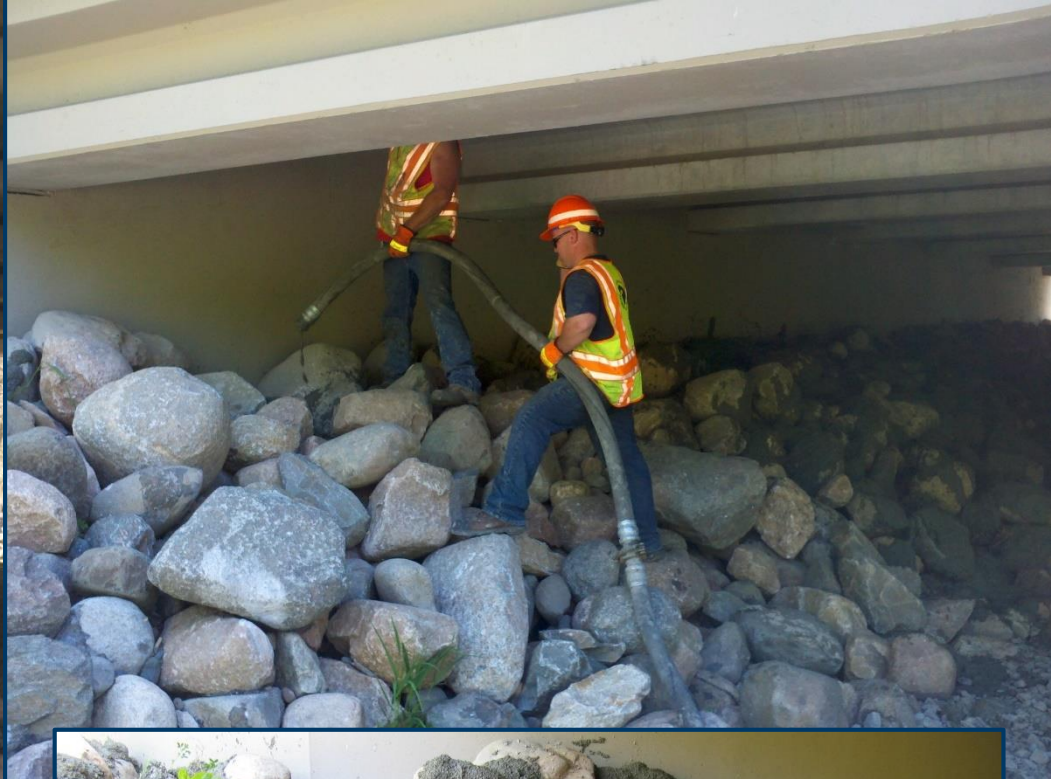
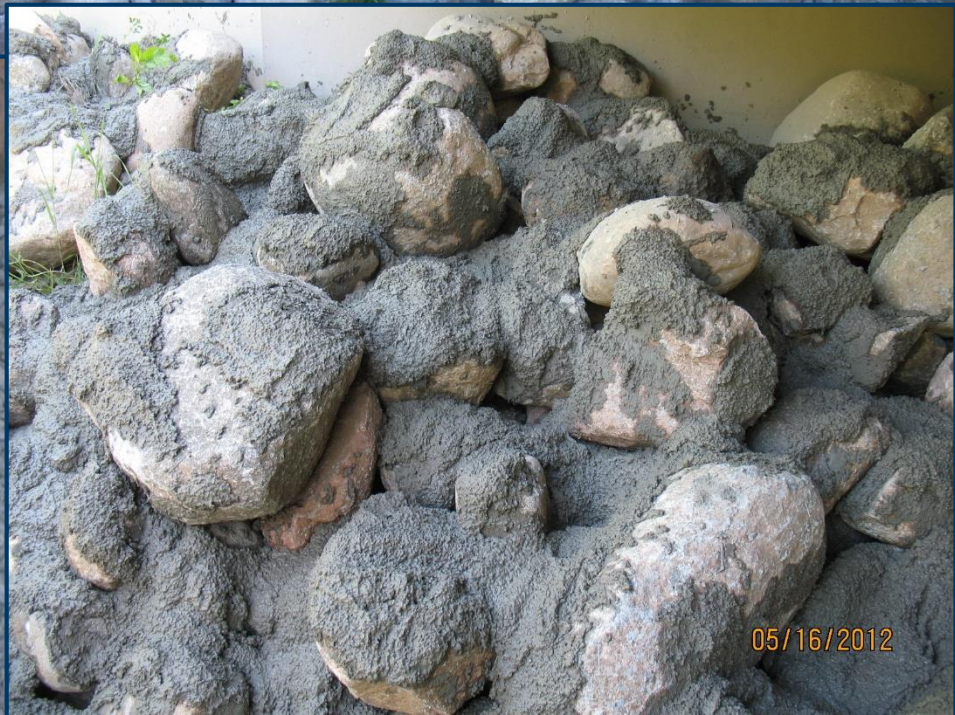
Implementation Research project

- May 2012 – Hired Paul Clopper of Ayres Associates for a demonstration project
- Installed grout on an abutment slope with rounded riprap, only installed on one abutment

- Best to use a screw-type pump (got “pulses” of grout with a dual-piston)
- 2-3” hose diameter (2” minimum)
- Need contractor education on this method
 - Website with youtube video on installation and grout
- Always need to be onsite during install

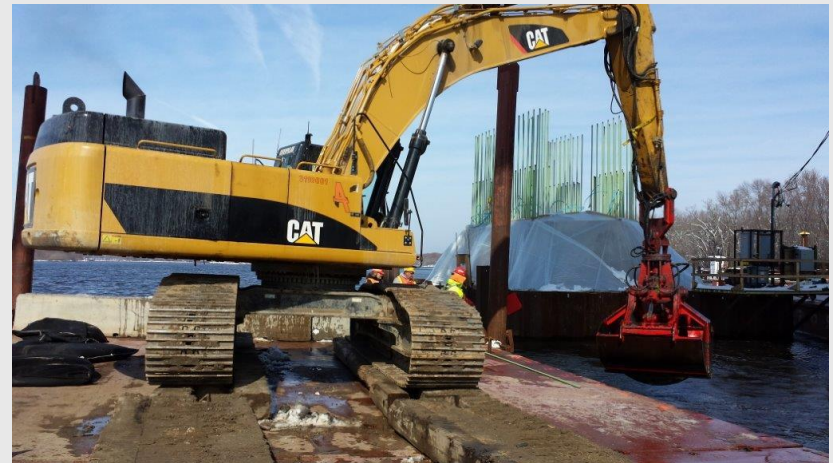
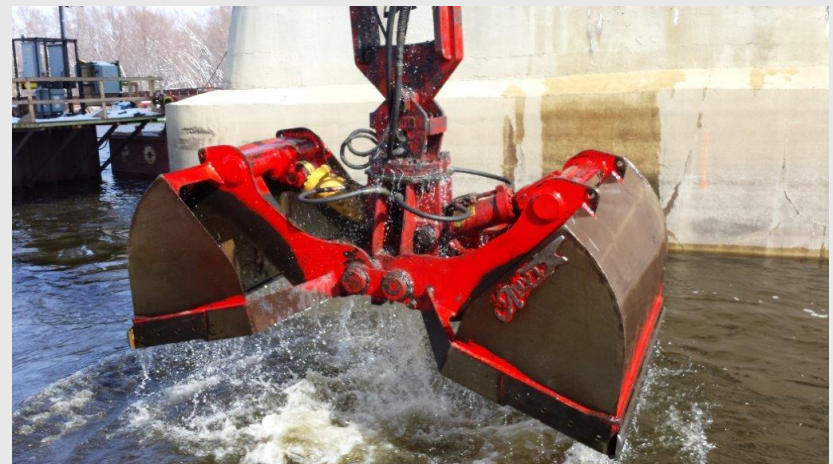
Geobags

- Placing filter material in deep or fast moving water is difficult
 - Big 4'x4' geotextile bags partially filled with aggregate
- Used on 2 jobs on the Mississippi River

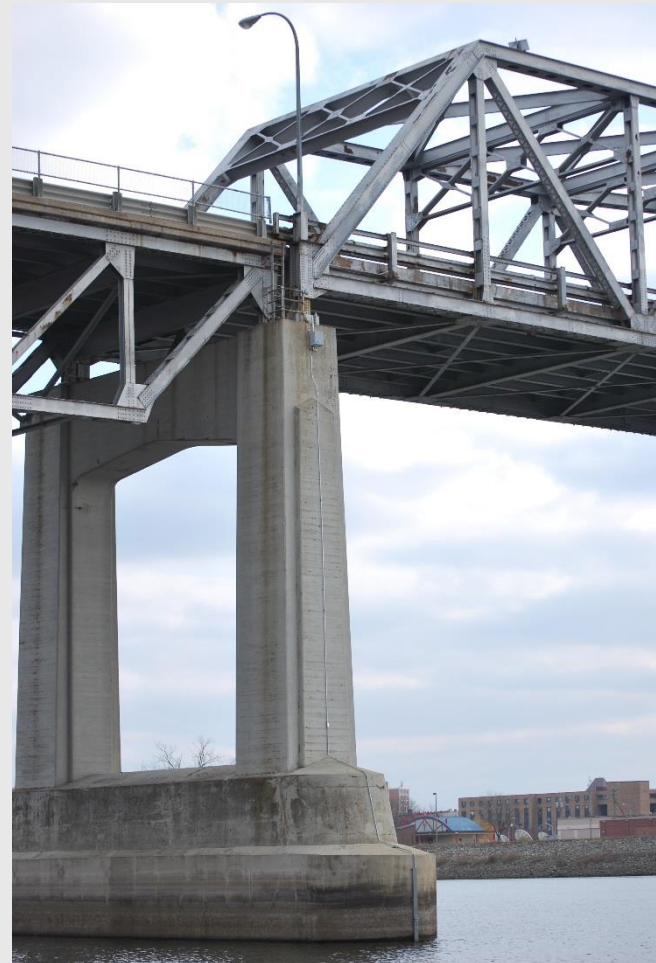
Fixed Monitoring

- Fixed sonar
- Float-outs
 - Monitor geobags and riprap placement
- Tilt sensors

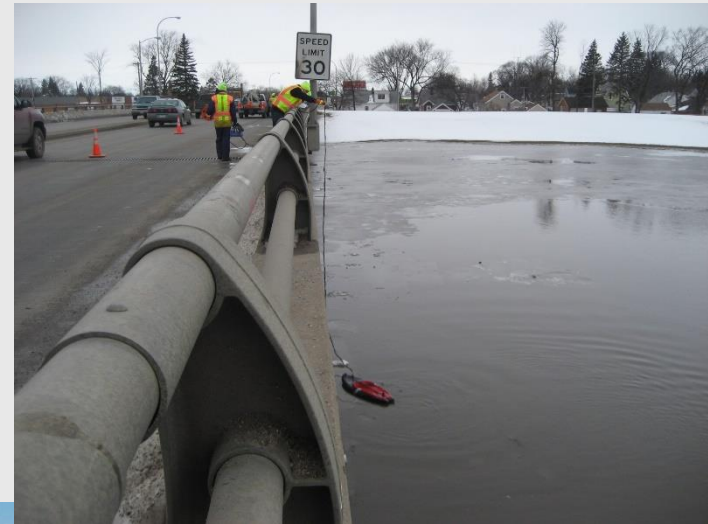
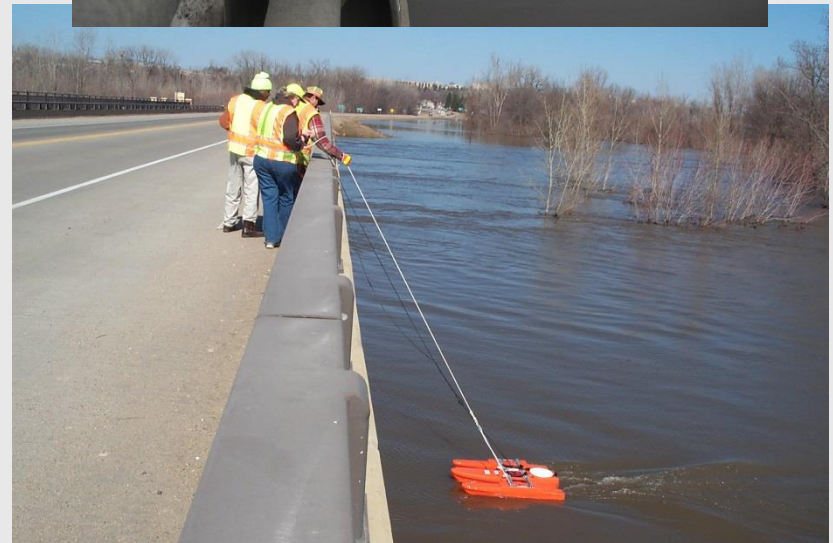
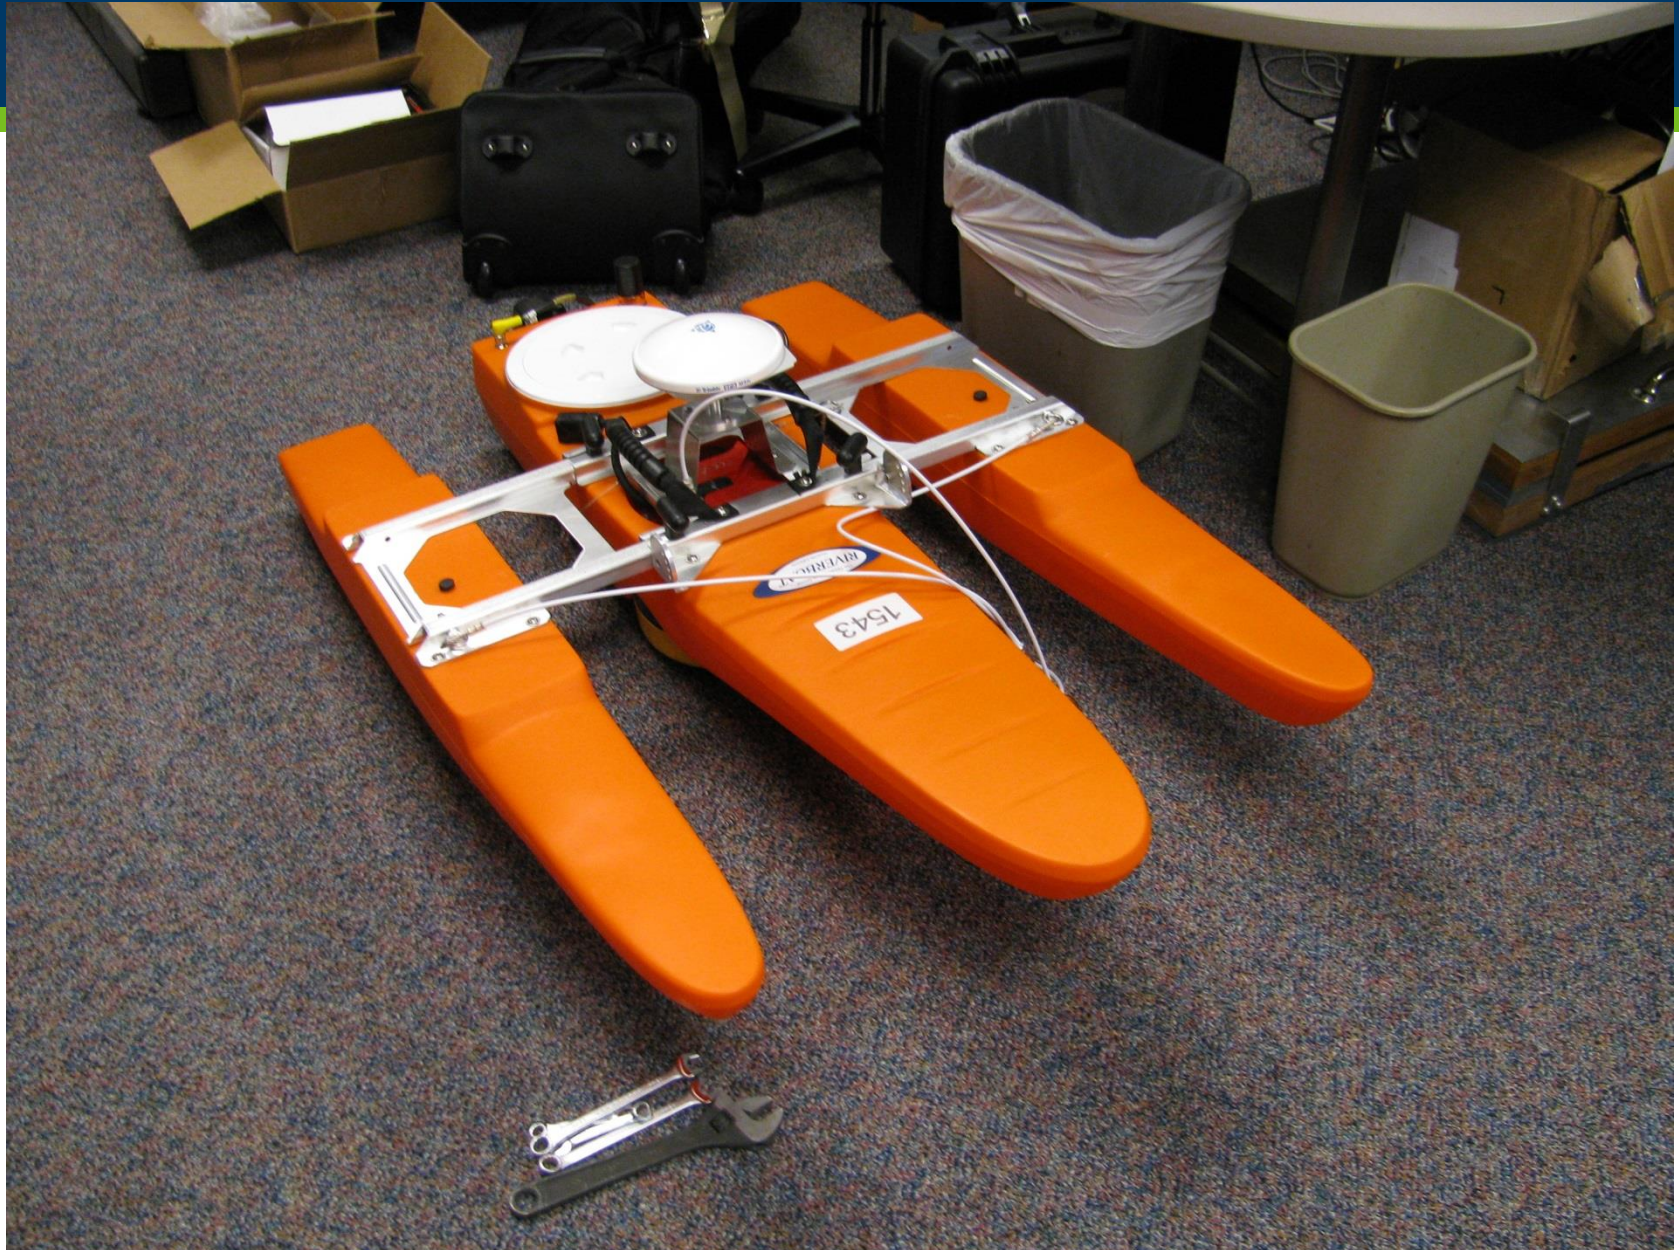
Monitoring during floods

- Side-scan sonar (Humminbird 898c)
 - Pole mounted
 - Boogey-board
- ADCP
 - Mounted on riverboat
- Partner with USGS to measure tough spots

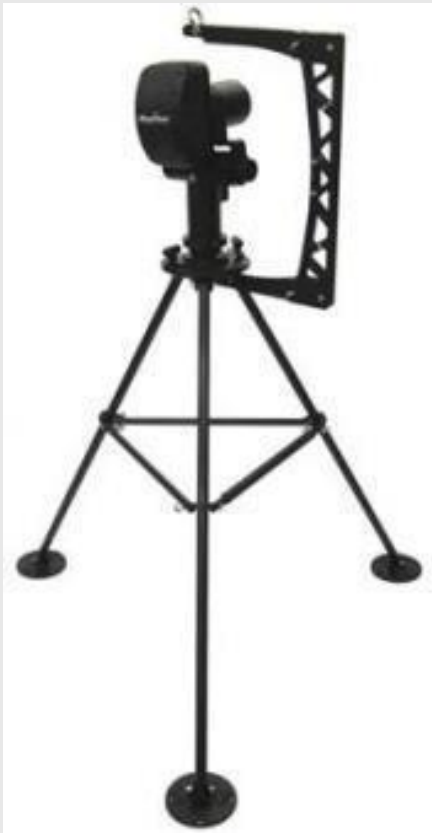
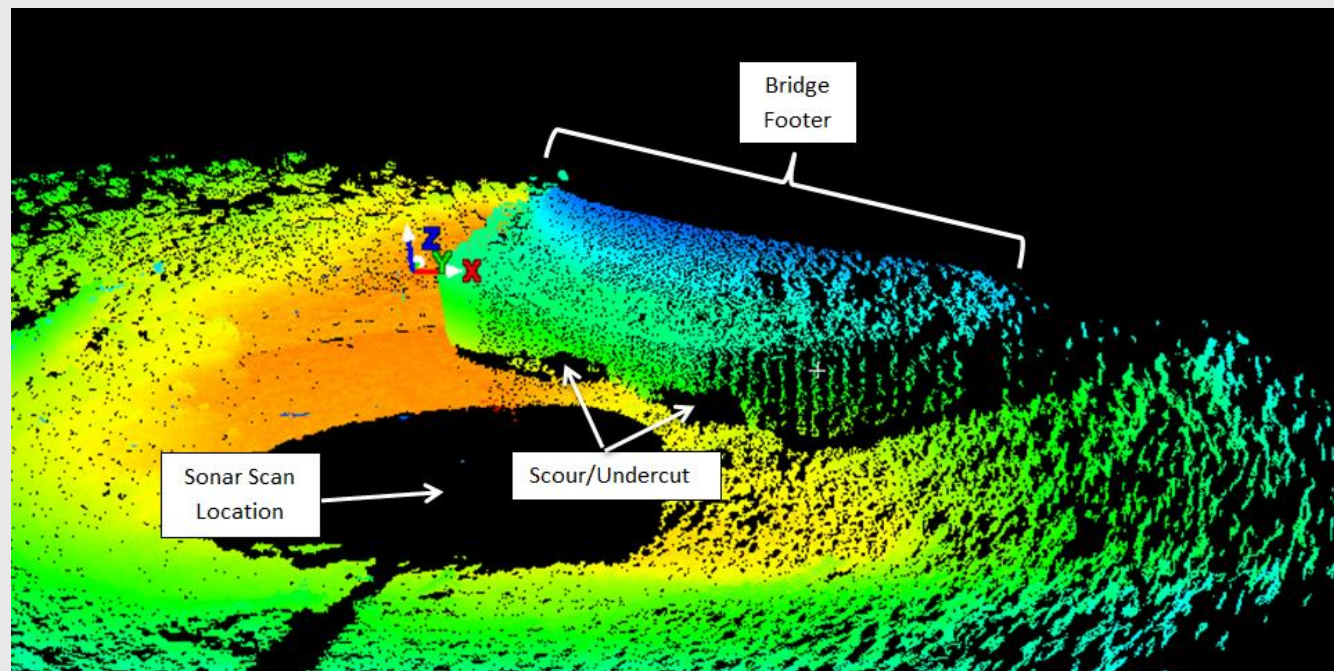
BV5000 3D System

- 3D mechanical scanner
 - Blueview 1350
- Side scan
- Visual inspection
- Partner with underwater divers to get a complete picture

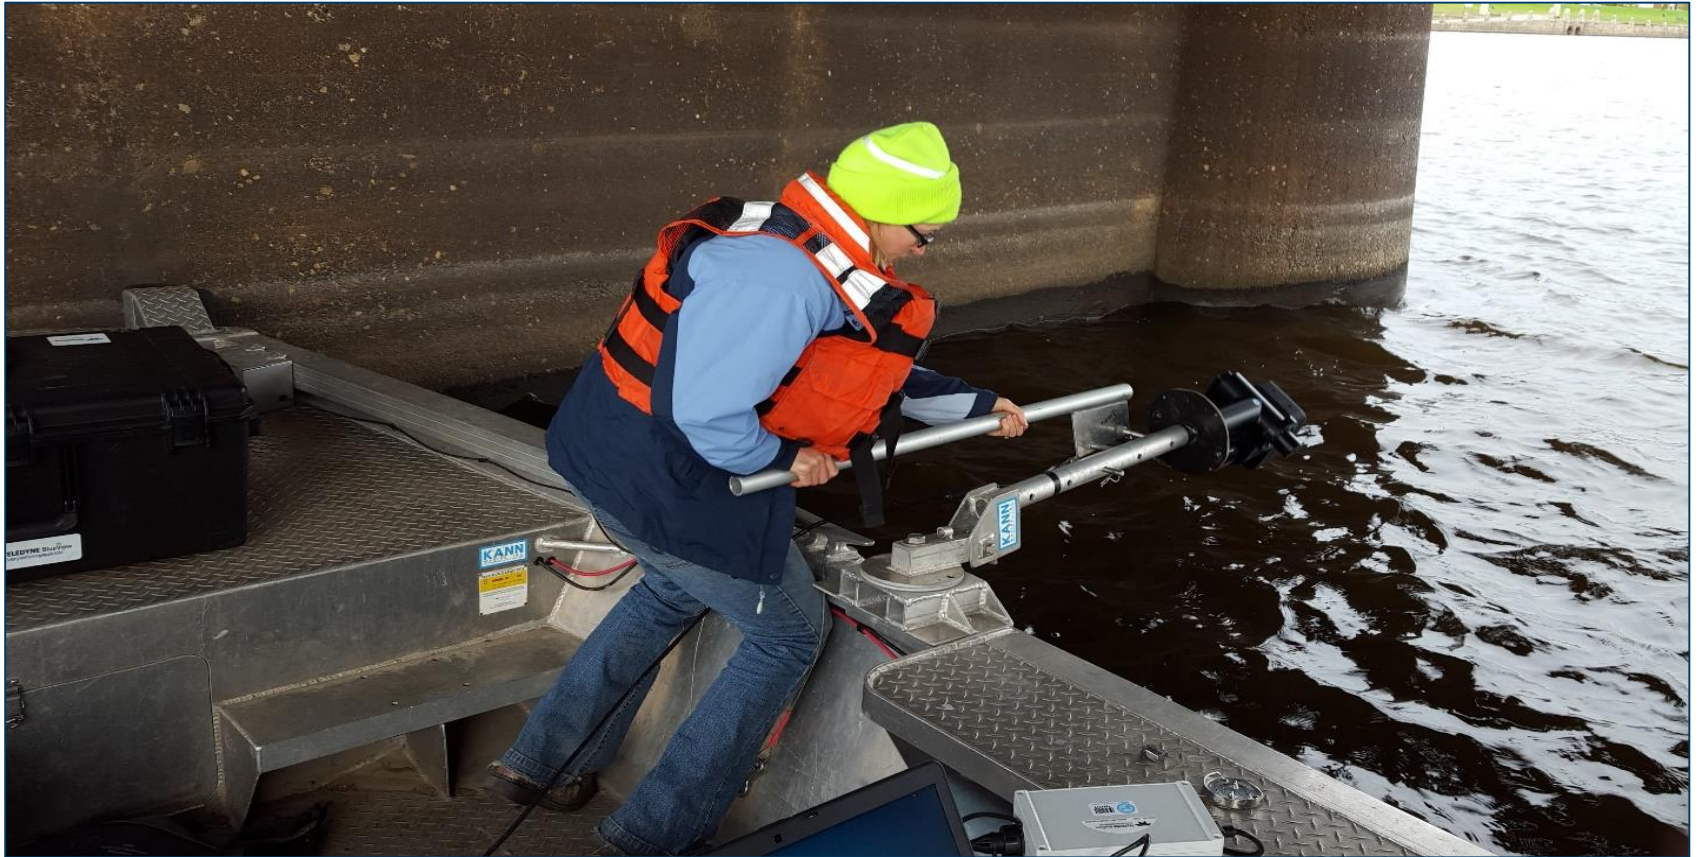
Boat Mounted Surface Stationary Deployment Method

- There are three basic deployment methods: boat mounted surface, metal plate, and tripod.

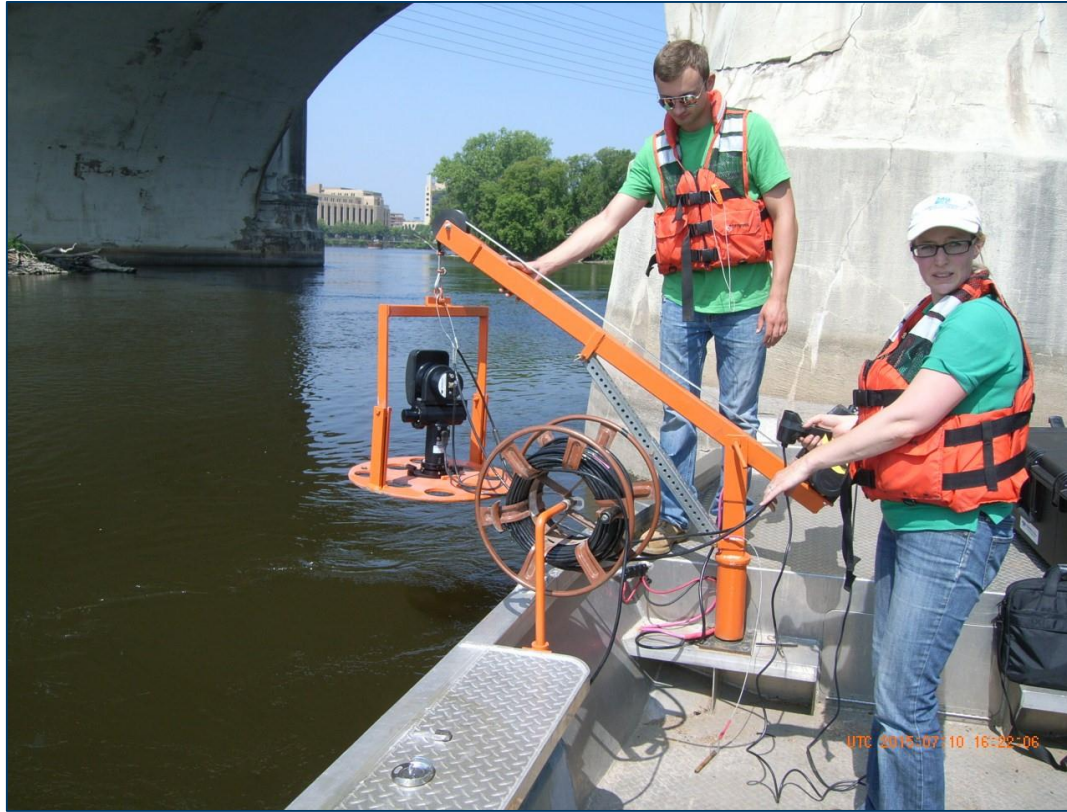
Metal Plate Stationary Deployment Method

Plate was manufactured by our Mankato District bridge maintenance staff. It weighs about 75 lbs with the pan and tilt unit mounted on it.

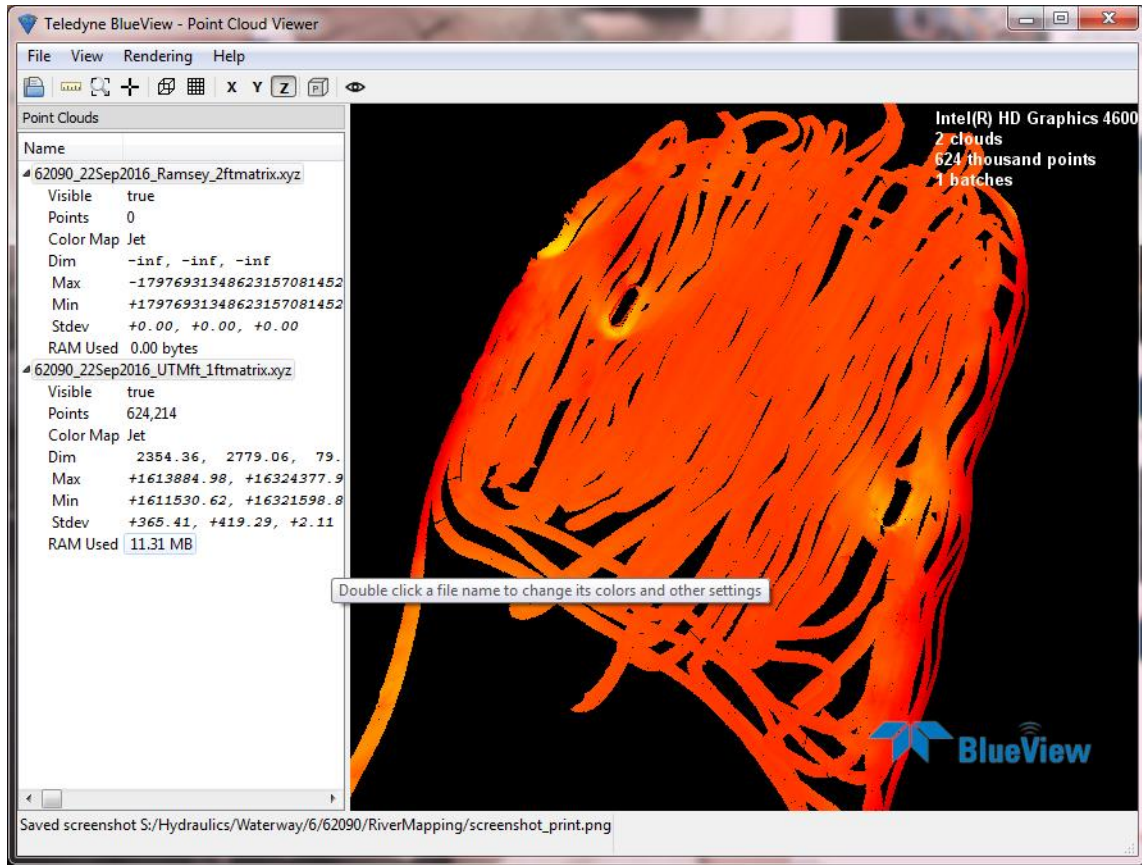
Mobile Scanning

- Data is Geo-Referenced
- Pitch and Roll are accounted for
- Soundings of structures using stationary methods can be “dropped” into this data set
