Report on In-situ Water Quality Monitoring over Three Years in the Upper Tiffin River, Michigan

C. Brooks, C. Hatt, T. Dajos, L. Liversedge, M. Wienert, and R. Shuchman

May 2008

Michigan Tech Research Institute (MTRI)

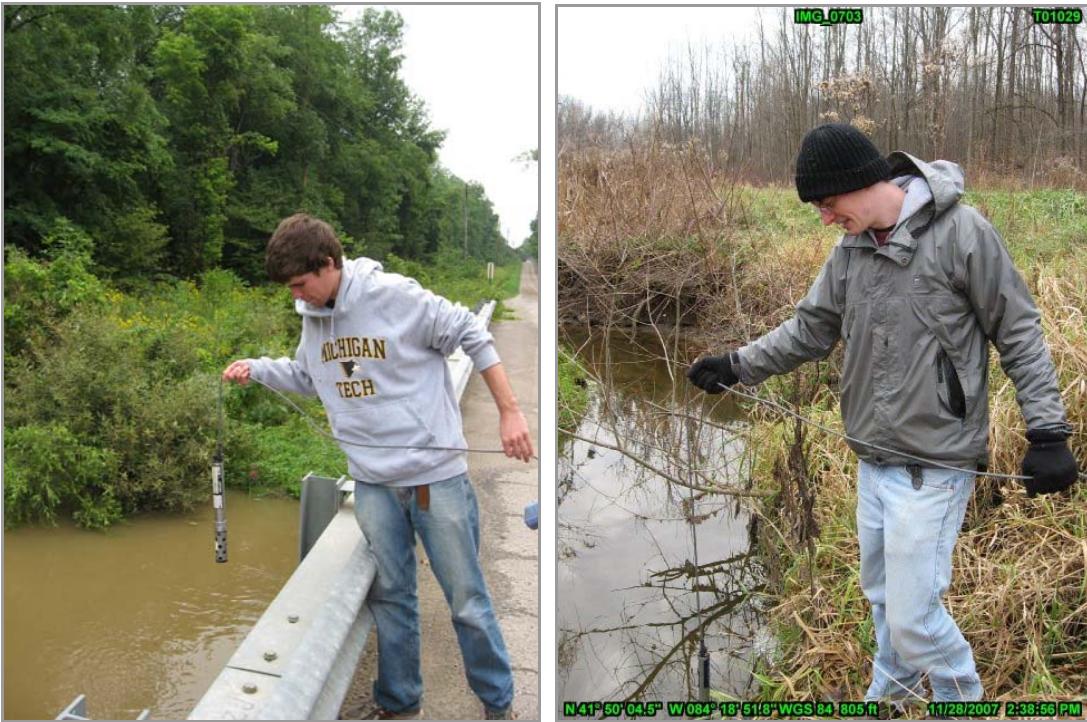
Figure 3-1: Two examples of the Horiba U-22XD instrument being used by MTRI interns to collect water quality data in the Tiffin River study area. The photo in the left shows the instrument about to collect data in a turbid segment of Bean Creek; the photo on the right shows the instrument being used to actively collect data along part of Lime Creek

Sampling was conducted April 2005 to December 2007 to establish a baseline dataset. A Horiba U-22XD multi-parameter water quality monitoring device, a product of Horiba, Ltd, was used to collect water quality data. Figure AA shows two examples of the Horiba U-22XD instrument in use in the study area. This 46mm diameter sensor probe simultaneously measured ten water quality parameters within 20 seconds and stored the collected data for later retrieval and analysis. The Horiba U-22XD probe measured the following parameters:

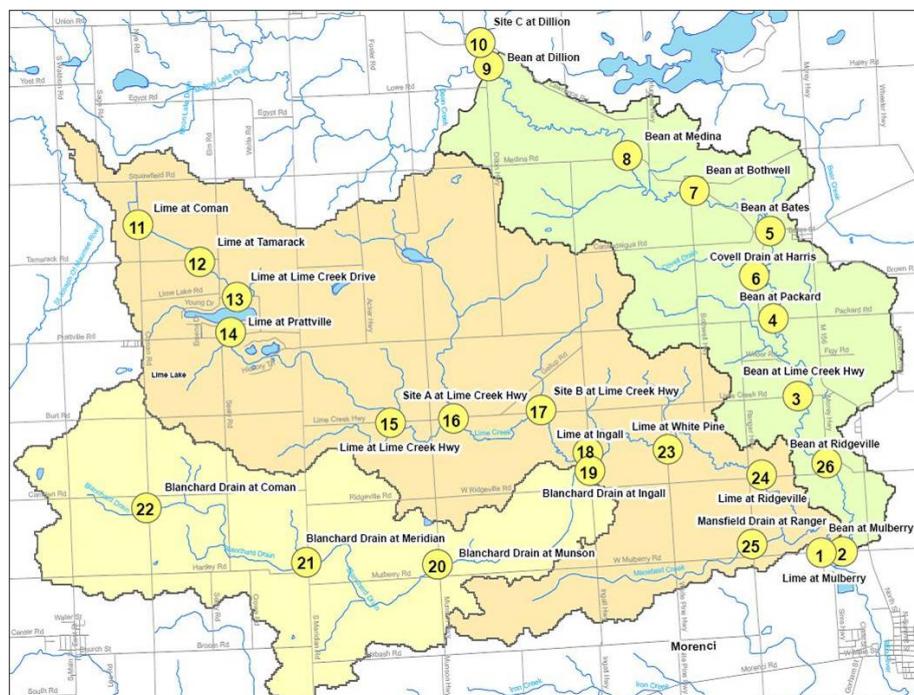
Figure 3-2: Tiffin study area. Green indicates Bean Creek, orange Lime Creek and yellow Blanchard Drain

The Tiffin study area can be broken into three portions; Bean Creek, Lime Creek and Blanchard Drain (Fig. 3-2) (for many of our analyses, we included Blanchard as part of Lime). The Bean Creek subwatershed extends north past the designated Tiffin study area, so only the lower 7 miles of the creek, accounting for 10 sampling locations, were examined during the 32 month program. The entire Bean subwatershed is approximately 41.5% agricultural land, 17.5% forested and 26.9% Conservation Reserve Program (CRP) and other grassland, using MTRI's 2006 land cover classification of the study area as our base. Typically, Bean Creek has a wider riparian area than either Lime Creek or Blanchard Drain. Lime Creek has 72.7% agricultural land cover and 13.2% grassed CRP, while Blanchard Drain is 81.5% agriculture and 7.1% CRP. These two streams account for 12 and 4 sampling sites respectively. Photo example of all the sampling points shown in Figure 3-2 are included in Appendix E.

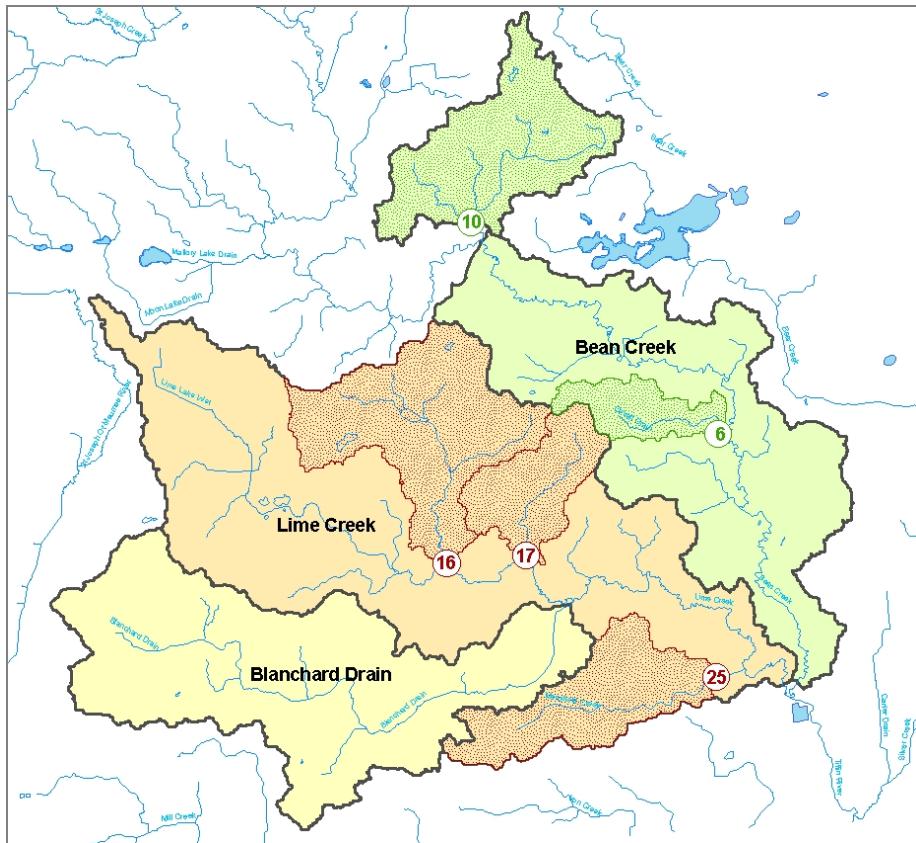
Figure 3-3: Drainage area represented by sampling points for sub-watersheds entering the Bean Creek, Lime Creek, and Blanchard Drain parts of the study areas.
Site 10 is Site C at Dillion (which drains 3,152 acres); Site 6 is Covell Drain at Harris (which drains 898 acres), Site 16 is Site A at Lime Creek Highway (which drains 3,723 acres), Site 16 is Site B at Lime Creek Highway (draining 1,503 acres), and Site 25 is Mansfield Drain (draining 2,268 acres).

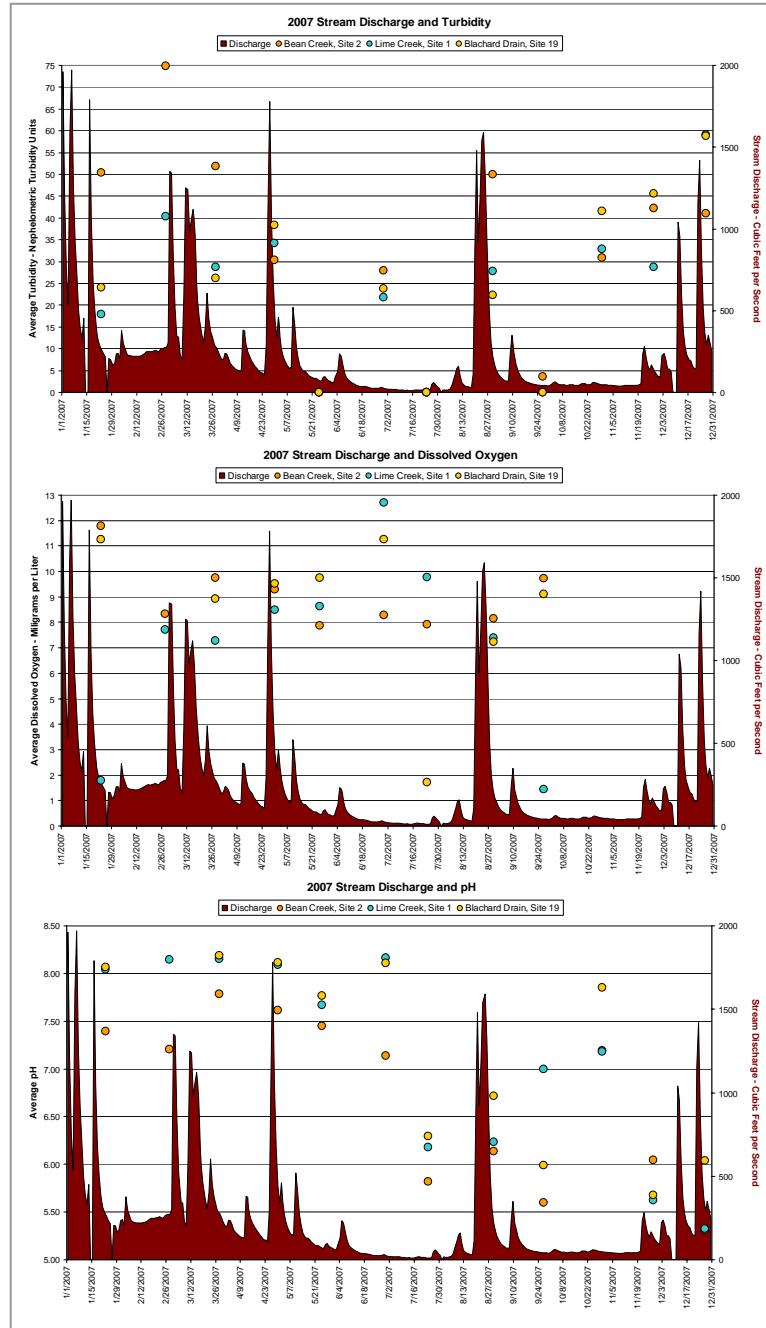
Figure 4-2: Daily discharge and average turbidity, dissolved oxygen and pH at points furthest downstream.

Figure 4-2 compares the daily discharge in cubic feet per second with pH, dissolved oxygen, and turbidity for the sites representing the mouths of each of the three main stream systems sampled (i.e., the furthest downstream point of each sampled creek). These are Site 2, Bean Creek at Mulberry, Site 1, Lime at Mulberry, and Site 19, Blanchard Drain at Ingall.

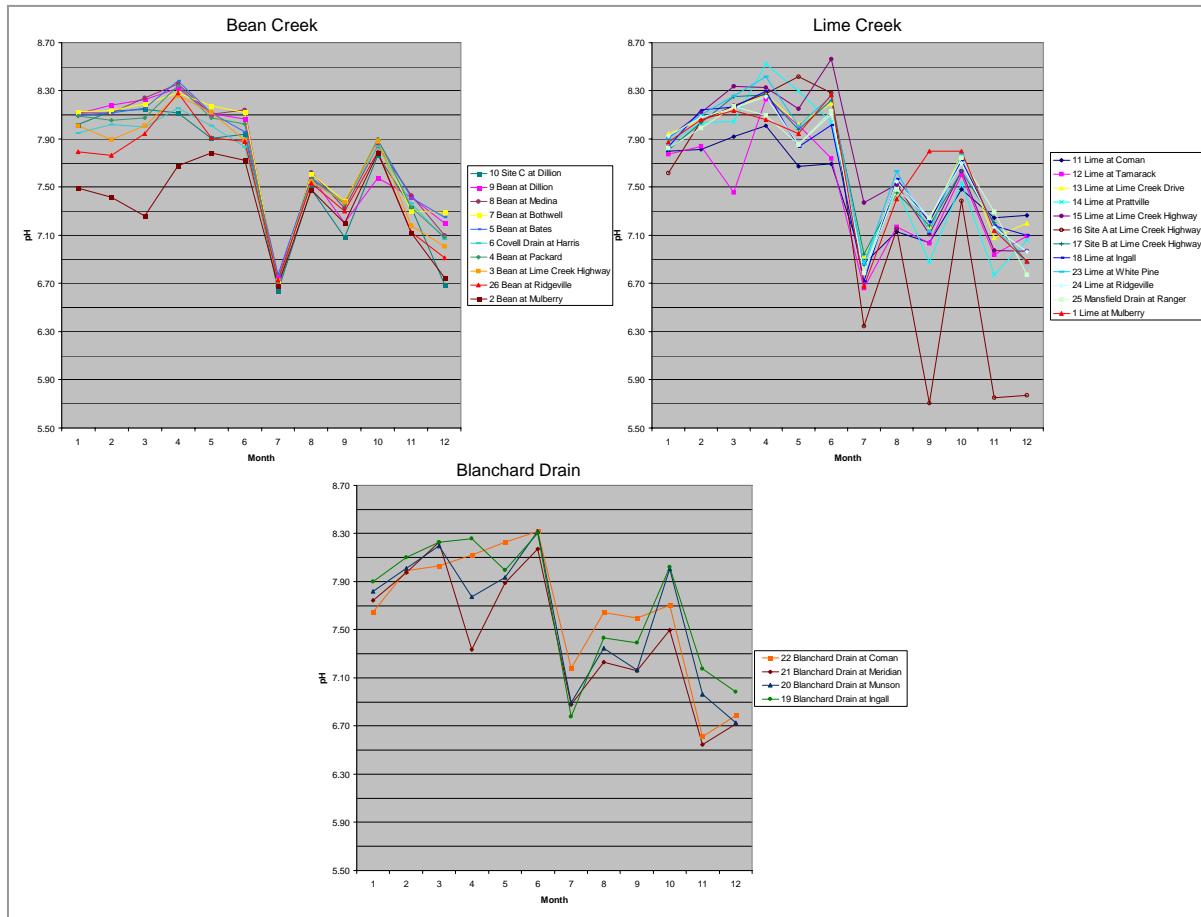
Figure 4-3: Average monthly pH trends for all sites on Bean Creek, Lime Creek and Blanchard Drain. An obvious decrease in pH across all sites can be observed in the month of July.

Each parameter was also analyzed statistically by month for each year. From this, it can be determined if there are seasonal variances in the data. Appendix A contains the tables detailing these statistical values, from which graphs were created using combined values for the three years by month (Appendix B). Of the seven parameters graphed, the monthly pH, turbidity and dissolved oxygen averages were perhaps the most interesting. In Bean Creek, the pH sees a dramatic drop in July and drops again in December. This decrease can also be easily seen in Lime Creek and Blanchard Drain (Figure 4-3).

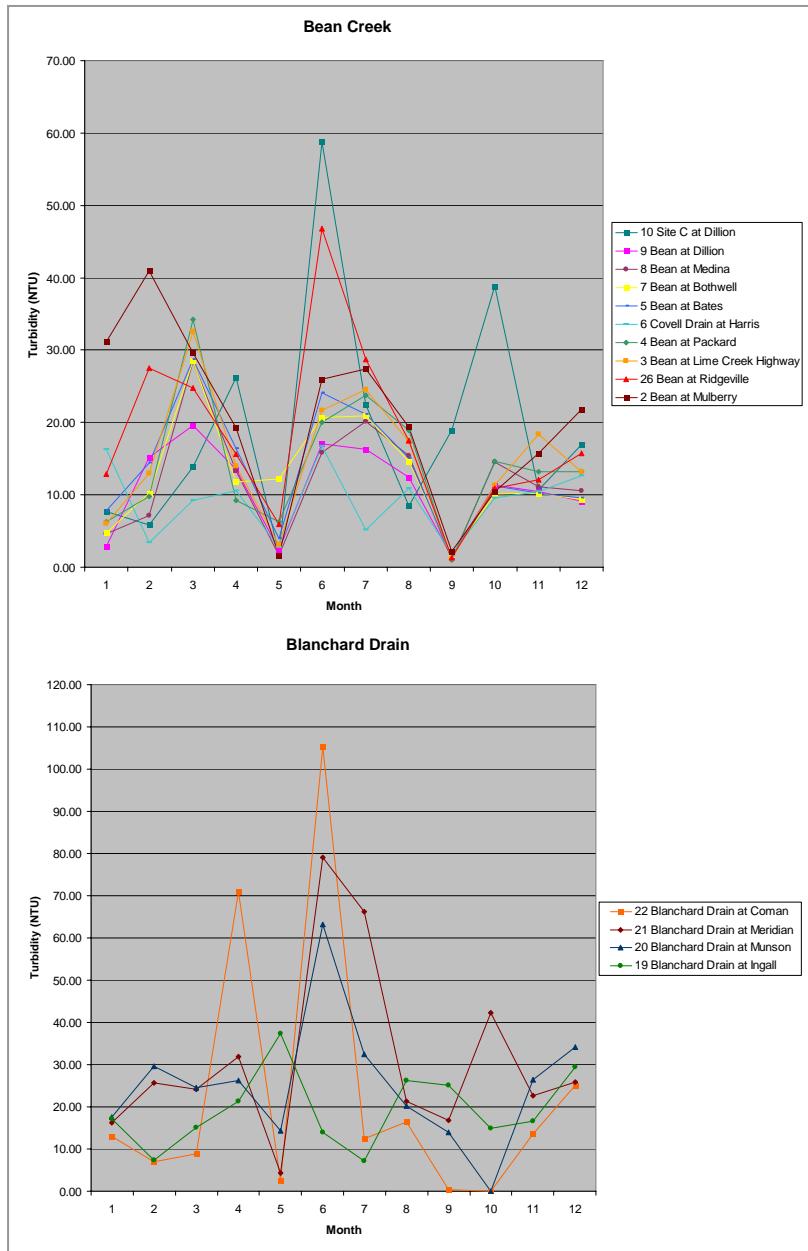
Figure 4-4: Average monthly turbidity trends for all sites on Bean Creek and Blanchard Drain. Sharp increases can be noted in March, April, and especially June, for multiple sites on both stems.

Bean Creek and Blanchard Drain also had similar trends in turbidity (Figure 4-4). Both showed increases in turbidity in June. In Bean Creek, the largest increase can be seen at Site 26. In Blanchard Drain, the increase is noted at three of the four sites. There are also significant increases observed in March for many sites on Bean Creek as well as in April for one site at both Bean and Blanchard.

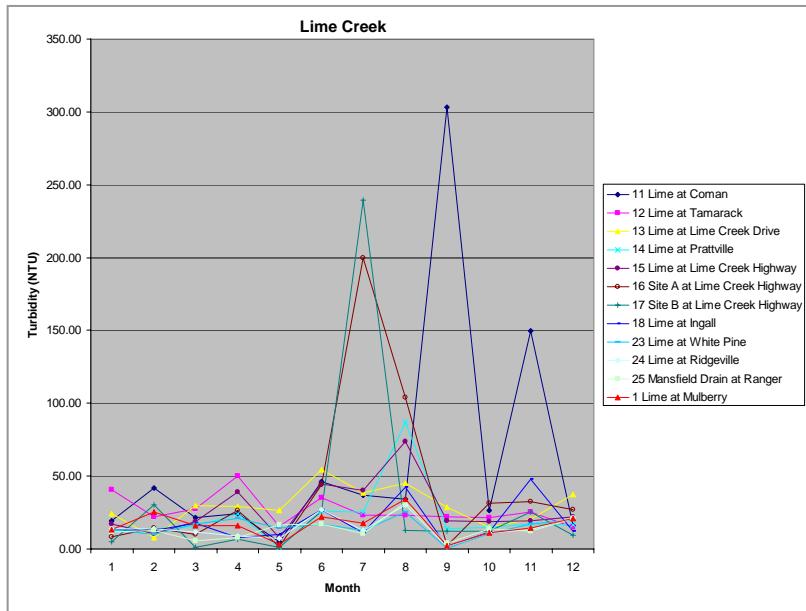
Figure 4-5: Average monthly turbidity trends for all sites on Lime Creek. Three sampling sites, 11, 16 and 17, show extremely large turbidity values at various points when compared with the remaining sites on the stream.

While Lime Creek also experienced increases in turbidity in April and June, the most dramatic changes can be seen in September and October for Site 11 and in July for Sites 16 and 17 (Figure 4-5). The values in these months are much greater than those at any other site on this creek. The next greatest average turbidity value after these four high data points is 87.16 (Site 14, in August). This is a difference of 62.38 to 216.24 NTU.

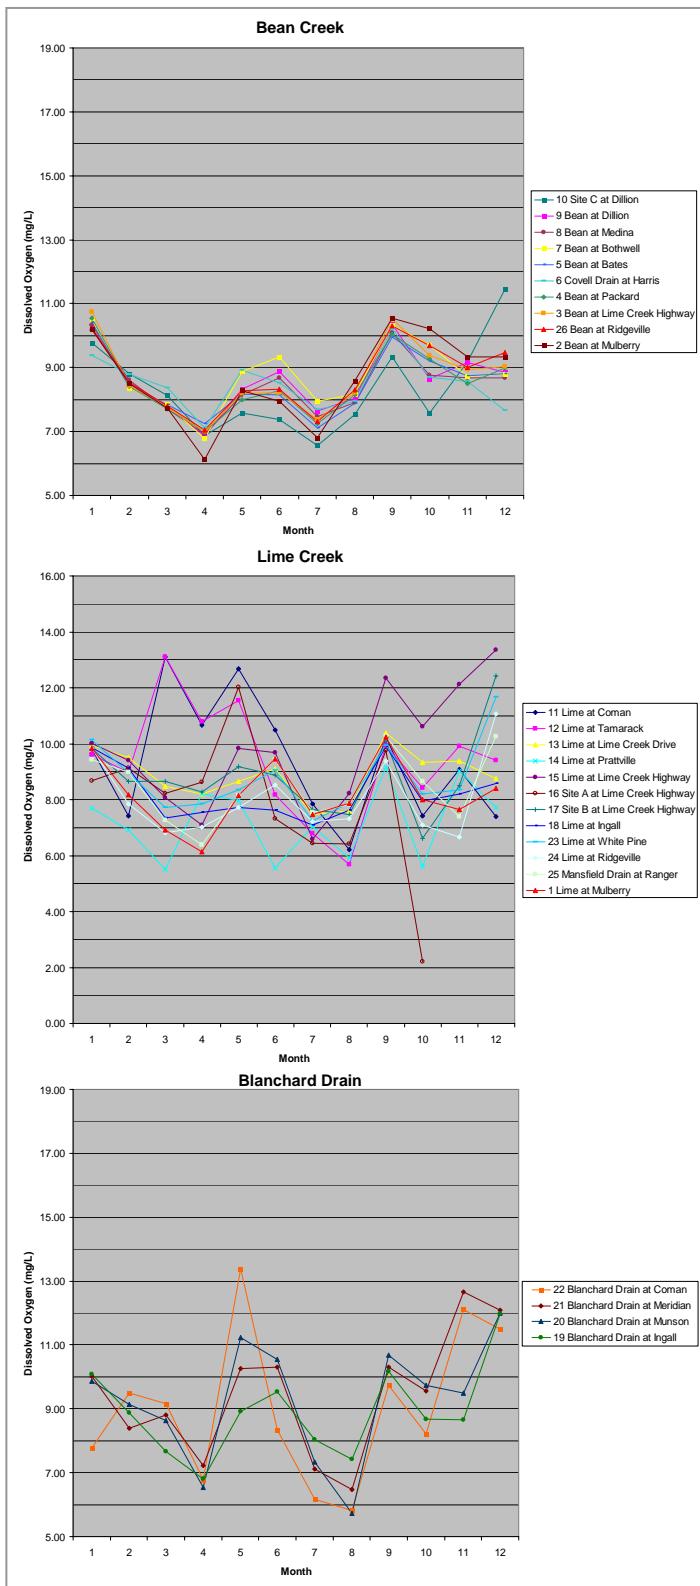
Figure 4-6: Average monthly dissolved oxygen trends for all sites on Bean Creek, Lime Creek and Blanchard Drain. Decreases in April and July/August can be seen across all streams.

The three streams sampled showed varying trends in dissolved oxygen (Figure 4-6). In Bean Creek and Blanchard Drain, all sampling sites displayed a decrease in dissolved oxygen in April. A second decrease can be seen in Bean Creek in July, while the second round came to Blanchard Drain in August. Lime Creek is less consistent between sampling sites, but a decrease at most sites can be seen in April and July/August. Sites 11 and 12 show an increase in March, out of sync with the other sampling sites.

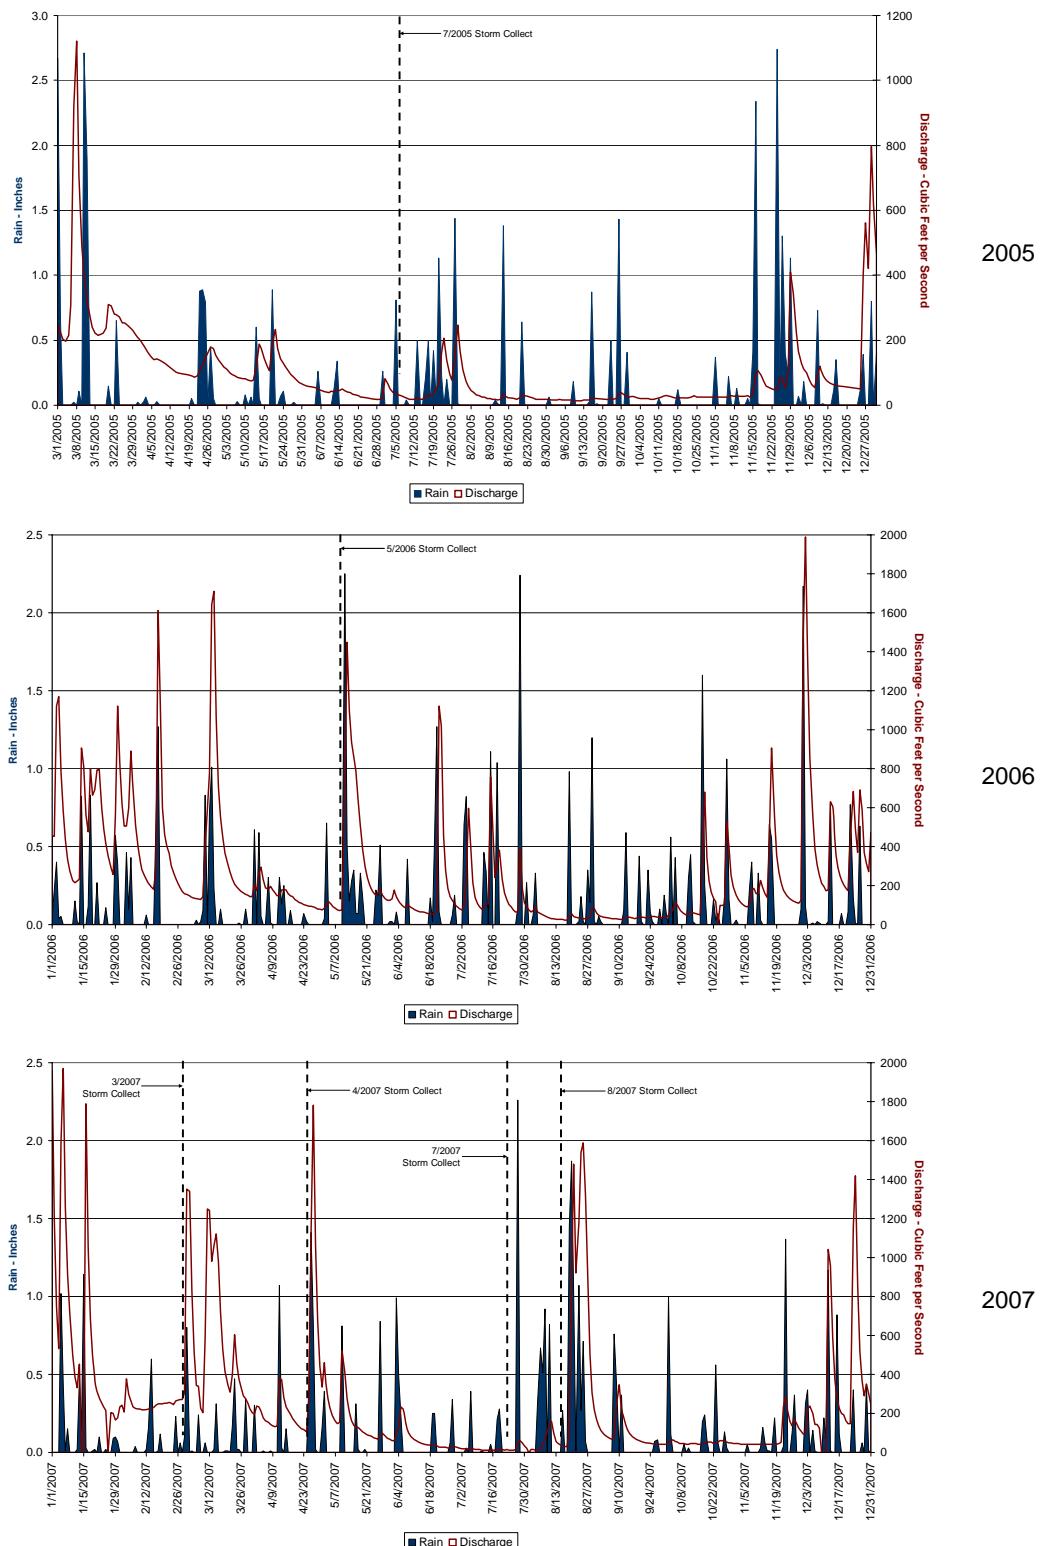
Figure 4-7: Daily rainfall and discharge for 2005-2007. Dates streams were sampled after storms are marked with arrows.

To gain insight into the effects of increased water input during rain events, samples were taken during or immediately after periods of significant precipitation. Those dates were 7/1/2005, 5/15/2006, 3/2/2007, 4/27/2007, 7/27/2007, and 8/21/2007. To analyze change due to storms, the closest regular sample conducted prior to an event was used as our ‘before storm’ reading. A hydrograph for each year (Figure 4-7) shows where our storm collects fell in relation to rainfall and discharge rates.

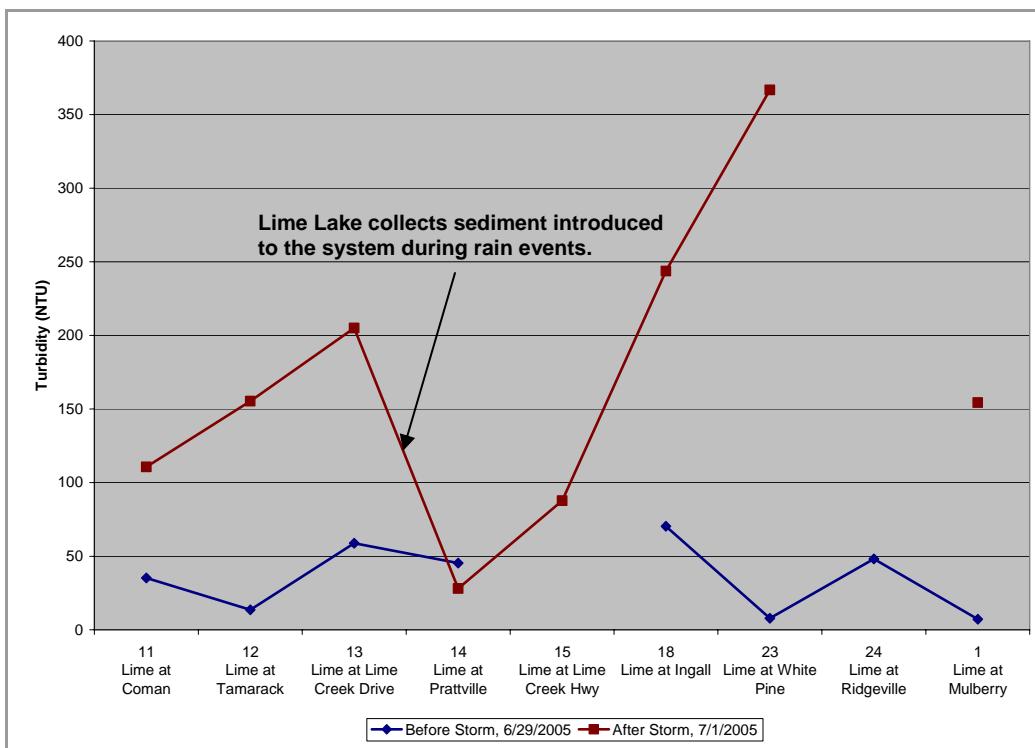
Figure 4-8: Lime Creek turbidity before and after 2005 Storm Event. Readings at all but Site 14 coincide with the typical increase in turbidity observed after storm events.

The decreased effect storms have on turbidity at Site 14 is likely due to its position in relation to Lime Lake. In all Lime Lake turbidity storm graphs for which there was sufficient data, turbidity increases as the points move downstream from Site 11 to Site 13. At Lime Lake, the area between Sites 13 and 14, there is a tremendous decrease in turbidity. The effect Lime Lake has as a settling pond means that at Site 14 storm turbidity values are generally near baseline values. Past Site 14, one can again see the cumulative effect of storm water flow on turbidity as the points move downstream.

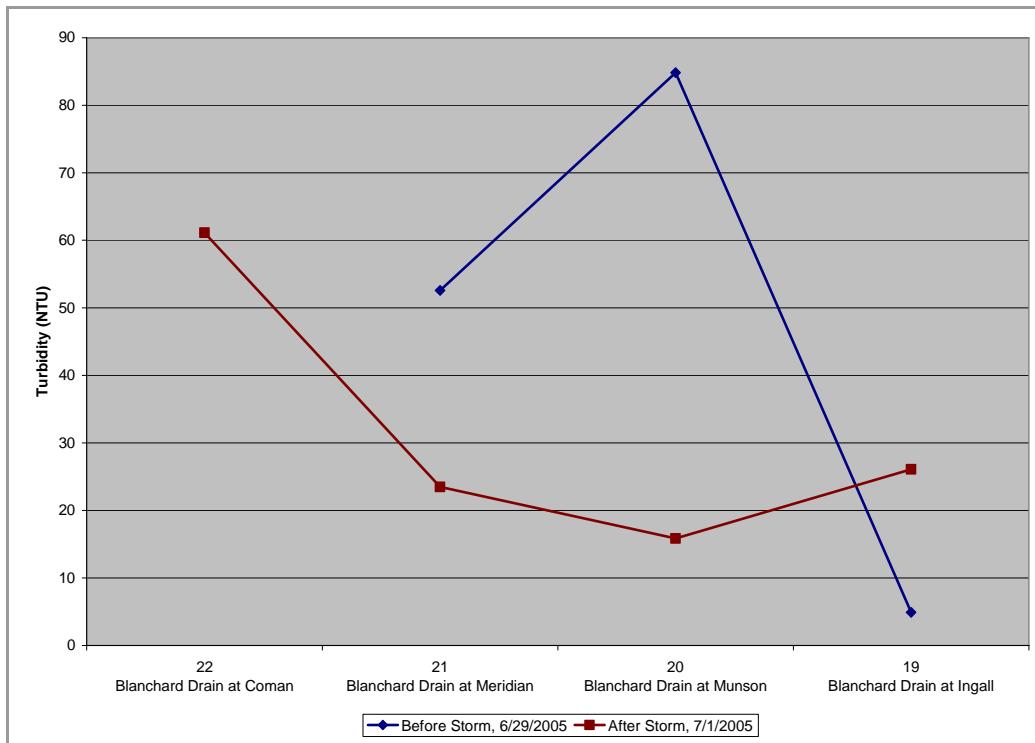
Figure 4-9: Blanchard Drain turbidity before and after 2005 Storm Event. At sites 21 and 20, turbidity decreased after the storm. This is in contrast to typical observations in which turbidity greatly increased after an event

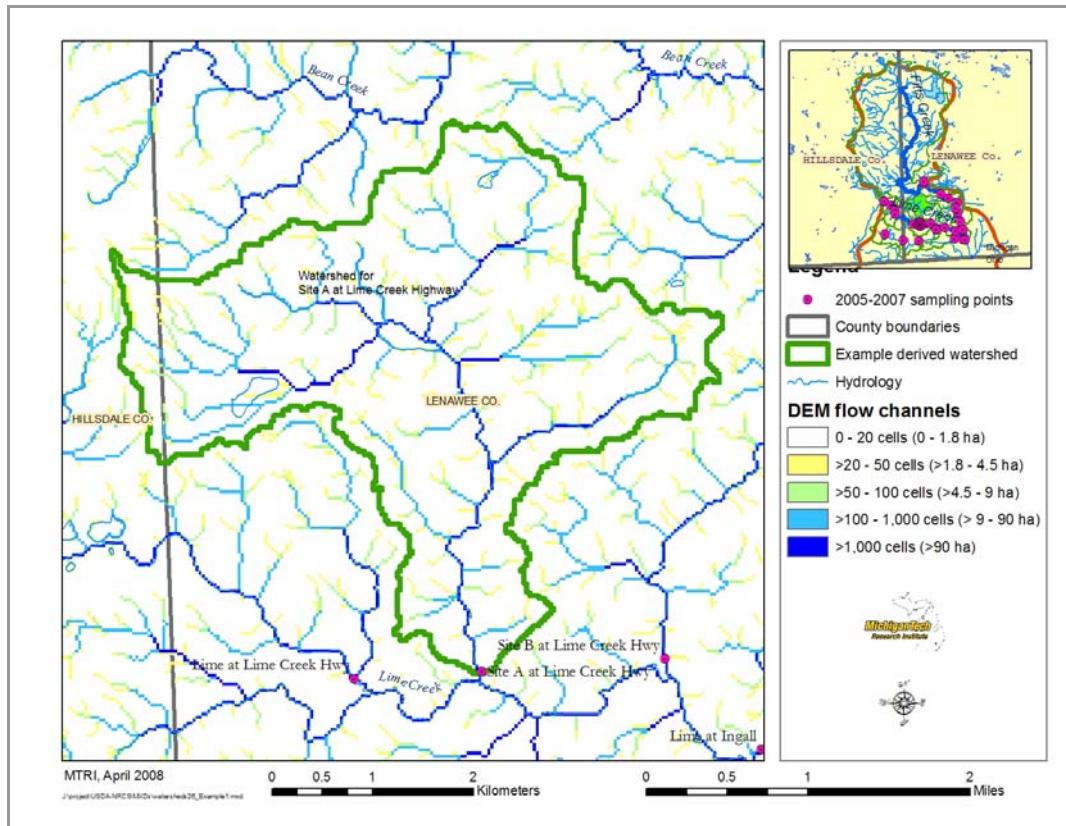
Figure 6-1: Example of watershed derived for one of the 26 sampling locations, using the ESRI ArcHydro extension and USGS 30-m DEM data. The colored flow channels show water flow locations (streams and ditches) calculated with the DEM, which show more detail than standard GIS streams layers and enables more accurate delineation of watershed boundaries.

Figure 6-1 shows an example of one of the watersheds we calculated with ArcHydro, for the "Site A at Lime Creek Highway" location, which is a small (3,723 acre) tributary to Lime Creek.

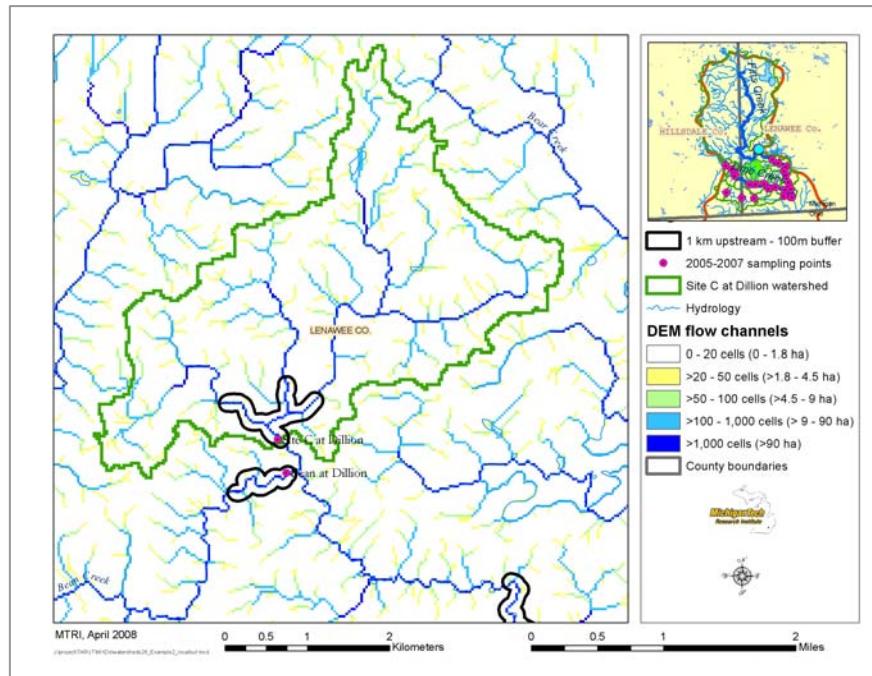
6-2a: Site C at Dillion upstream buffer example, with entire watershed analysis area for this site outlined in green.

For calculating the impacts of land-use for near-stream areas, we selected the parts of the streams that were 1 kilometer upstream of each of the 26 sampling locations. We selected the 1-km distance because in previous research, one of the researchers (C.Brooks) had found this to be a reasonable distance characterizing the “near upstream” areas of rivers and creeks (see Opperman et al. 2005). We used a routine for ArcView 3.x in the “RouteSurvey” extension called “Buffer upstream a distance” that enabled us to select the 1-km distance, and then buffer out on each side by 100-meters. In our previous work for NRCS, we had determined that 100-m on each side of a stream effectively captured the riparian of streams in the Upper Tiffin River area. One key aspect of the RouteSurvey extension is that it captures the “true” upstream distance of all the upstream hydrology network – if a side tributary is reached after a certain distance (say 700 m), then in addition to selecting the next 300 m of the main stem, it will also select the needed distance of the side tributary (also 300 m). Figures 6-2a and 6-2b shows how this translates into actual areas for the “local upstream buffer” of Site A and Lime Creek Highway and Site C at Dillion. Site C at Dillion has two small tributaries that come into its main stream before the creek empties into the main stem of Bean Creek.

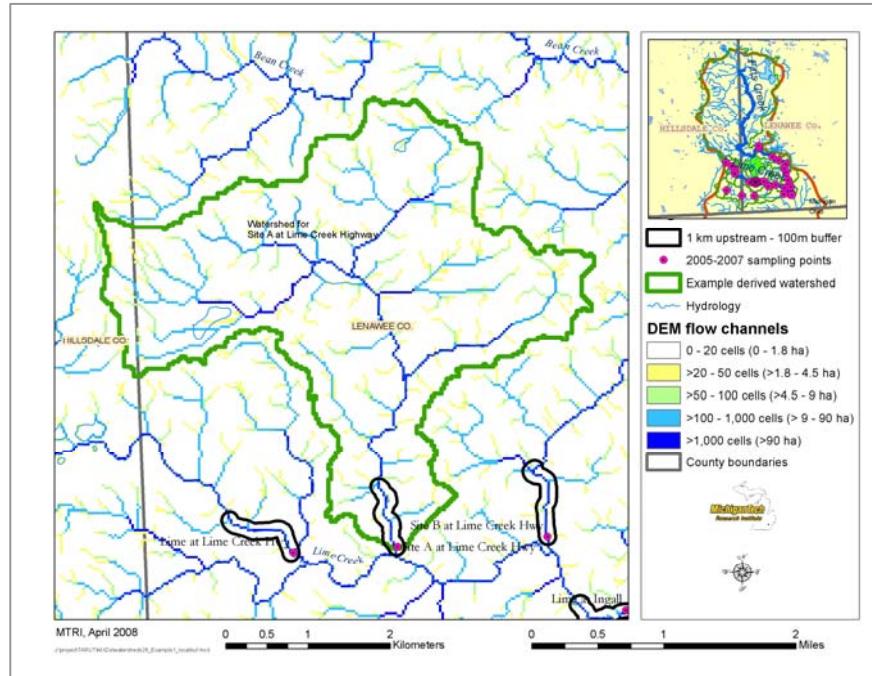
6-2b: Site A at Lime Creek Highway upstream buffer example, with entire watershed analysis area for this site outlined in green.

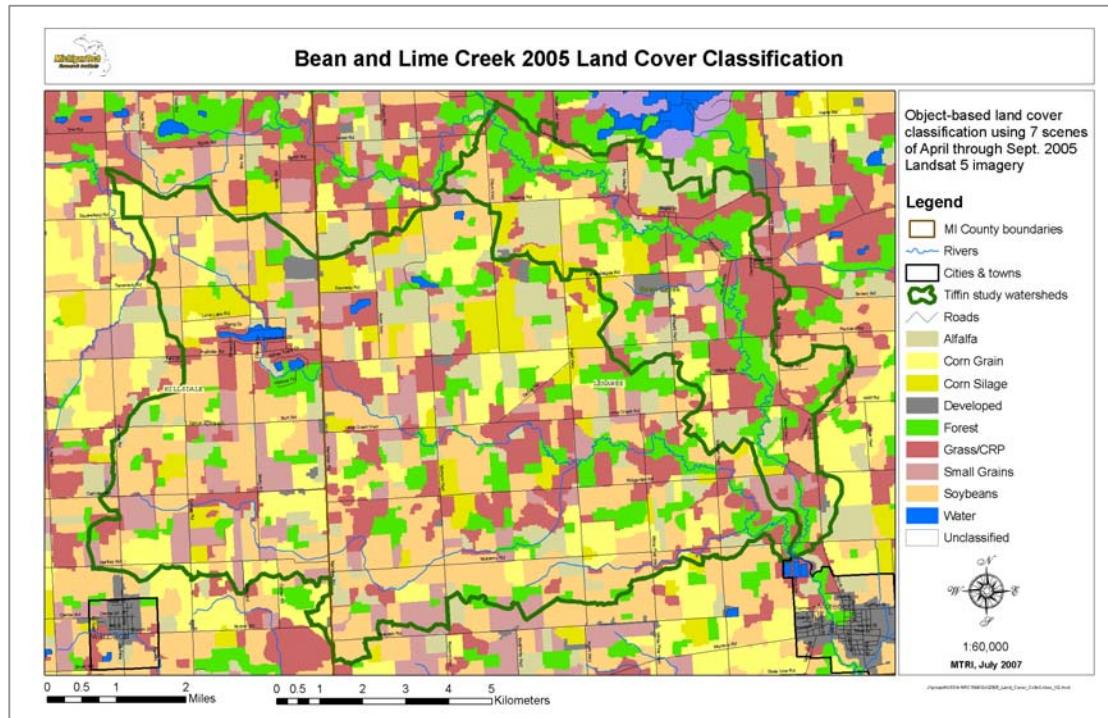
Figure 6-3: 2005 land cover for the Upper Tiffin River study area. We calculated land cover for the entire Bean Creek area upstream of the study area so we could capture the land cover profiles for the entire watersheds of Bean Creek sampling points. We also calculated equivalent 2006 land cover, also using multiple growing season Landsat scenes to capture crop phenology.

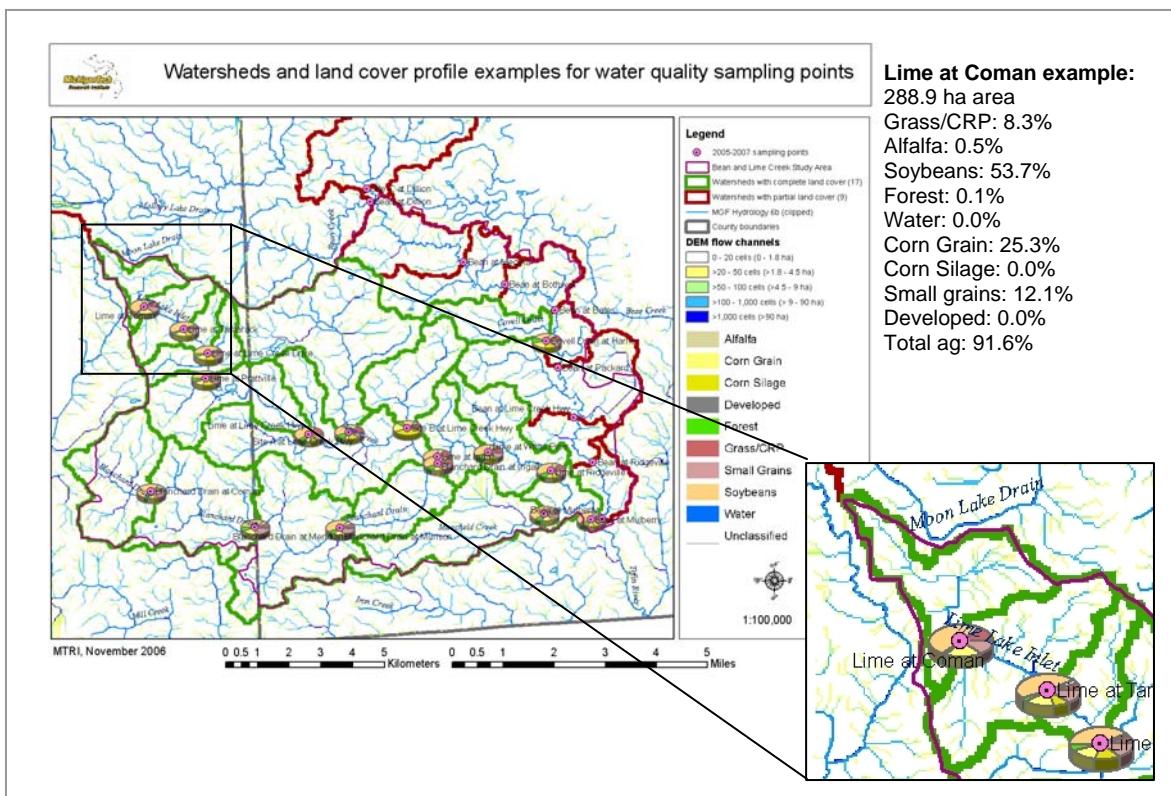
Figure 6-4: Example land cover profiles for the 2005 Lime Creek-area sampling point watersheds.

Figure 6-4 shows the result of intersecting the watersheds we calculated for each of the 26 sampling sites with the 2005 land cover. To intersect the watersheds and 1-km upstream buffers for the 26 sampling points, we used the “Tabulate Areas” functionality of ArcGIS and processed the results into percentages of land cover types using Microsoft Excel. Using this method, each sampling site watershed and 1-km upstream buffer had a land cover profile for it. For example, in 2005, the 288.9-ha (713.9 acre) Lime at Coman watershed was 53.7% soybeans, 25.3% corn grain, 12.1% small grains (wheat or oats), 8.3% grassland / Conservation Reserve Program (CRP) land, 0.5% alfalfa, 0.1% forested, with no corn silage or detectable water bodies, and 91.6% active agricultural land during that growing season. The same type of profile data was calculated for the 1-km upstream buffer areas so we could investigate if the local buffer or watershed scale was having a stronger impact on water quality.

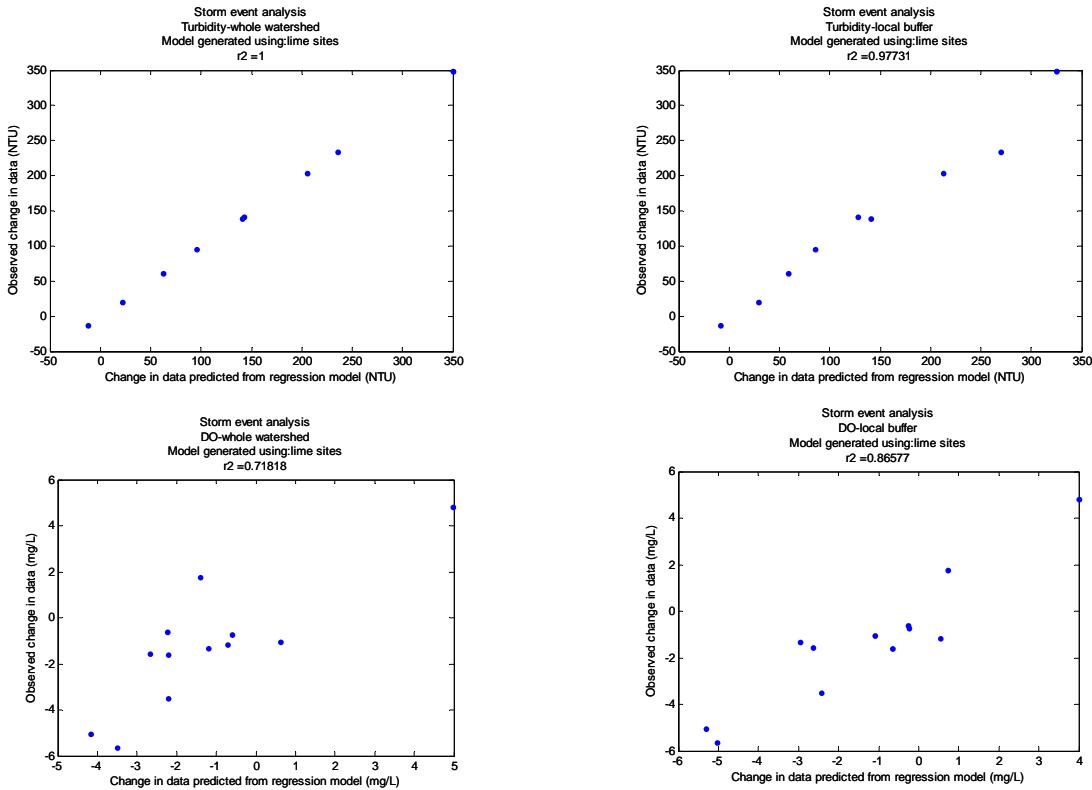
Figure 6-5: Examples of the regression models displayed graphically for turbidity and DO for the local buffer and watershed scales. Stronger relationships between water quality parameters can be seen with straighter lines, which equal higher r^2 values. Turbidity is consistently strongly associated with land cover at both the watershed and local buffer scales, while DO is more strongly associated with land cover at the local buffer scale.

Figure 6-5 shows four examples of the regression models for turbidity and DO, at both the watershed and local buffer scales of analysis. Using the storm event water quality data, these figures depict how well these parameters can be predicted using the land cover area profiles we extracted using the intersection method described previously. For example, at the whole watershed scale, the DO values are more scattered, equating with a lower (0.71818) r^2 value as compared to the local buffer scale ($r^2 = 0.86577$). This means that DO can more reliably be predicted with land cover data at the local buffer scale (100-m each side of the 1-km stream reach).

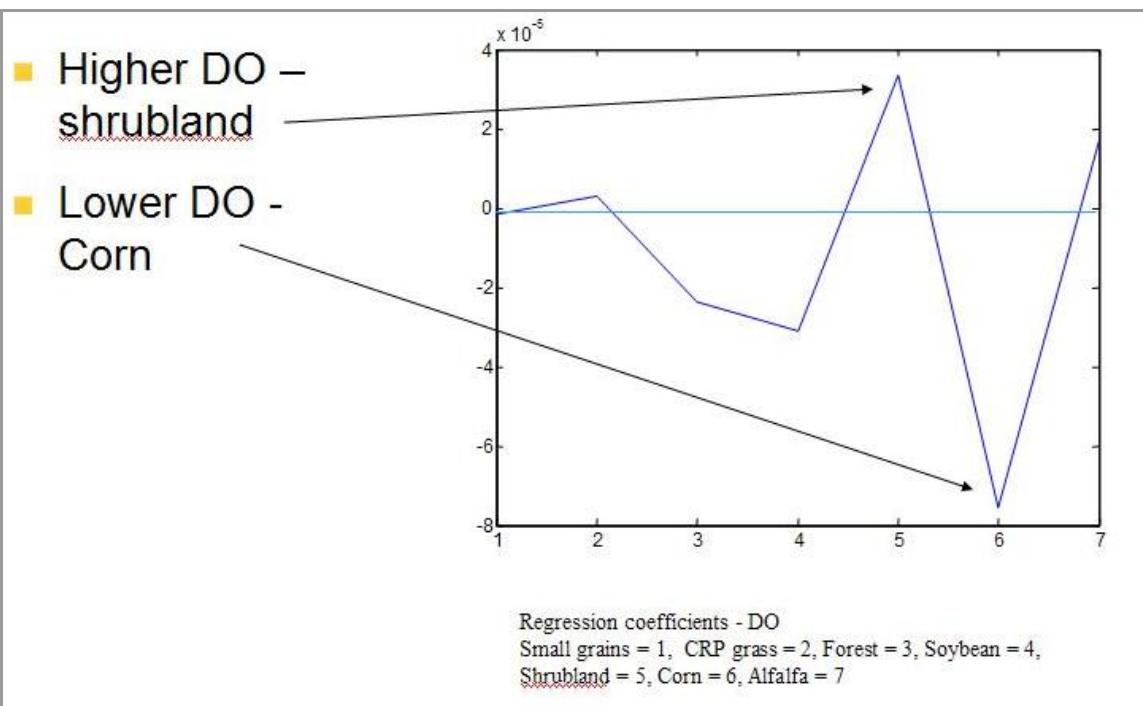
Figure 6-6: Graph of the relative contribution of land cover variables on variation in regression model for Dissolved Oxygen. Relatively high or low values indicate that a particular land cover variable is having a greater impact on the water quality variable, and in a particular direction. In this example, shrubland (land cover type 5) is associated with higher DO levels, while corn (land cover type 6) is associated with lower DO values.

With these regression equations calculated, we were able to see if specific land cover types were associated with changes in water quality parameters. Figure 6-6 shows an example for DO for this parameter analysis, while figure 6-7 shows an example for pH; these were calculated for all parameters. In Figure 6-6, the two emphasized peaks show that higher DO values are most strongly associated with larger amounts of shrubland, while lower DO values were strongly associated with larger amounts of corn in the watershed. In figure 6-7, soybeans, shrubland, and particularly corn are associated with increased acidity (values below 0) while small grains, CRP/grassland, forest, and alfalfa are associated with decreased acidity. In the same analysis and looking at the data for an entire year, higher turbidity was associated with soybeans and corn grain; the latter was surprising since corn grain has higher crop residue levels. Alfalfa, corn silage (again surprising because of lower residue values), small grains, and forest were associated with lower turbidity values.

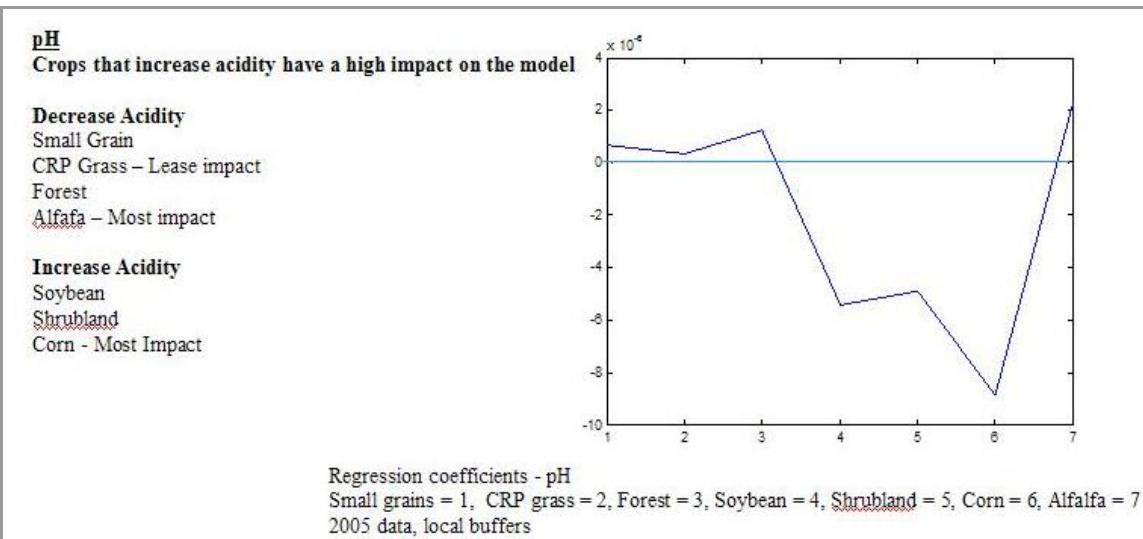
Figure 6-7: Graph of the relative contribution of land cover variables on variation in regression model for pH. In this example, soybeans, shrubland, and corn are associated with increased acidity (lower pH) based on Horiba water samples in 2005.
