**BRIDGE CONDITION ASSESSMENT
USING REMOTE SENSORS**

Volume II of II – Appendices

An Evaluation of Commercially Available Remote Sensors for Assessing Highway Bridge Condition

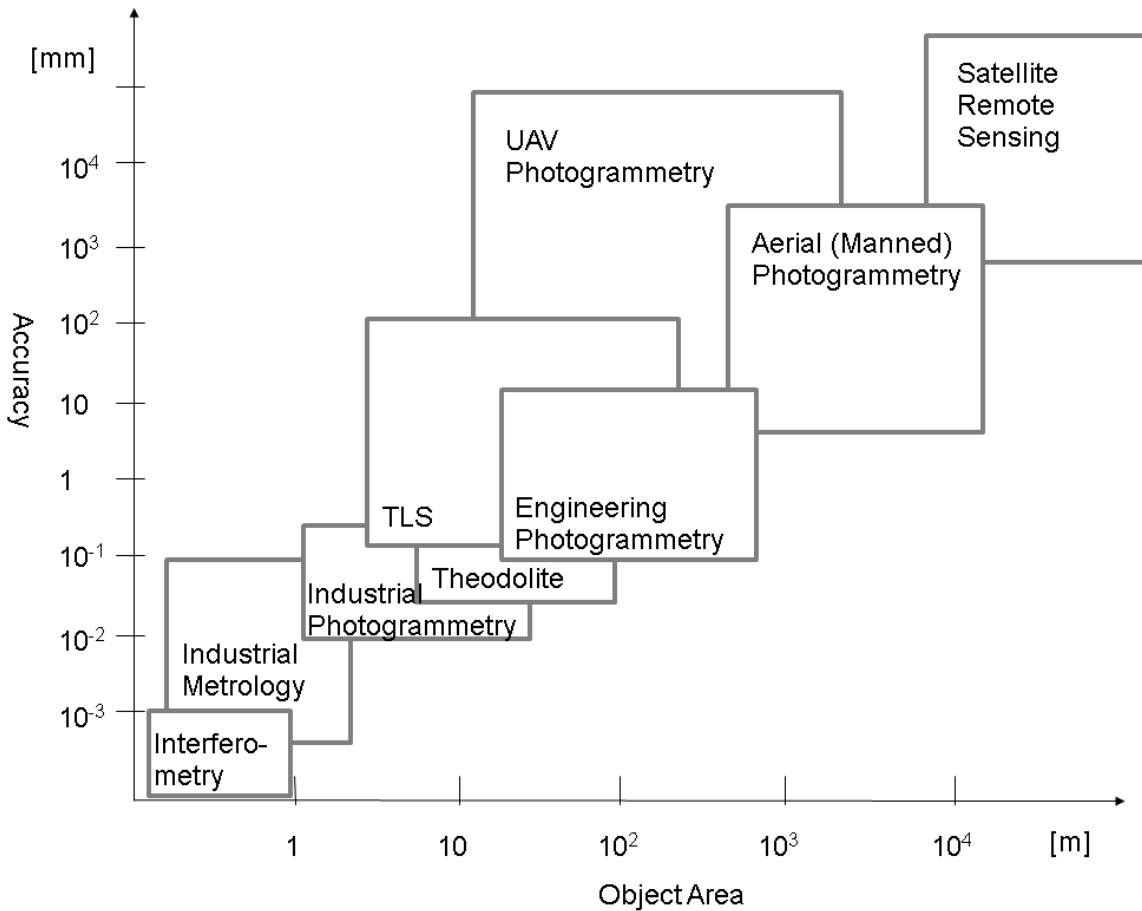
Figure 2: An example of the trade-offs of spatial resolution in terms of accuracy needs and the size of an object or part of an area on the ground that needs to be analyzed via remote sensing (Luhmann et al. 2006)

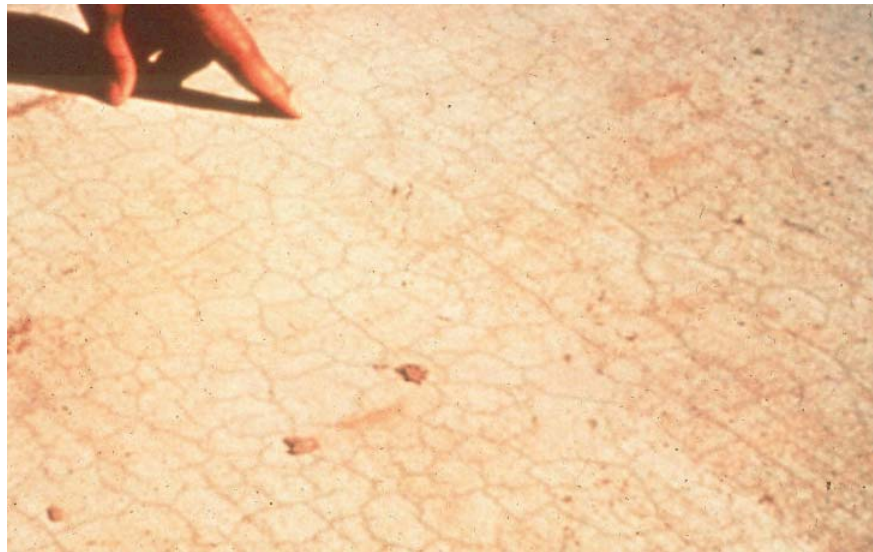
Figure 5: Map cracking on bridge deck surface (FHWA 2006)

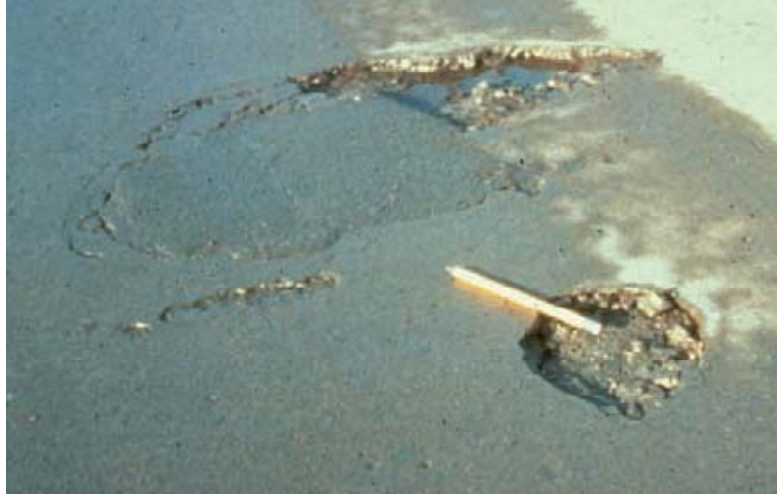
Scaling is an issue with the deck surface that covers the loss of material due to material degradation. Within this review, scaling is considered on the order of magnitude of 1/4” to 1” in depth (FHWA 2006). Figure 6 provides a representative example of moderate surface scaling of the deck surface. The current method for identifying the amount of scaling on a bridge structure is visual assessment and quantification.

Figure 6: Concrete deck surface scaling (FHWA 2006)

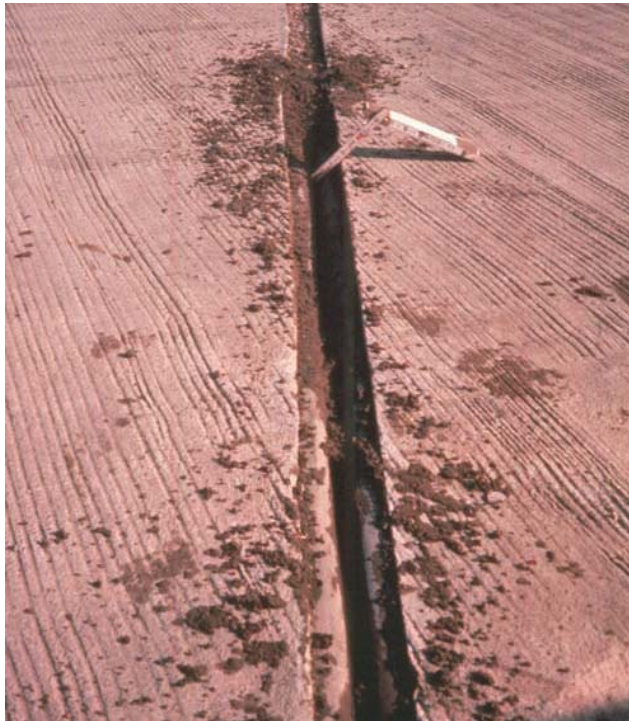
Excessive material in the expansion joint causes increased stresses in the components of the bridge due to the inability to expand. The quantity of material is inconsequential, but the presence of material fill is typically noted from visual assessment. Figure 8 shows an expansion joint that was filled with material.

Figure 8: Material in expansion joint (FHWA 2006)

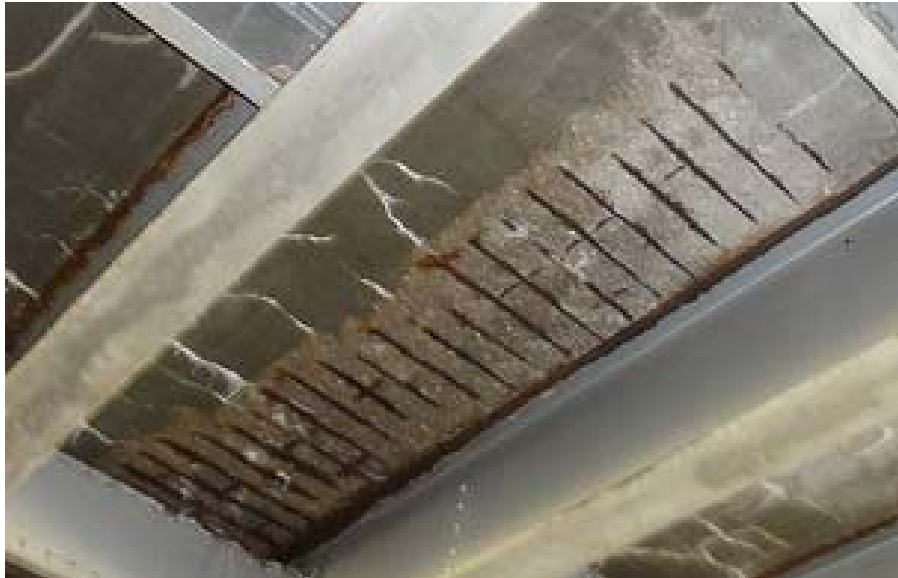
Figure 9: Spalling on bridge deck surface

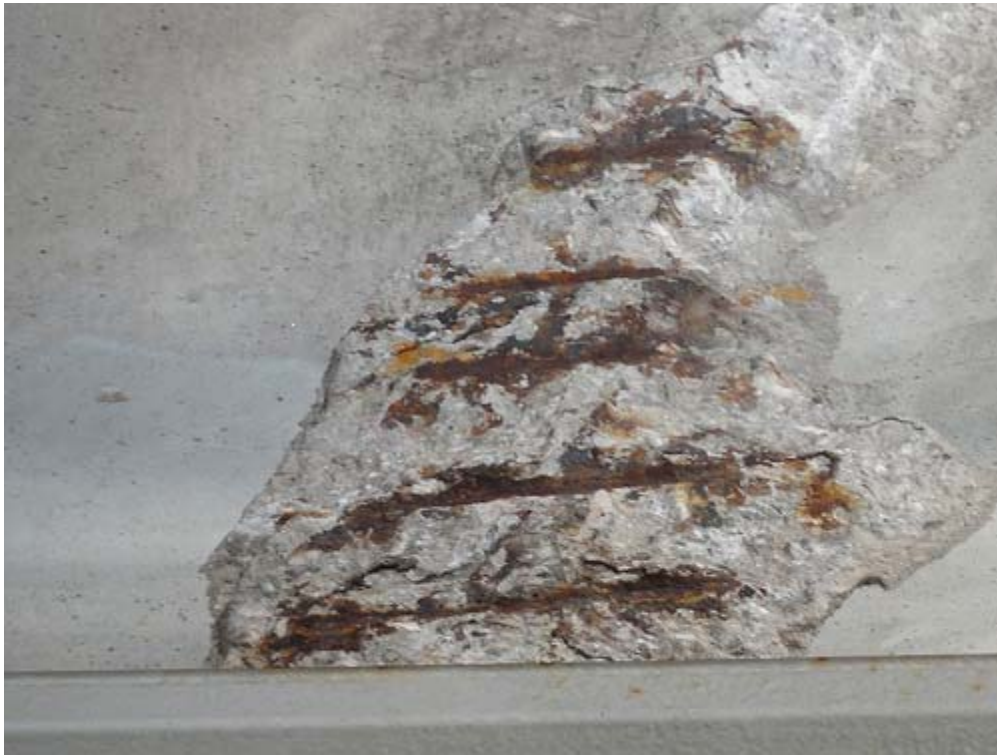
Figure 10: Corroded reinforcement in bridge deck

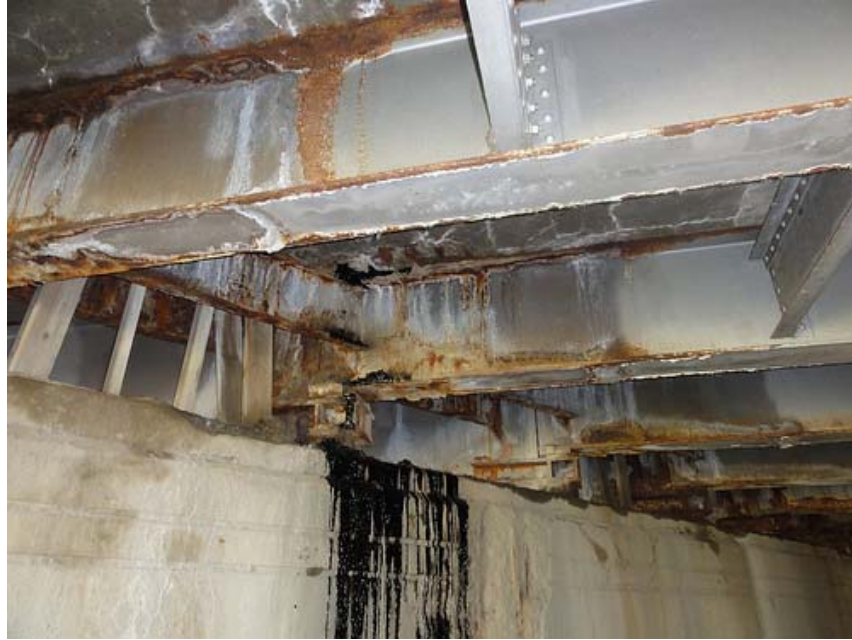
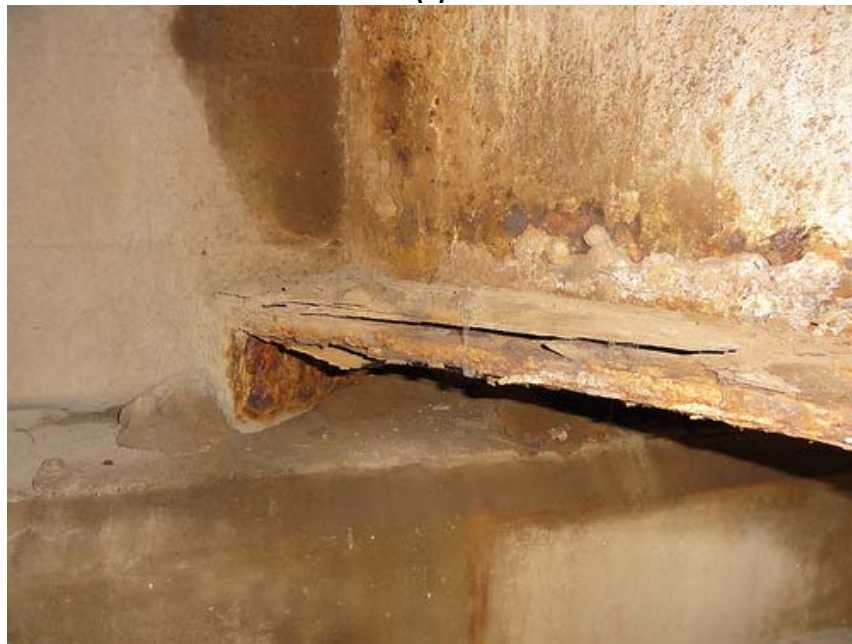
Steel section loss is defined as the change (reduction) in area or volume of a structural component in which the structure's stiffness or strength is decreased. Indicators of this type of steel section loss would be a loss or change in cross sectional area or thickness of elements. Representative examples of steel section loss are shown in Figure 11a and 11b. A quantitative measure of section loss is essential to determine the appropriate reduction, relative to design values, in capacity and stiffness that must be considered for structural load rating and capacity analyses. Techniques commonly used for measuring steel section loss include: visual evaluation, dye penetration, fiber optics and imaging devices (FHWA 2006).

Figure 11: a) Steel section loss in bridge girder viewed from the side; b) Steel section loss viewed from along the beam

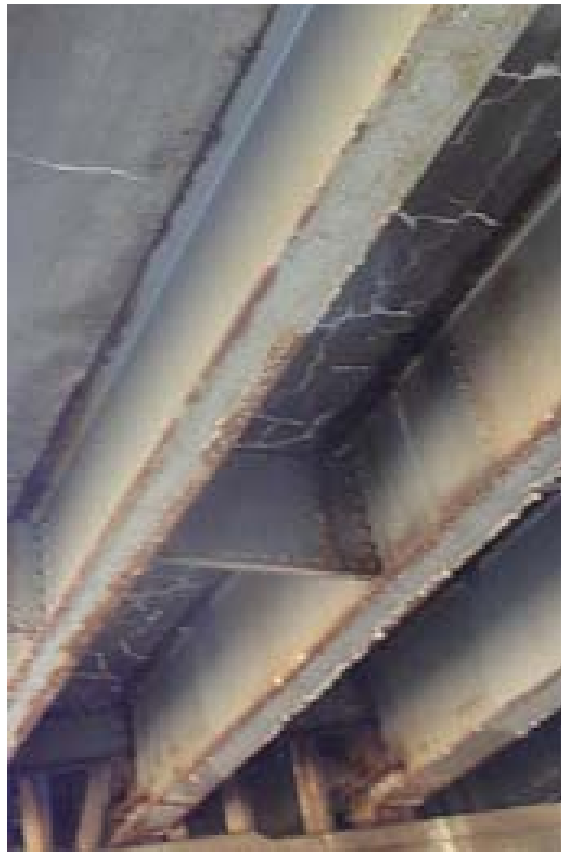
Paint is typically used as a protective layer on steel beams (often aesthetics on concrete beams) to prevent or minimize corrosion from initiating or continuing to grow. The loss of this protective coating provides a mechanism for corrosion to initiate, but may also be indicative of underlying issues with the member such as member cracking. Figure 12 demonstrates loss of paint from the surface of the girders. Current methods used for evaluating the condition of paint include visual evaluation and imaging techniques (FHWA 2006).

Figure 12: Paint loss on girder surface

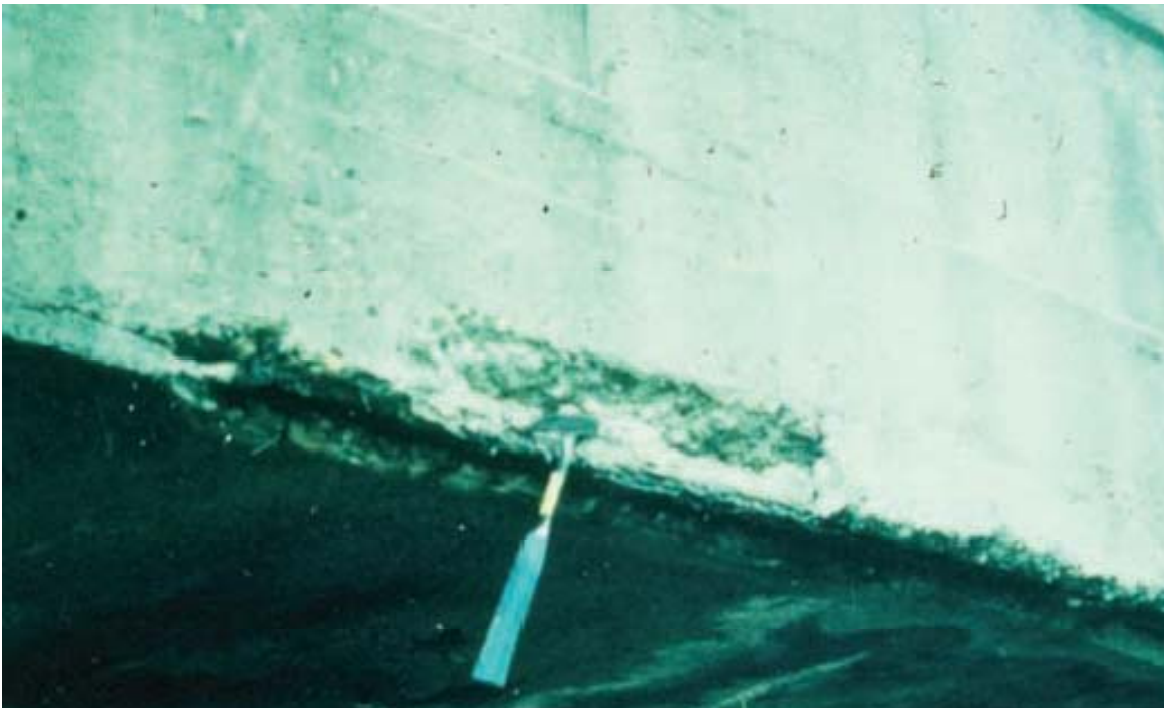
are typical). Figure 13 shows the section loss in a concrete girder component in which the reinforcement is showing. Similar to steel section loss, a quantitative measure of section loss is essential to determine the appropriate reduction, relative to design values, in capacity and stiffness that must be considered for structural load rating and capacity analyses. Current techniques used for evaluating section loss include visual evaluation, imaging devices, and fiber optics (FHWA 2006).

Figure 13: Concrete section loss (FHWA 2006)

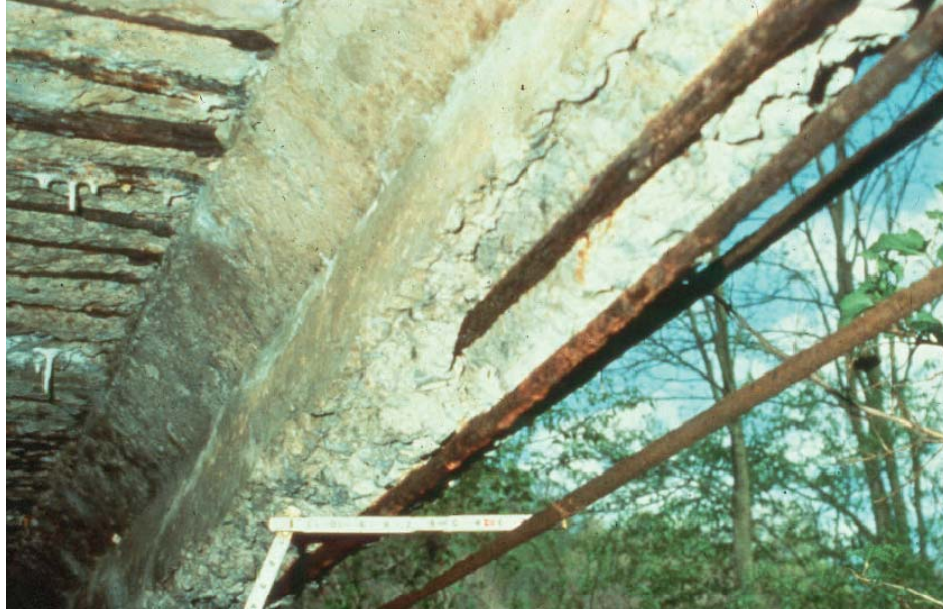
Figure 14: Corroded reinforcing bars

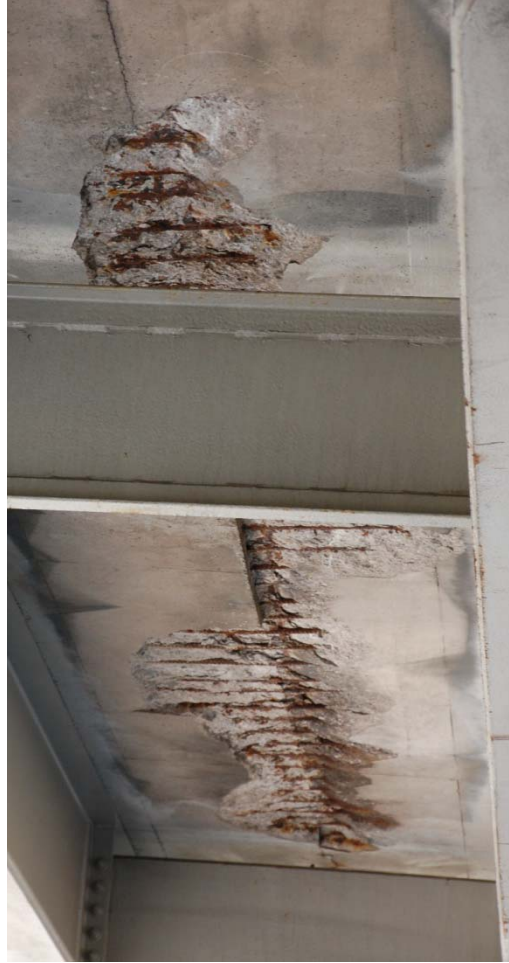
Figure 15: Significant spalling of a bridge bay that merits full replacement

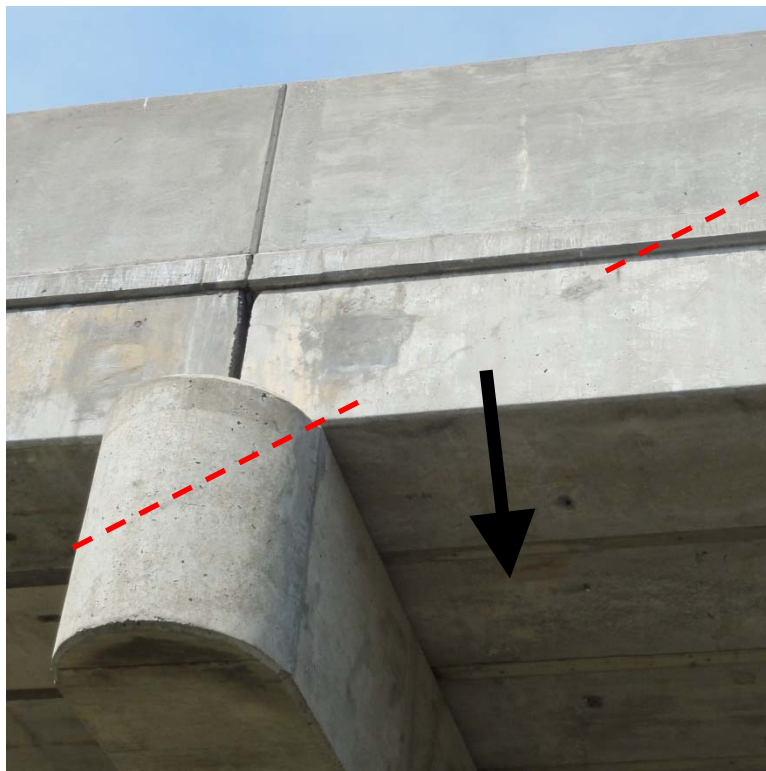
Figure 17: Photograph of fascia beam on box-beam bridge with thin, 45-degree crack near top of pier and post-tension box

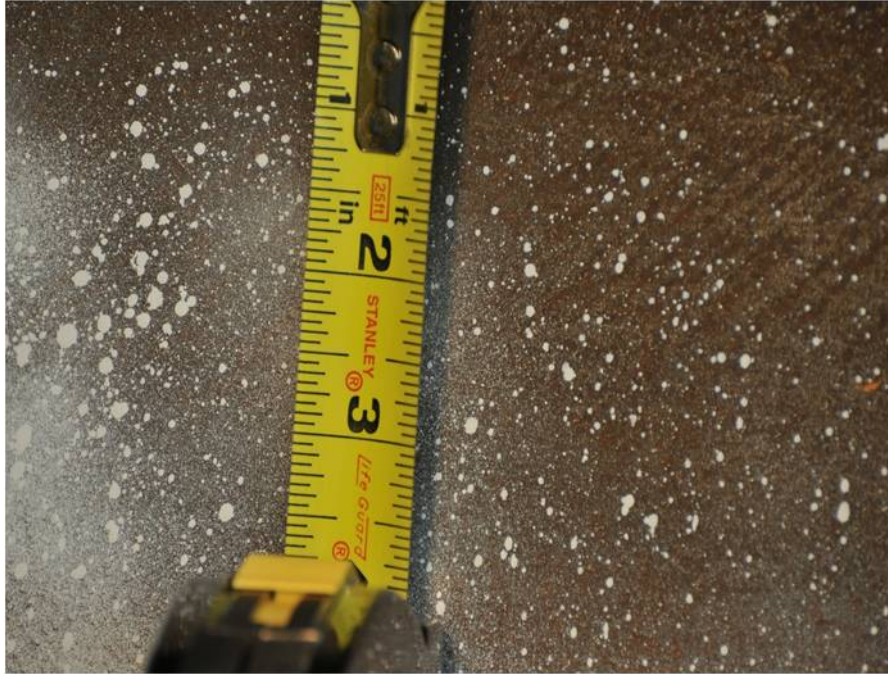
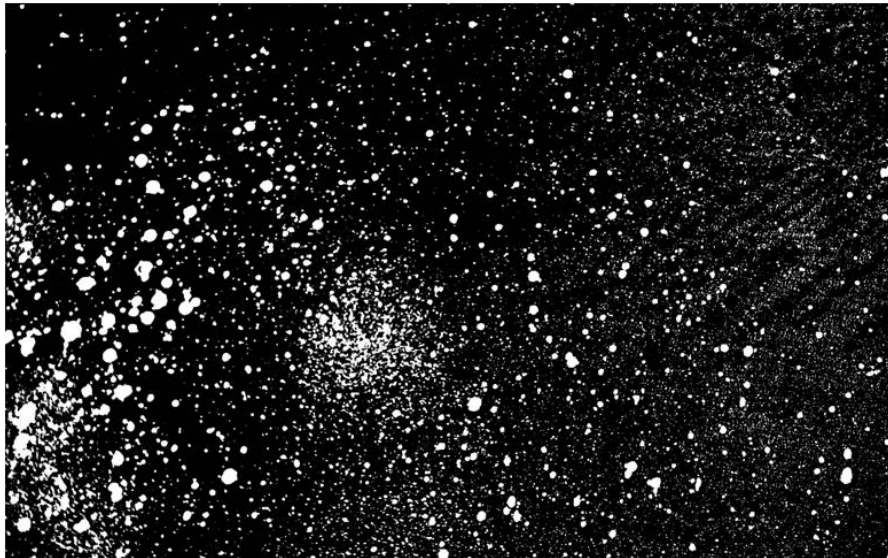
Where DIC might be used for measuring bridge settlement, transverse movement, or detecting a change in bridge length the required temporal resolution makes the technique impractical. To enable the correlation of images separated by 6 months, a year, or several years, the camera would have to remain in the exact same place, sheltered from environmental interference and anything else that would induce artificial displacements. These displacements are likely inevitable, and though their effect can probably be removed with sophisticated post-processing, only non-rigid displacements and deformations would be preserved. Even when the technique is applied to images separated seconds or less in time, the post-processing is not trivial. The analysis can be performed automatically using an analysis package such as MATLAB software, but requires additional post-processing and tuning for meaningful results. Image processing is often required before analysis to increase the contrast of the fiducial markers or features of interest (Figure 18b). Inversion in MATLAB 7.0+ is the most common processing technique in the available literature.

Figure 18: Two images of paint spots on a structural I-beam for digital image correlation. (a): the paint spots should have a wide distribution of sizes; (b): post-processing of images is used to bring the spots to a contrast threshold

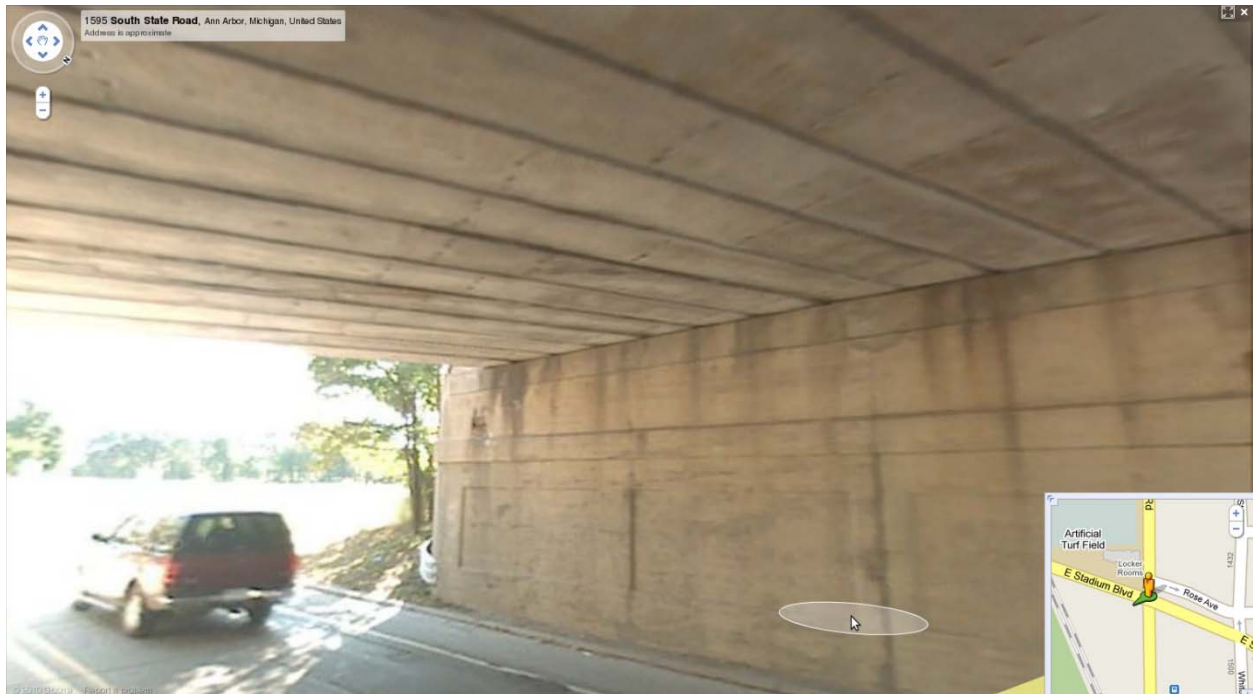
The value of this technology is realized when the bridge inspector or manager uses a StreetView-style application to assess a bridge from the office. The technology enables anyone to review a bridge’s structural condition, in which indicators can be detected visually, without actually traveling to the bridge (see Figure 20). Bridge inspectors might find such an application useful for reviewing a bridge they have already performed an inspection on or for looking at updated imagery of a bridge ahead of its next scheduled inspection. Such a scenario might occur where an inspector suspects that he or she should increase the inspection frequency of a bridge, but does not have the funds or time to do so. In the performance evaluation of high-resolution, panoramic photography such as StreetView, it was determined the technology would be most useful for bridge deck surface features including torn or missing expansion joint seals, damage to armored expansion joint plating, cracks and spalls near expansion joints, map cracking, scaling and spalling of the bridge deck, and delaminations expressed as surface cracks. For all of these features, StreetView-style imagery offers immediate commercial viability, automated image processing for visual inspection of results, a vehicle-based collection platform and, consequently, no traffic disruption whatsoever. The resolution requirements for these challenges can very likely be met, but there appears to be no available literature on using high-resolution panoramas to assess these or any other bridge condition indicators. It is likely that hairline cracks in steel or concrete are too fine to be resolved from this imagery, but high-resolution panoramas may be useful in assessing surface roughness in addition to the deck challenges previously described.

Figure 20: Example image from Google's StreetView showing the underside of a box-beam bridge in Michigan. With higher-resolution panoramas, such an interface could be extremely valuable to bridge inspectors and managers.

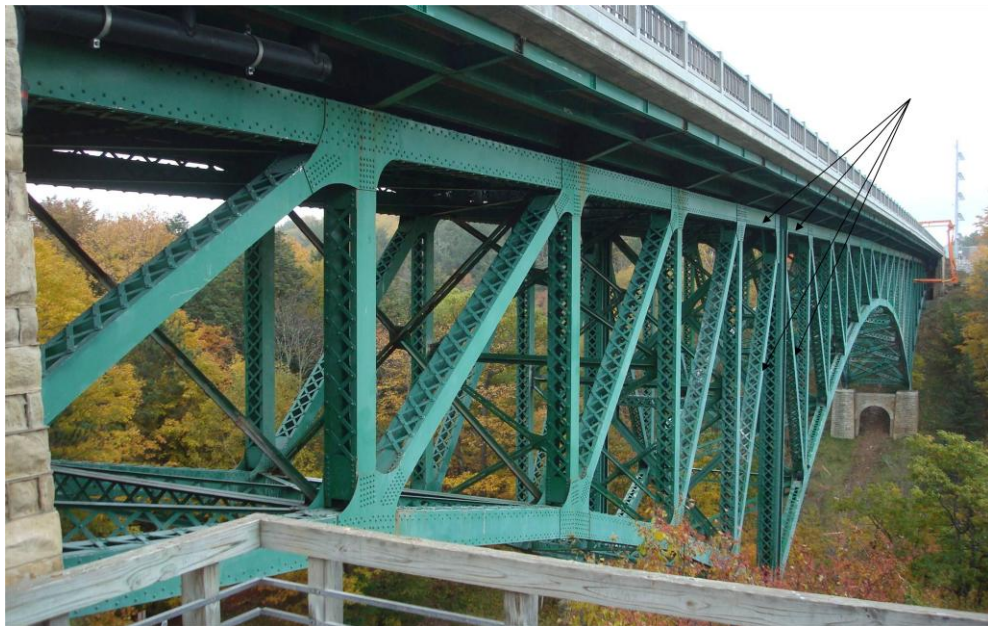
There are eight wireless fiber optic strain gages on each side of the bridge along with two temperature sensors for a total of sixteen fiber optic strain gages and four temperature sensors. The location of the strain gages can be seen in Figure 1 where the arrows are pointing to. There are two bridge deck environmental sensors placed on the bridge. The temperature and environmental sensors can be used to correlate their values to the strain gages to see how the strains are affected by temperature and other environmental factors. The bridge is also equipped with one wireless weigh-in-motion sensor along with two traffic monitoring sensors. This allows for the correlation of loads crossing the bridge with the strains on the bridge. Two close circuit television cameras are also in place on a seventy foot tower which can be used to confirm the values of the weigh-in-motion sensor and the traffic monitoring sensors.

Figure 1: Location of Sensors on Cut River Bridge

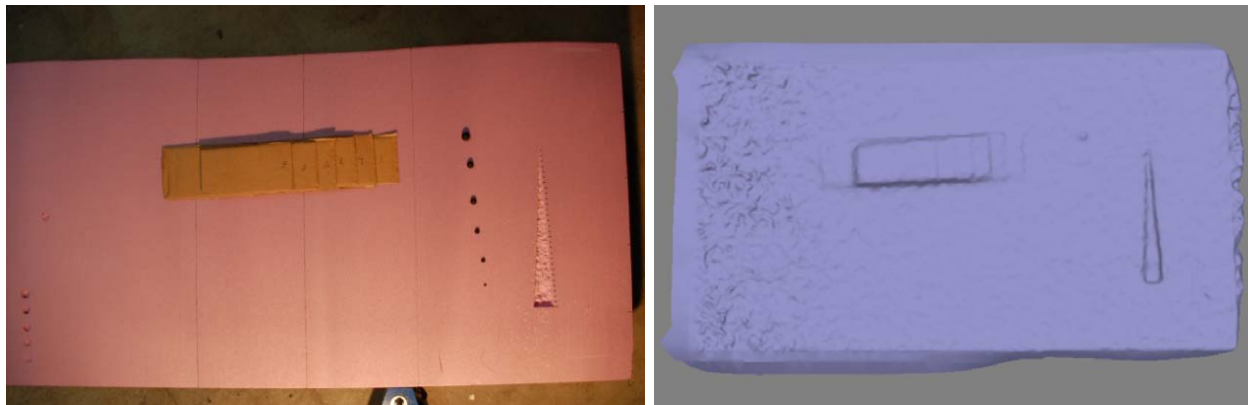
Figures 1a & 2a: First experiment with foam board in the lab with original photo on the left and 3D model on the right.

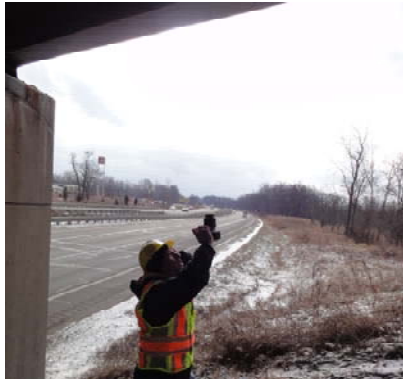
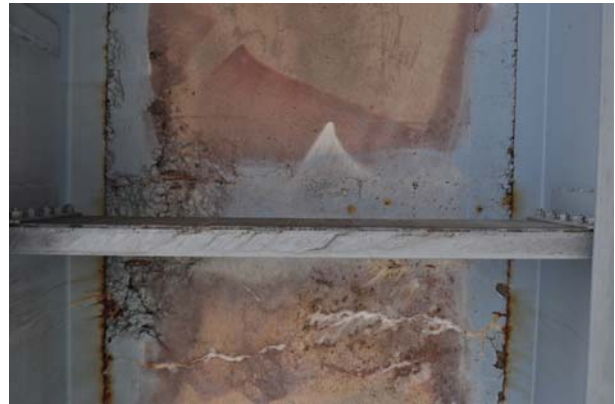
The first in-field test was conducted by taking the camera and capturing spalls on the underside of the 6 Mile Bridge over US-23 north of Ann Arbor, MI (see Figures 5a and 6a). 3D models of spalls were generated by taking four to six photos in a line, with the spalls being located approximately 2.5 meters above where the photo was taken (see Figures 7a & 8a). Spalls at a distance were of importance to demonstrate how a 3D setup could be deployed to measure the length, width, and depth of spalls that would otherwise require equipment to reach. Calculations of resolution attained by this camera, distance, and number of photos are currently being related that to desired measurement sensitivities.

Figures 5a & 6a: Researcher taking photos of the underside of 6 Mile Bridge at US-23 near Brighton, MI. The distance from the camera to the spalls was approximately 2.5 meters (8 feet). Photo taken of spall on deck bottom surface from the field test shown above at 6 Mile/US-23 Bridge.

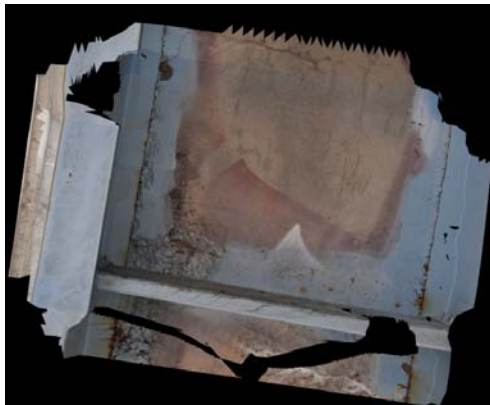
Figures 7a & 8a: Models generated from the infield photos with textured model on the left and shaded model output from PhotoScan on the right.

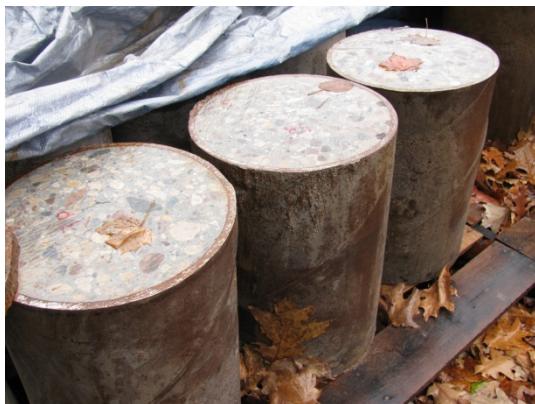
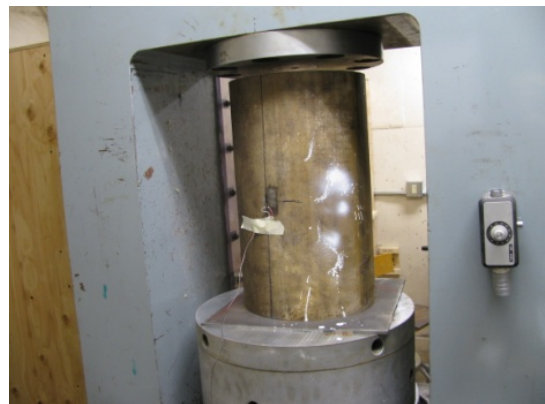
Figures 1c & 2c: Bridge pylons on a pallet and pylon before a compression test.

In these tests, the standoff distances of the camera will be compared at short distances (within 5 to 10 feet), long distances (greater than 10 feet) and from vertical distances (from the top of the structures at different angles). Unique marks applied to the specimen's surface will enable detection of movement or rotation of the structure. This will allow the method to be analyzed for different displacement measurements in relation to bridge settlement, bridge movement and bridge length. The testing will also be applied to vibration testing in which a corresponding sampling rate for the images with be used for frequency detection. This sample testing involves 2D analysis, but can be further expanded to 3D image analysis with an additional camera implemented in the setup.

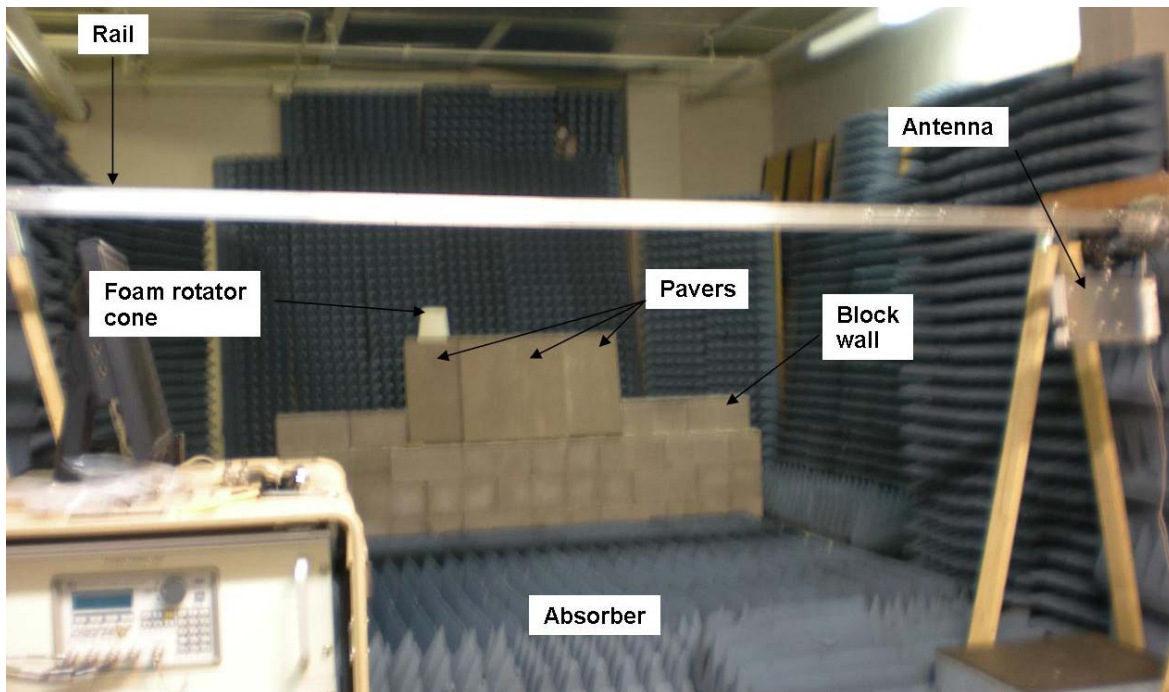
Figure 1d: MTRI antenna chamber with Lab Genie set up.

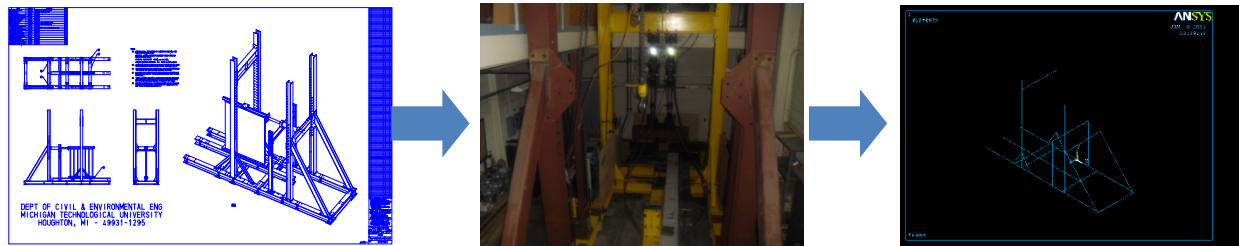
The laboratory tests will also be used as test bed for an expanded feasibility study particularly on DIC testing. The laboratory tests will focus on component testing that can be used to validate the model approach and compare with the DIC measurements. The calibrated finite element model is a simulation of the structure's behavior and global responses that will be validated through the DIC tests. The schematic of this idea is shown in Figure 2. These results can in turn be extrapolated to the development of a full bridge model for simulating global responses. Following the completion of the laboratory studies, the structural simulation studies will enable progression toward full scale bridge finite element simulation that will be used as part of the field demonstration phase. The models developed for this stage will aid in determining where measurements for global system response will be collected and for result comparisons.

Figure 1a. Finite Element Model Creation of the structural facility's loading frame

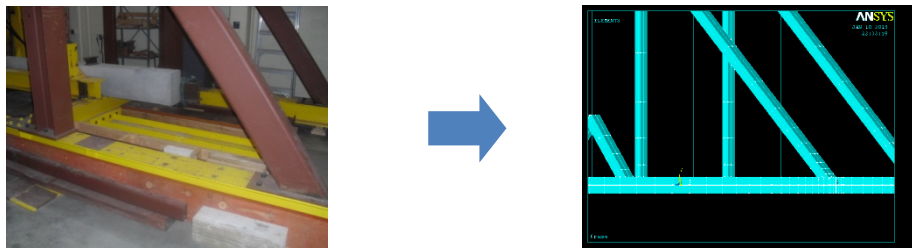
Figure1b. Close up of meshing capability in finite element model compared to digital photo image

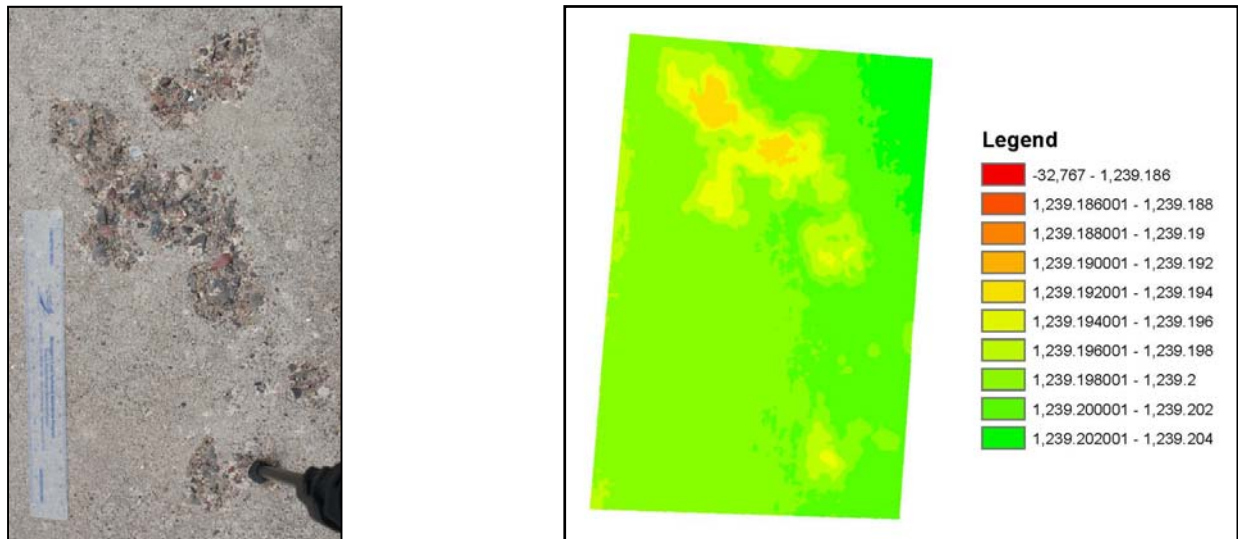
Figures 3a & 4a: Actual picture of sidewalk and DEM of spill.

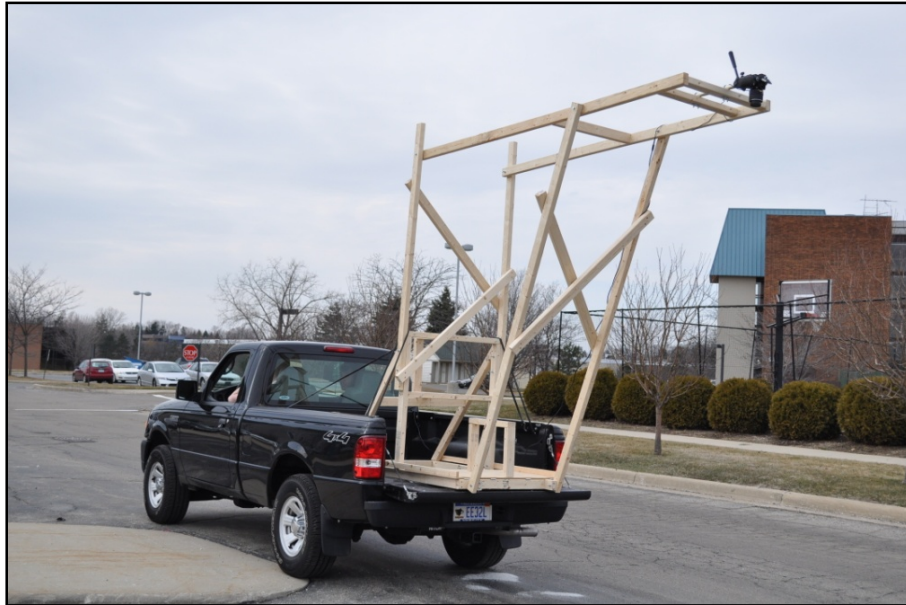
Figure 7a: Demonstration of close-range photogrammetry image collection system for bridge deck surface condition evaluation, currently undergoing further testing.

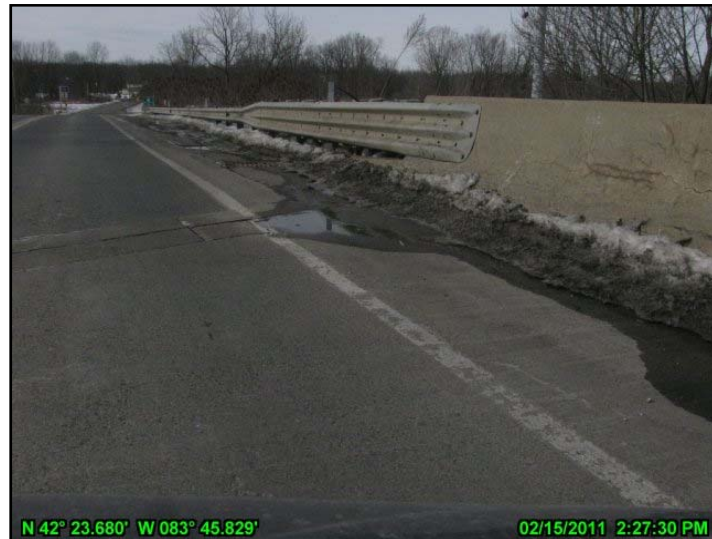
Figure 2b: A GPS-tagged photo created when driving over the 6-Mile over US-23 bridge using the BridgeViewer Remote Camera System.

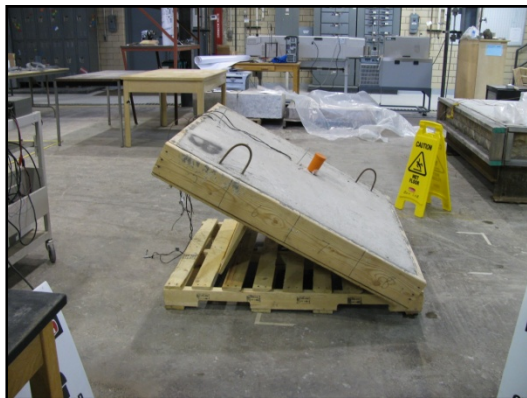
ThIR tests on slab CD (see technical memorandum n^o 11) were repeated with a new lab setting to take perpendicular images. Also, noise reduction was turned off on the camera in order to collect raw data. Figures 4c and 5c show the test set up for taking perpendicular images. The plan layout and size of this specimen was attached in technical memorandum n^o 5.

Figures 4c & 5c: ThIR lab test set up showing camera and slab perpendicular to each other.

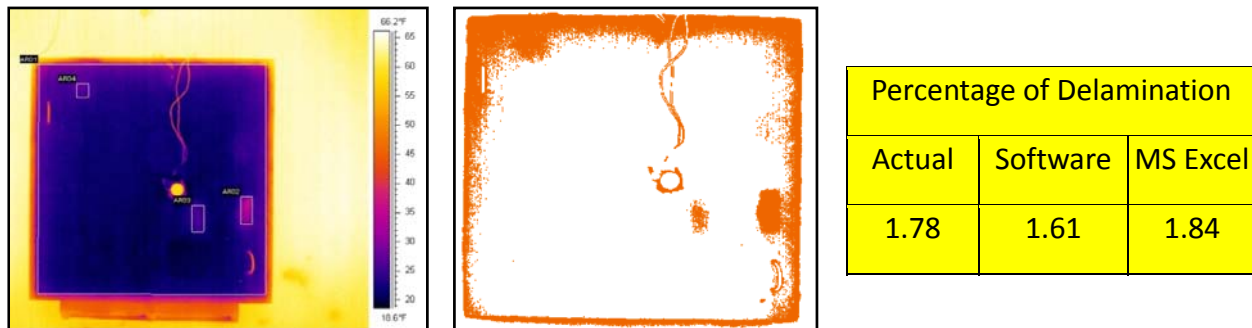
The second approach was saving the data as a comma-separated value file and using an MS Excel spreadsheet to count the number of pixels. In this test, the spreadsheet was set up to highlight and count the number of pixels within a specific temperature range that best shows the delaminations. One error that appeared in this test was the effect of the thermal gradient from the slab's edges which makes it difficult to assign a pixel to the outer most delaminated areas. Test results are shown in Figures 4c and 5c. The percentage of delaminated areas can be calculated by using the same equation as the first method as shown in Table 1c.

Figures 4c & 5c / Table 1c: Results of calculating the percentage of delaminated areas on the concrete slab using three different methods.

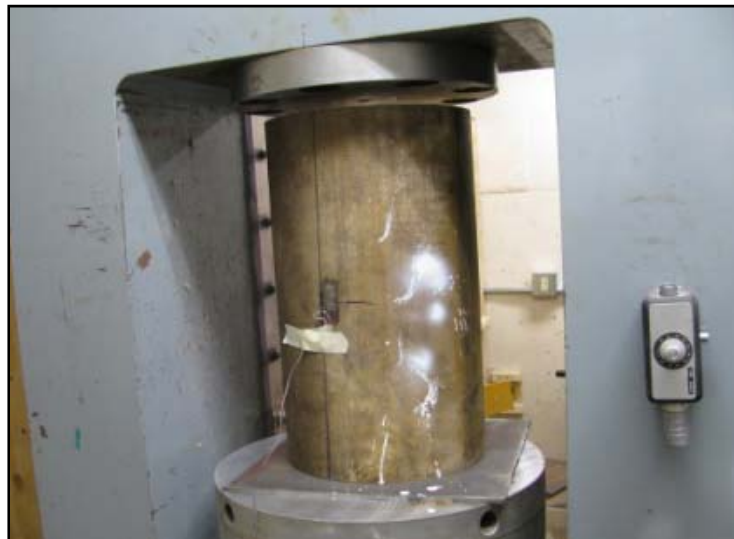
To date, there has been much investigation in the laboratory to measure dynamic and static bridge behavior associated with bridge global-metrics. Preliminary testing involved compression tests on bridge pylons (concrete-filled pipes) to determine correlation between optical images. An 18 inches tall section of a bridge pylon (Figure 1d) was placed in a compression-testing load frame and was subjected to a force of over 1,000 kip. The camera captured images at a ~12 inches standoff distance. In the analysis, the MATLAB software divided each image into a grid-of-grids; the sub-grids were then compared between images. Figure 2d shows the displacement field of the defined sub-grid on the images versus X- and Y-positions. Figure 3d shows the determined raw strain in the X-position found using the computer software. These measured values can be fine-tuned further by the specification of areas-of-interest on the images themselves.

Figure 1d: Section of a bridge pylon (concrete-filled pipe) in load frame compression test.

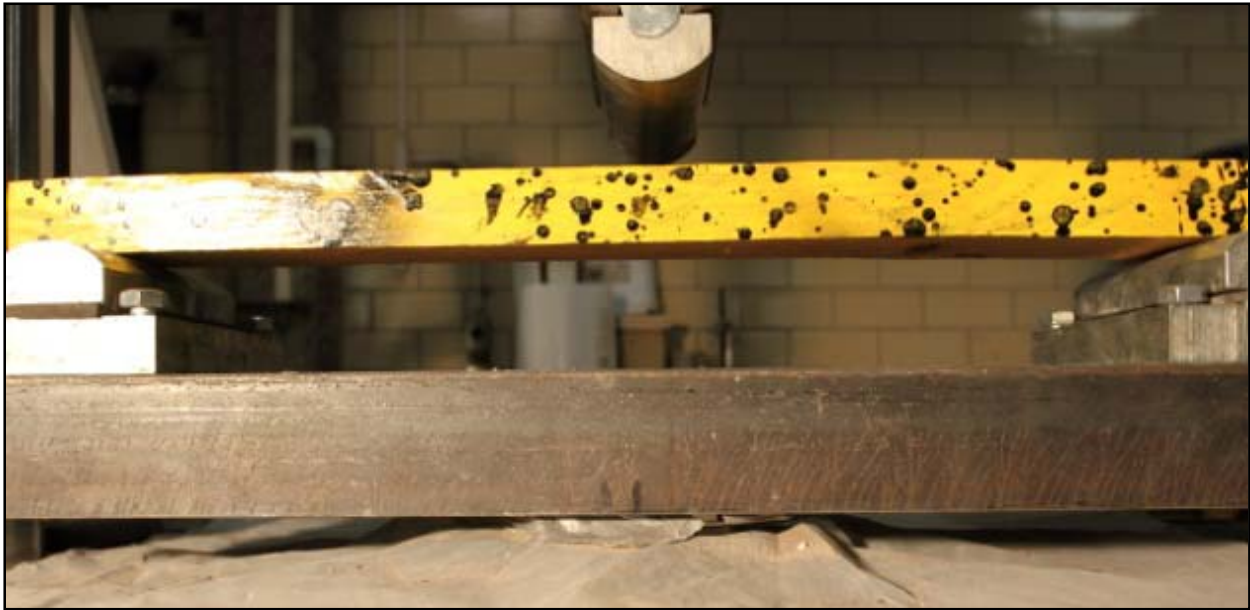
To further understand flexural behavior, a simple flexure test was also conducted using a “two-by-four” wood specimen with a distinct surface pattern. In these tests, the viewing angle was varied (in both X- and Y-directions) to test the capabilities of this process. Variations in the software and camera settings were also explored. Figure 6d shows the wood specimen in the experimental setup with the flexure point in the center of the photograph. Additional investigation of these distances in relation to detection measurement will be correlated and examined.

Figure 6d: Picture of “two-by-four” wood specimen in testing machine.

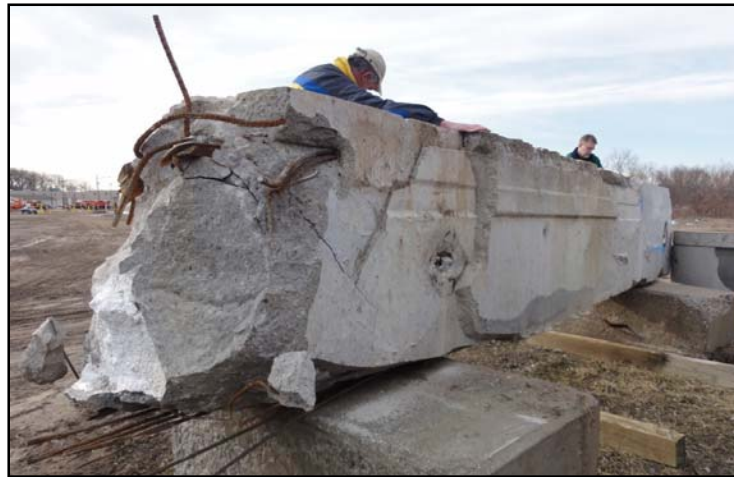
Contact with this box-beam highlighted the need for making measurements on ‘good structures’ and ‘bad structures’ (both with known defects) in order to be able to make quantitative assessments of condition. The box-beam not only provided an appreciation for the types of structures to be measured it also granted insight into the concept of operations for the field implementation.

Figure 1e: Silverbell bridge box-beam saved for radar sensing work by the Oakland County Road Commission after the bridge was recently removed from service due to poor beam condition.

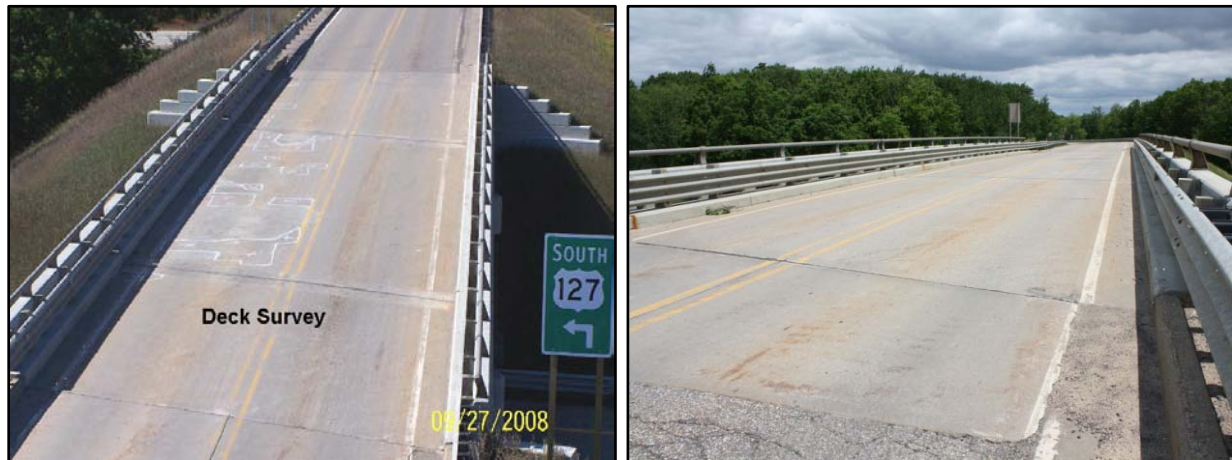
The current condition of the deck surface is an area of major focus and concern; it's rated at a "4" on the NBI scale. In 2008, a detailed inspection and scoping were completed of the top and bottom of the deck surface (project team has access to this report from MDOT). The scoping revealed that on the top surface of the concrete deck 176 ft² or 4.4 % of the deck was delaminated. Additional testing on the bottom surface revealed that 623 ft² or 15 % of the deck was in distress. The deck also possesses light scaling throughout and numerous transverse, longitudinal and diagonal cracks are present. In concern with the superstructure several high-load hits have resulted in scrapes and spalls but currently there is no sign of exposed reinforcing steel or pre-stressing strands. The bridge is scheduled for complete replacement in 2012/13.

Figures 3 & 4: Photos of the Mannsiding Road bridge, from a 2008 MDOT scoping report (left), and from a June 2011 site visit (right).

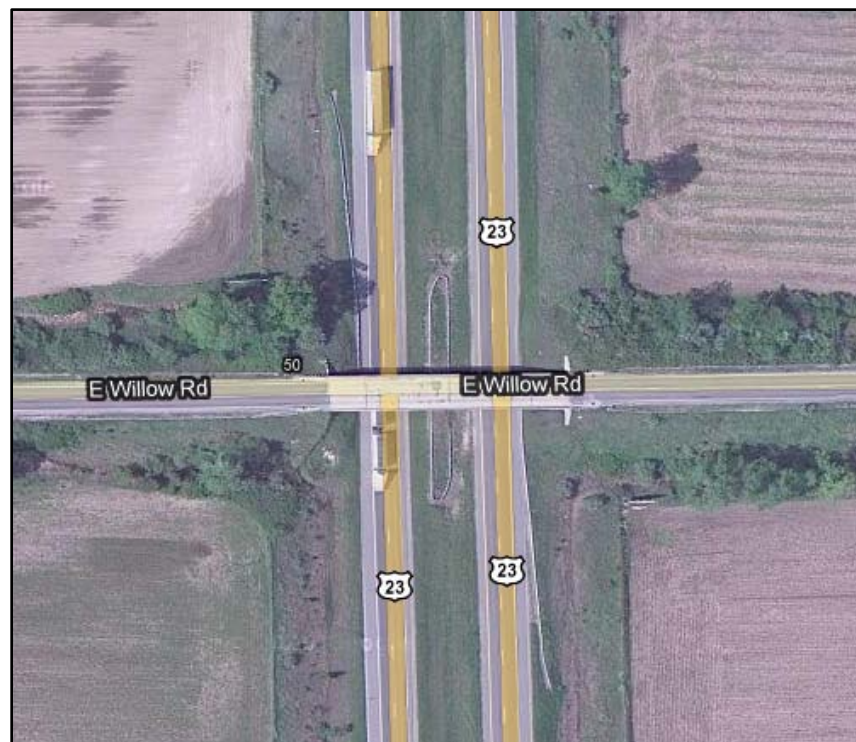
Figure 5: Aerial view of MDOT structure n° 10892 – Willow Road over US-23.
