**BRIDGE CONDITION ASSESSMENT
USING REMOTE SENSORS**

Volume II of II – Appendices

An Evaluation of Commercially Available Remote Sensors for Assessing Highway Bridge Condition

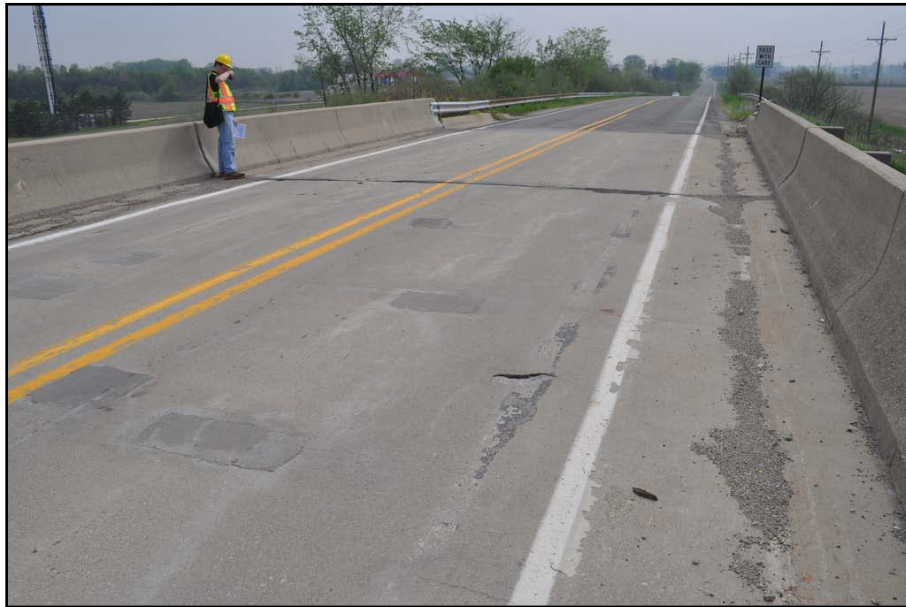
Figure 6: An example photo of the bridge deck of the Willow Road bridge taken on May 13, 2011 (note the variety of visible deck surface defects).

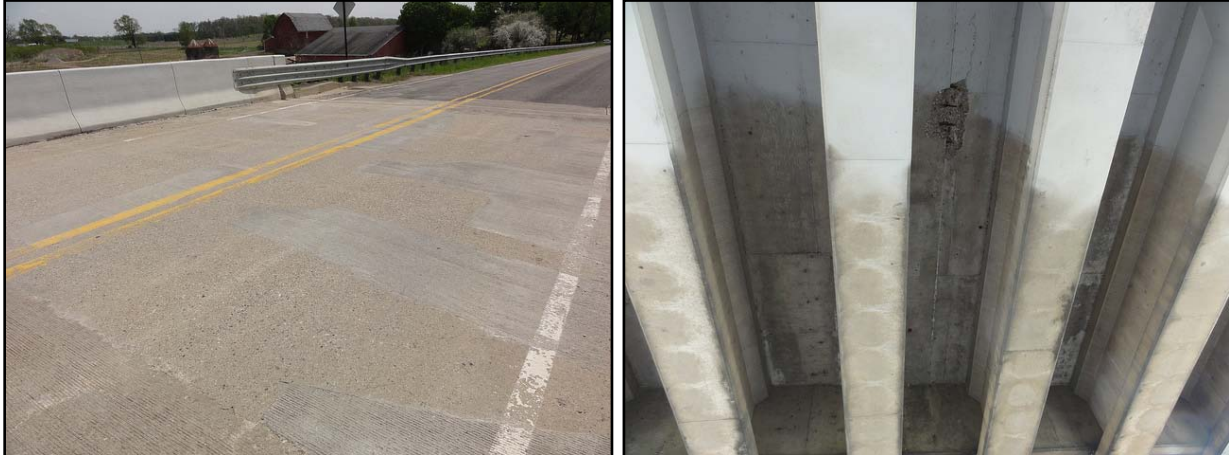
there are also areas of interest on the superstructure where the concrete material has spalled and cracked. These areas of interest are located at the beam-end locations on the bottom flange. None of the spalled sections are currently deep enough to expose any reinforcing steel or pre-stressing strands (Figures 8 and 9 show two sample photos of the bridge).

Figures 8 & 9: Two sample photos taken of the Freer Road bridge over I-94 on May 13, 2011.

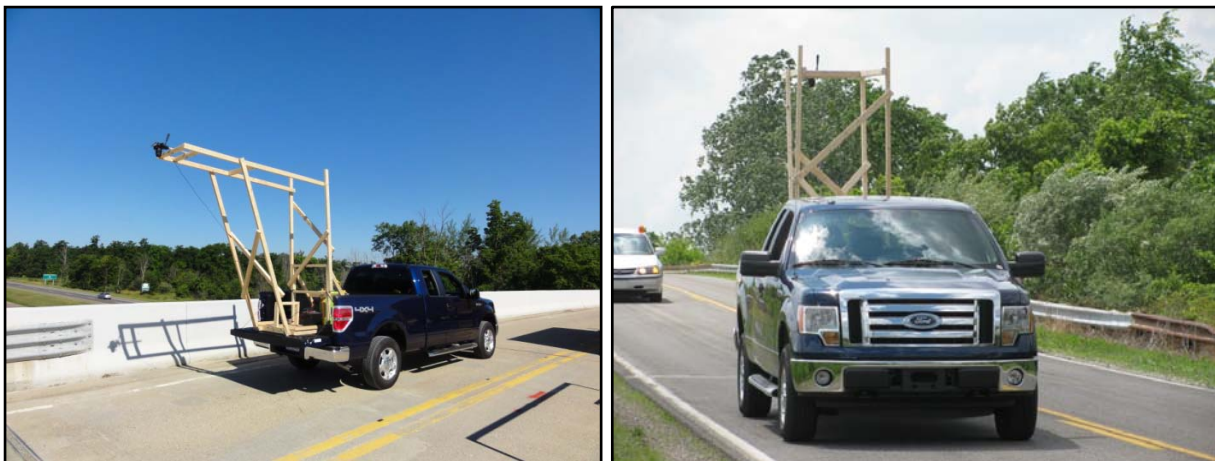
- Assemble the vehicle mount (see Figures 11 and 12)
- Attach the Nikon D5000 camera being used for the field test
- Drive across the bridge at a speed around 2 mph (4x4 low at idle speed)
- As the truck drives across bridge, camera will take photos at 1 fps
- Repeat pass on the other lane of the bridge

Once at the site, the vehicle mount for the 3D system is put together, the camera is mounted and the vehicle mount is strapped down to the bed of a truck. The camera is then connected to the computer and then tested to make sure there is a good connection and everything is working properly. Once everything is ready, the truck drives along the bridge at a slow speed (currently 1-to-3 mph); this has been achieved by putting the truck into 4x4 low and letting it idle across (see Figures 11 and 12). Note that potential future systems would be able to cross at higher speeds if more advanced digital cameras are used.

Figures 11 & 12: 3D Optics (3DO) data collection system deployed for pre-field demonstrations trials.

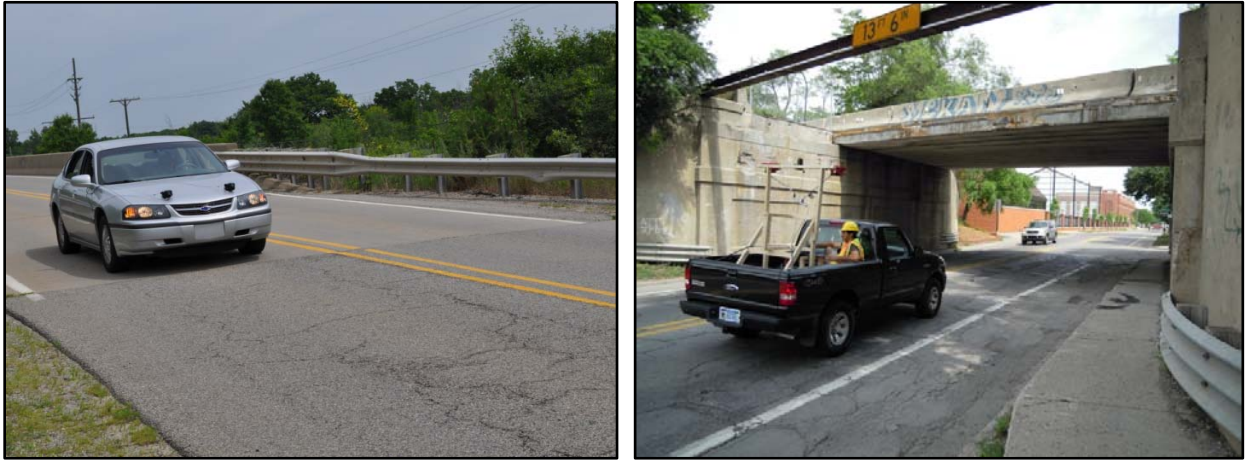
- Take a picture of Garmin GPS unit being used to geo-tag the photos later
- Mount the cameras to the hood of the car (see Figure 13)
- Align the cameras so that their field of views overlap in the center of the lane
- Drive over bridge at 5 mph while capturing images once every four seconds

- Take a picture of Garmin GPS unit being used to geo-tag the photos later
- Assemble vehicle mount with camera and lights (see Figure 14)
- When approaching the bridge, turn on the lights and start taking photos at 1 fps
- Drive along both lanes to collect full coverage under the bridge

Figures 13 & 14: Example deployments of the “Bridge Deck” (left) and “Bridge Underside” (right) versions of the BridgeViewer Remote Camera System (RCS).

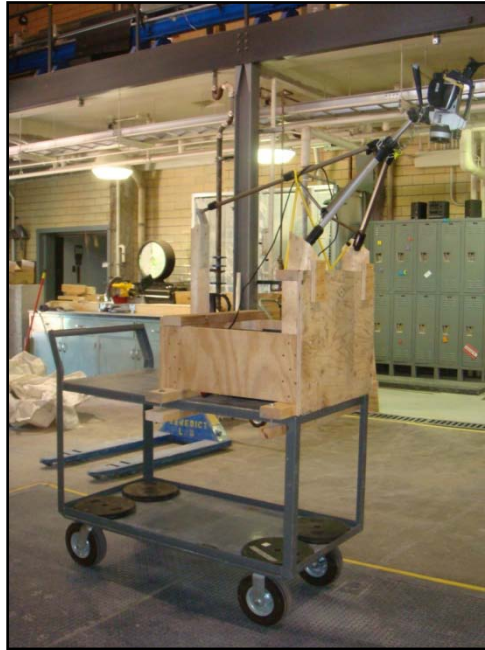
be calculated by comparing the boxed area to a reference area on the bridge deck. Figure 15 shows the cart with fabricated wooden frame for collecting the ThIR images. The height of the camera lens to the deck surface should be ~6.2 ft giving about a 2.67 ft by 1.98 ft FOV (5.29 ft²), allowing for the ThIR camera to take images 1 fps while the cart rolls along at ~1.3 mph.

Figure 15: FLIR SC640 ThIR camera mounted on the cart for field demo.

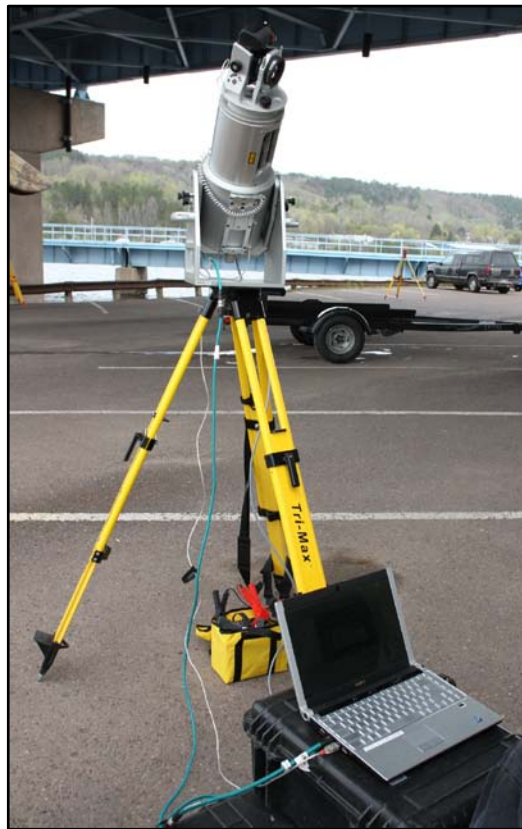
Figure 18: Typical Reigl LiDAR unit setup.

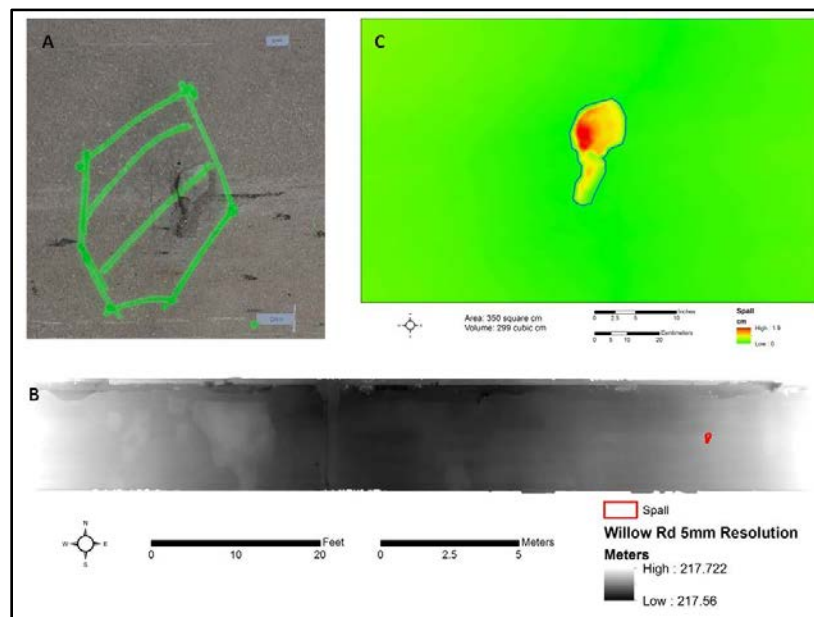
Figure 6: Analysis of a spall on Willow Road bridge based on 3D data collected with the 3DOBS at Willow Road bridge. A spall ('A' – within the green area marked by the Michigan Department of Transportation (MDOT) as a delamination) can be located on the DEM of the west bound lane ('B' – red area). Area and volume estimates can be calculated in Spatial Analyst (see 'C'). The spall above has an area of 350 cm² and a volume of 299 cm³.

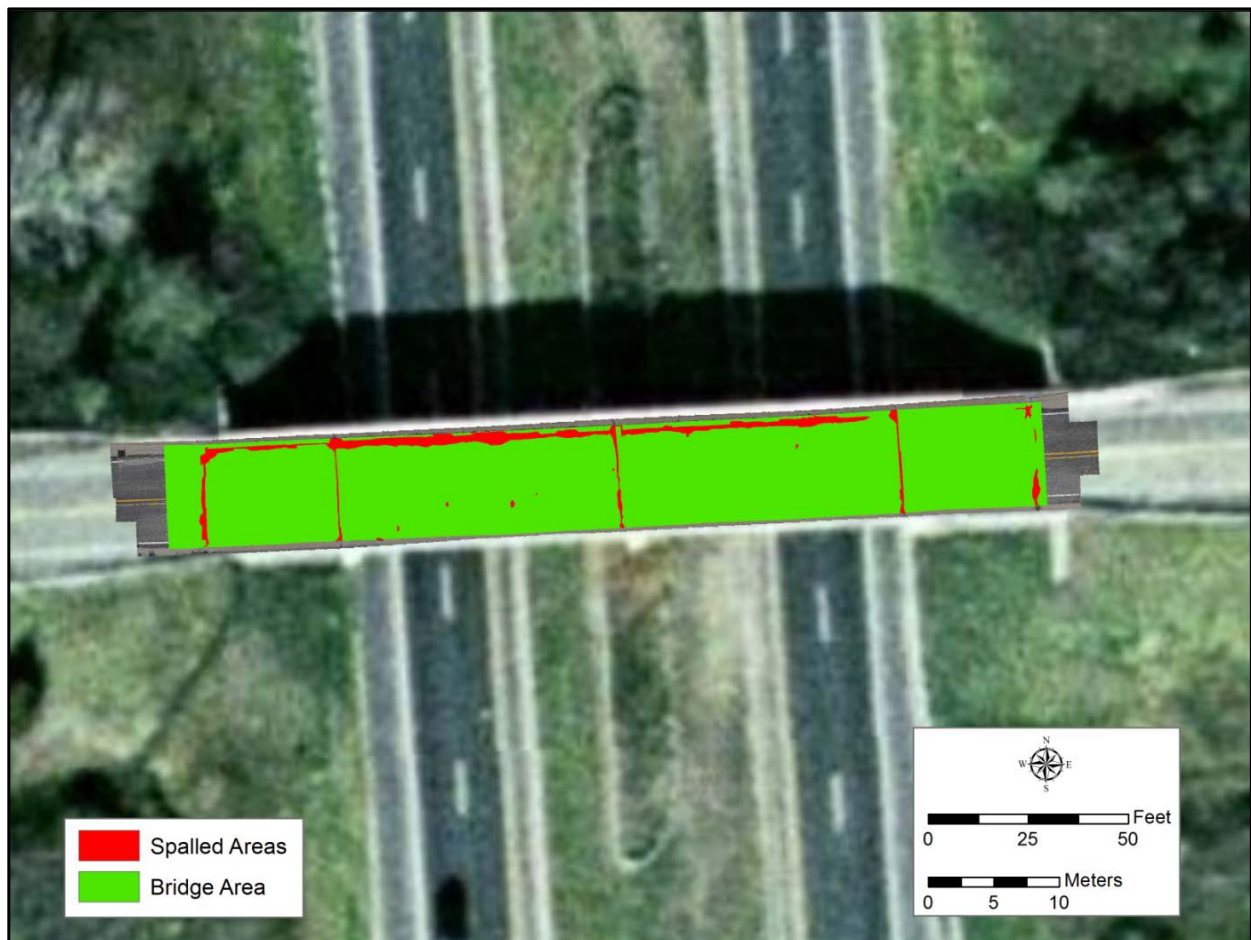
Figure 7: Example of calculating percent spalled area for Willow Road bridge using the 3DOBS data as the input and ArcGIS as the analysis software.

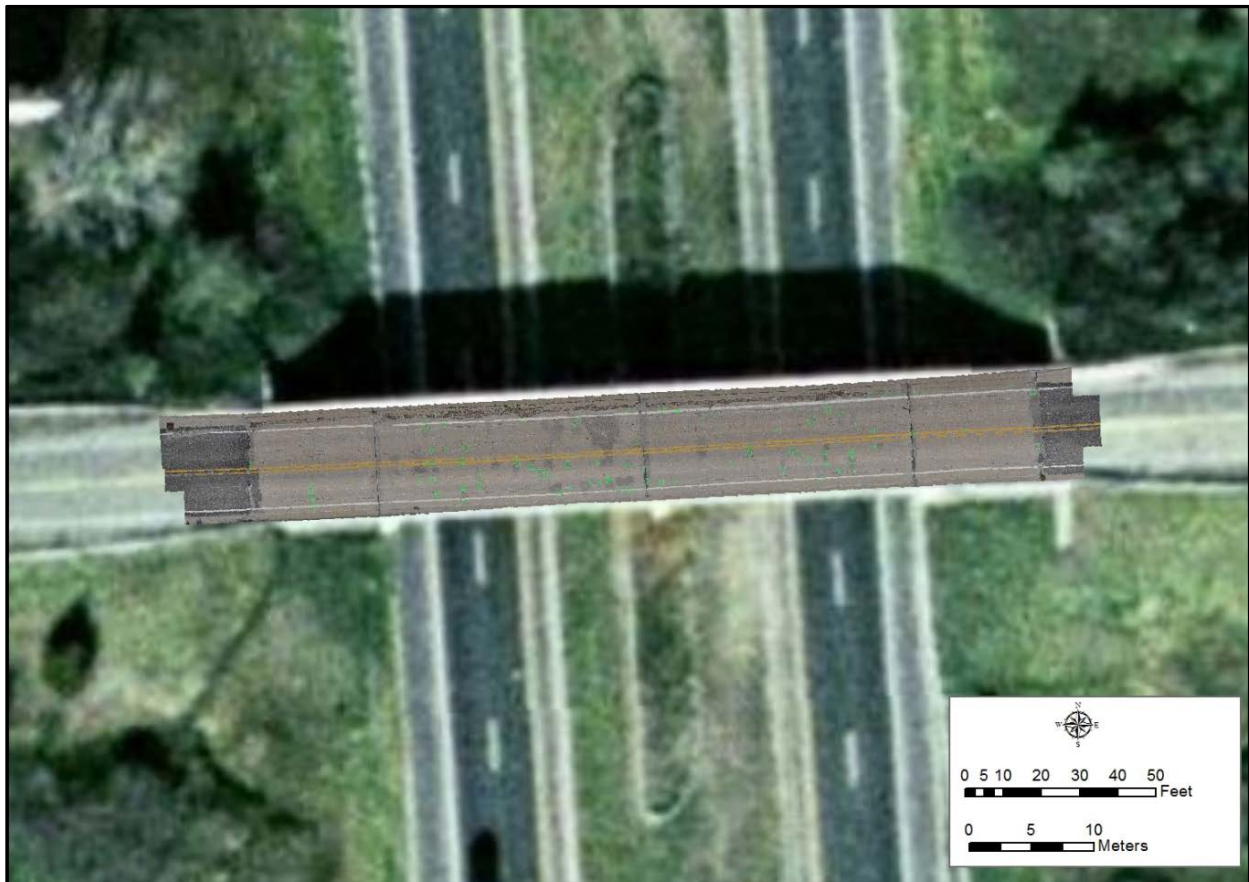
Figure 8: A composite image of Willow Road bridge deck that can be used to evaluate its condition as serve as a reference to understand deterioration over time, as collected by the 3DOBS.

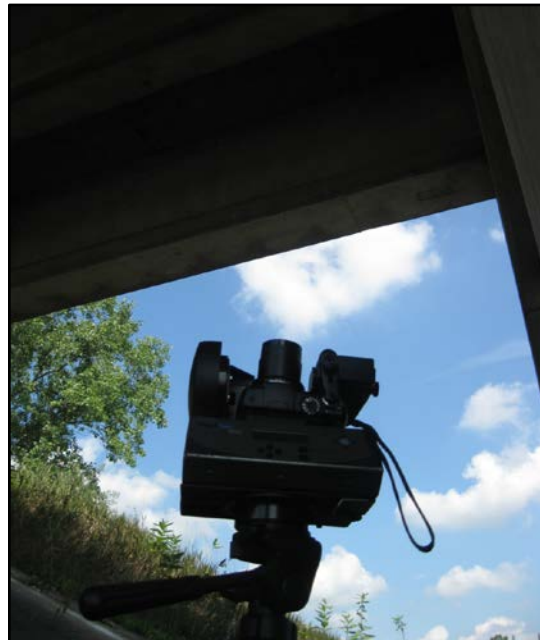
The GigaPan consisted of a GigaPan EPIC robotic camera mount, a PowerShot SX110 IS, and a camera tripod (see Figure 15). This system was deployed at all three bridges and collected both side (fascia) profiles and undersides of the bridges. The setup and break down times for the GigaPan were both less than 10 minutes. Collection times ranged from 20 minutes up to 4 hours, depending upon the size of the area being captured and the amount of photos taken. The end results were between 1- and 10-gigapixel photos for a particular part of a bridge, such as its fascia (see Figure 16).

Figure 15: An example of the GigaPan being used to collect high-resolution bridge inventory photos during August, 2011 field demonstrations at Willow Road bridge.

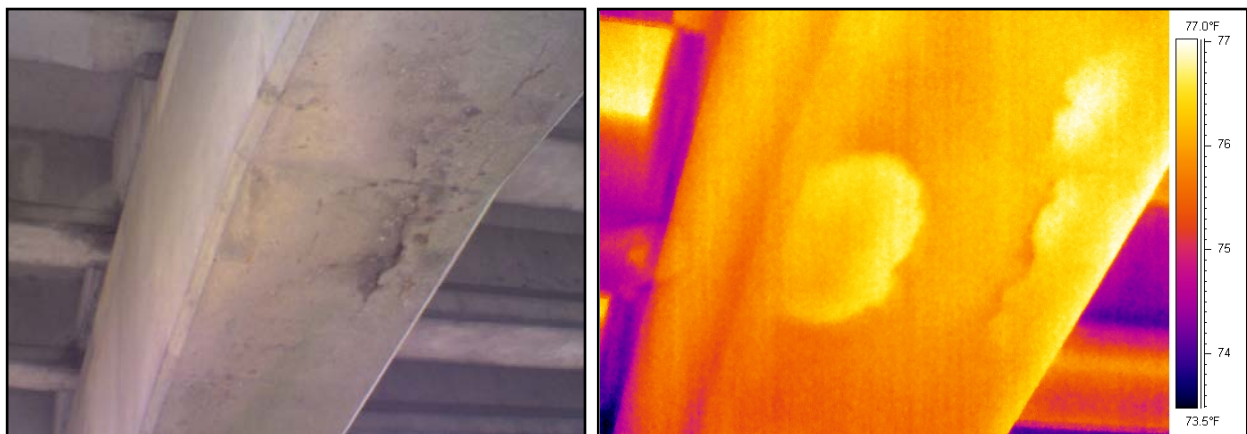
Figures 21 & 22: Optical and ThIR images showing delaminated area on a Willow Road bridge pier.

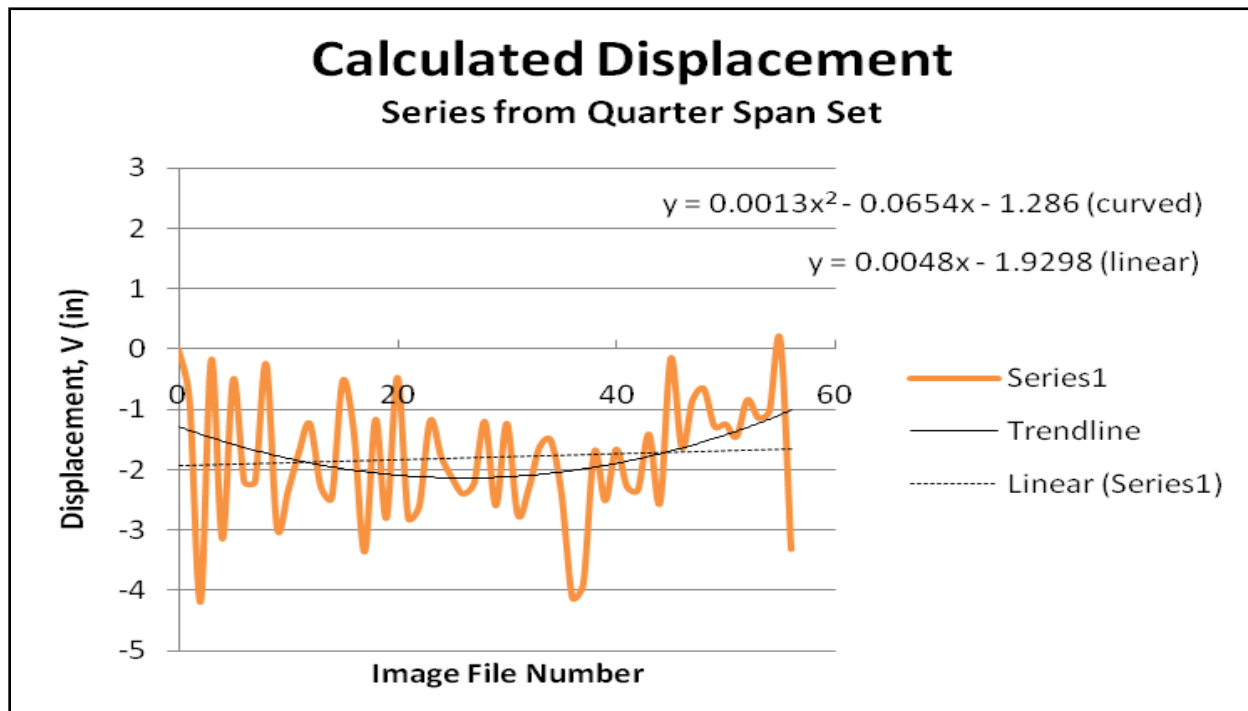
Figure 27: Vic-2D graphical plot of calculated displacement for a test series.

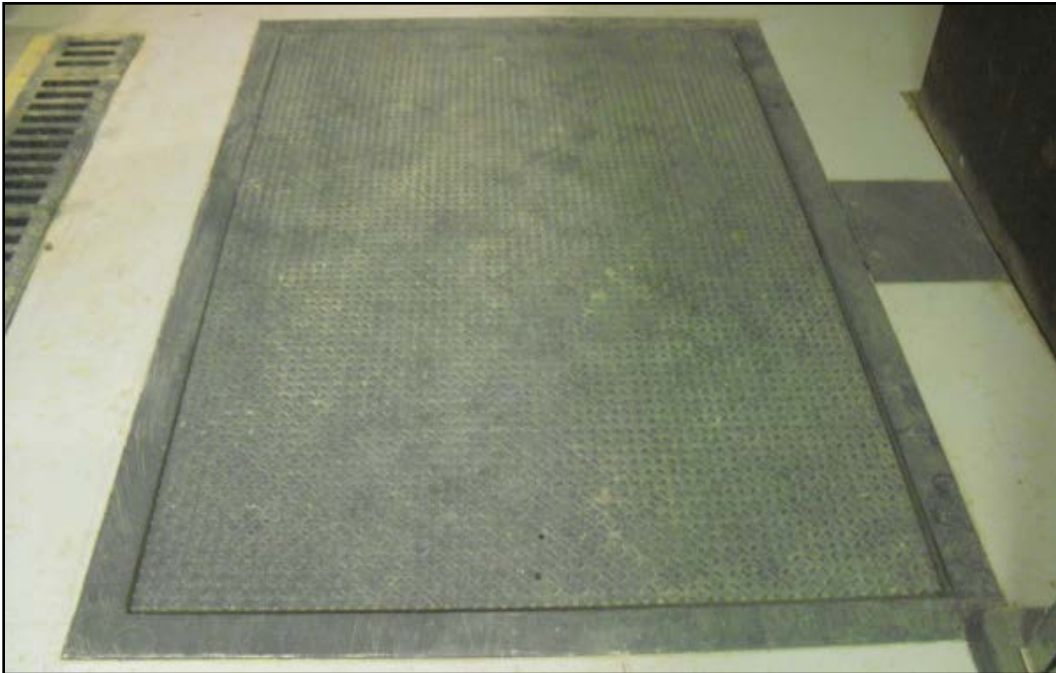
Figure 30: Floor scale loading platform used to simulate scaffolding movement.

At the closest distance, 2 ft, two different trials were completed; with (fan on camera) and without wind. Table 2 shows the percent difference in displacement values as calculated in Vic-2D software as compared to the data collection from the 810 Material Test System; the values had little error at 1.8%, but with wind simulation the change in displacement increased almost by half. For the 32 ft testing scenario, the camera was placed on the loading platform of a Fairbanks-Morse floor scale located on the MTU's Benedict Laboratory (see Figure 30).

The floor scale platform can easily move with a person walking or a simple shift of weight by objects. The camera and tripod were placed on the platform and images were taken of the rectangle speckled board. This test was repeated with a person moving on the platform to demonstrate a field like simulation of the scaffolding setup. Table 3 shows the results from the processed images in Vic-2D compared to the 810 Material Test System data and the percent differences.

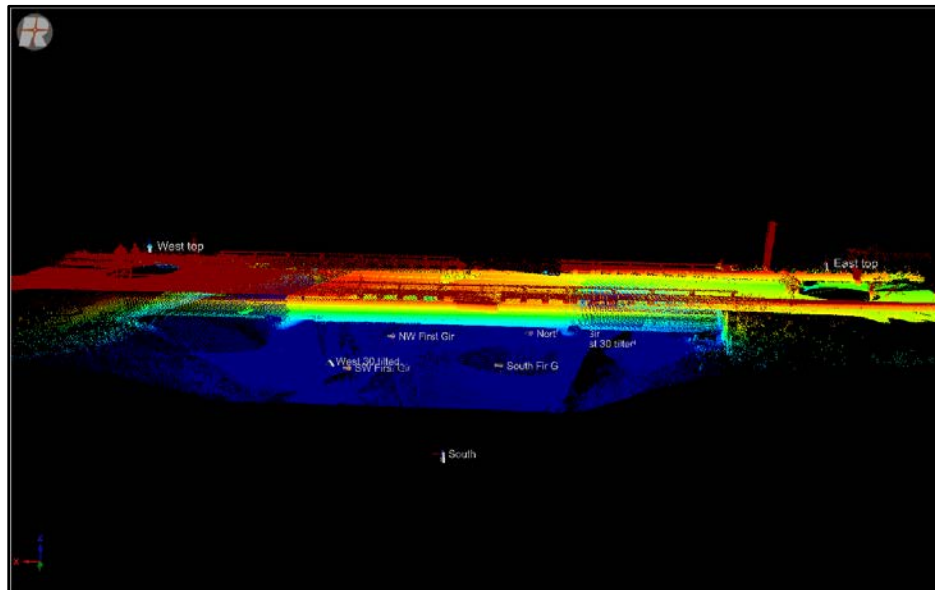
Figure 35: Master scan data image from the LMS-Z210ii and RiSCAN PRO.

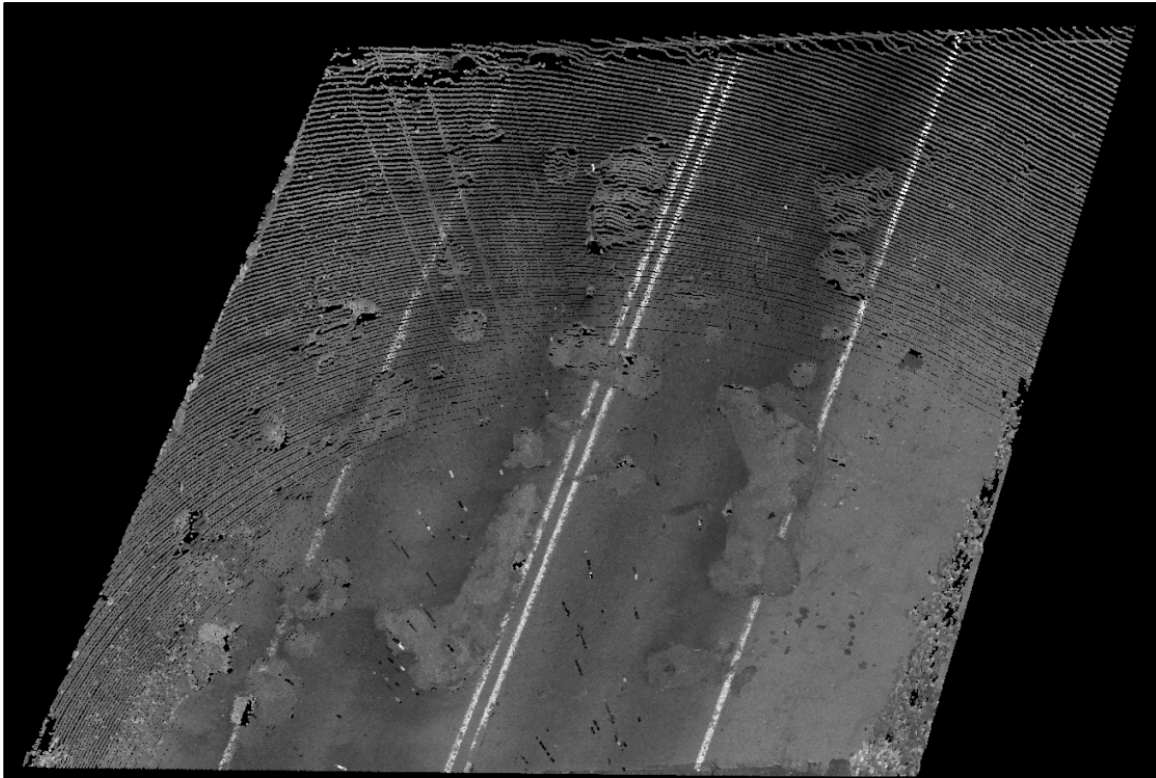
Figure 36: A LiDAR intensity image extracted from an MDOT sample data set (Warren Road over I-275). Deck condition is clearly visible as is increasing point spacing with distance from the scanner.

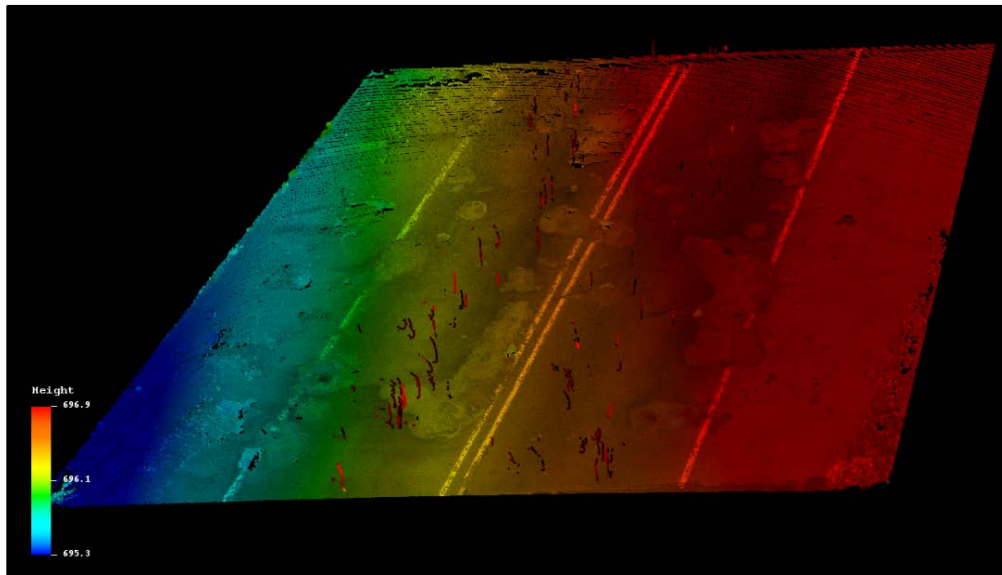
Figure 37: Composite LiDAR elevation and intensity image; deck condition can still be assessed from the intensity image. The bridge deck slopes from upper right to lower left with a total elevation change of about 48 cm.

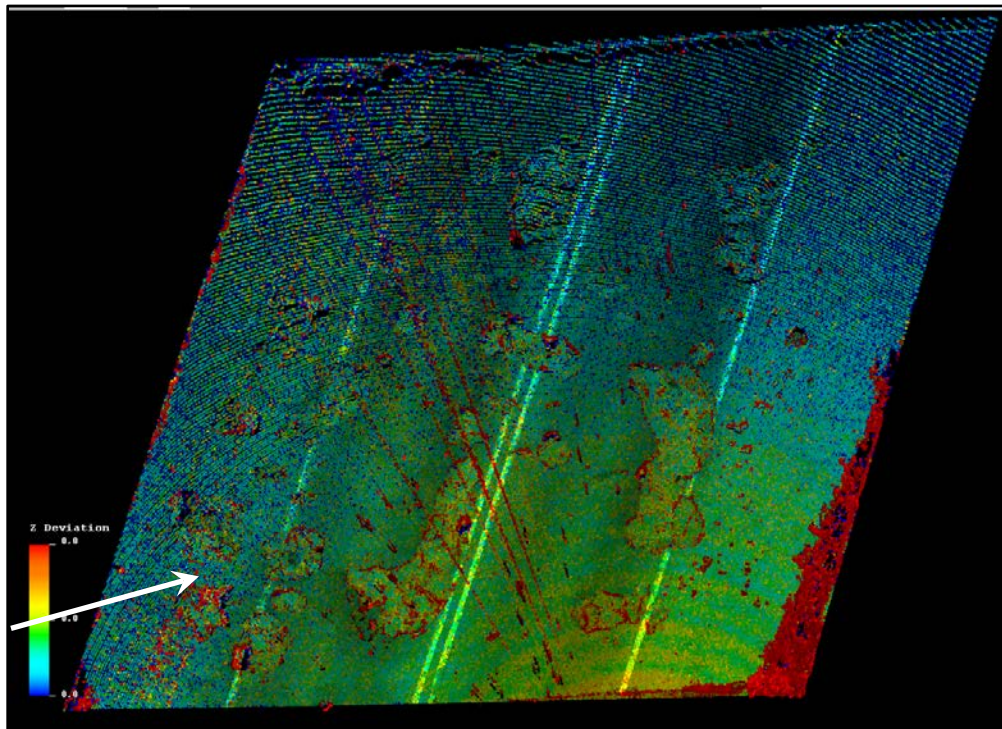
Figure 38: A composite Z-deviation and intensity image showing sharp changes in elevation between returns (red pixels). Outlines of potholes are visible as irregular shapes outlined in red. The large triangle of red pixels at the lower left is an accumulation of debris on the bridge deck. The red lines radiating from the lower right are returns from passing cars that have not yet been filtered out.

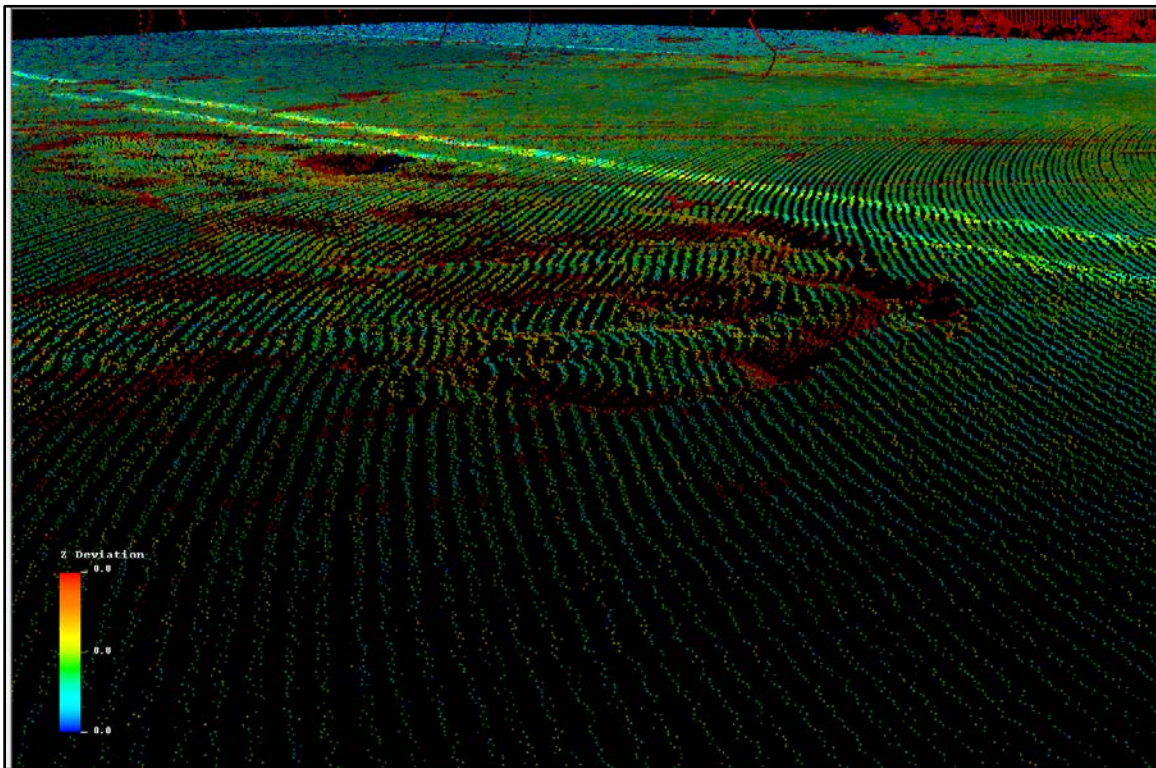
Figure 39: Demonstration of how LiDAR has captured the location and elevation values for a bridge spall. View is from the lower left looking toward the center right (white arrow) of the image. As in Figure 38, red pixels indicate rapid elevation change between returns. Further processing is expected to be able to extract deck damage area and volume values from the data.

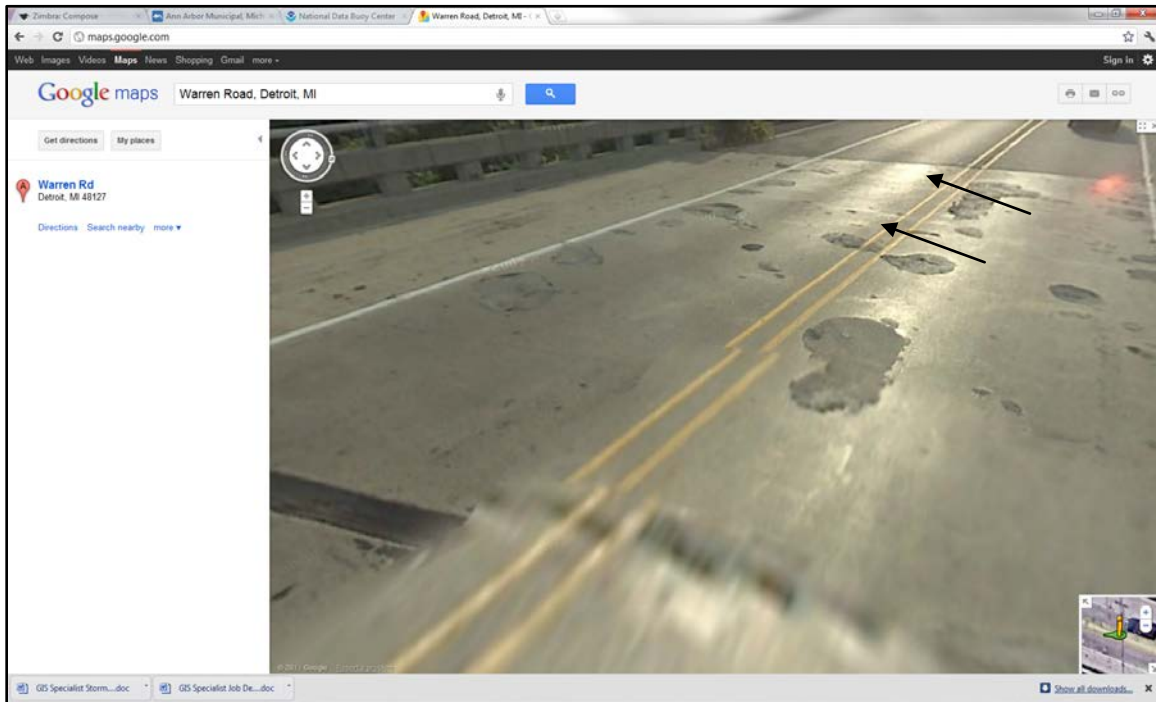
Figure 40: Street View image of the western-most span of the Warren Road bridge showing patches on the bridge deck.

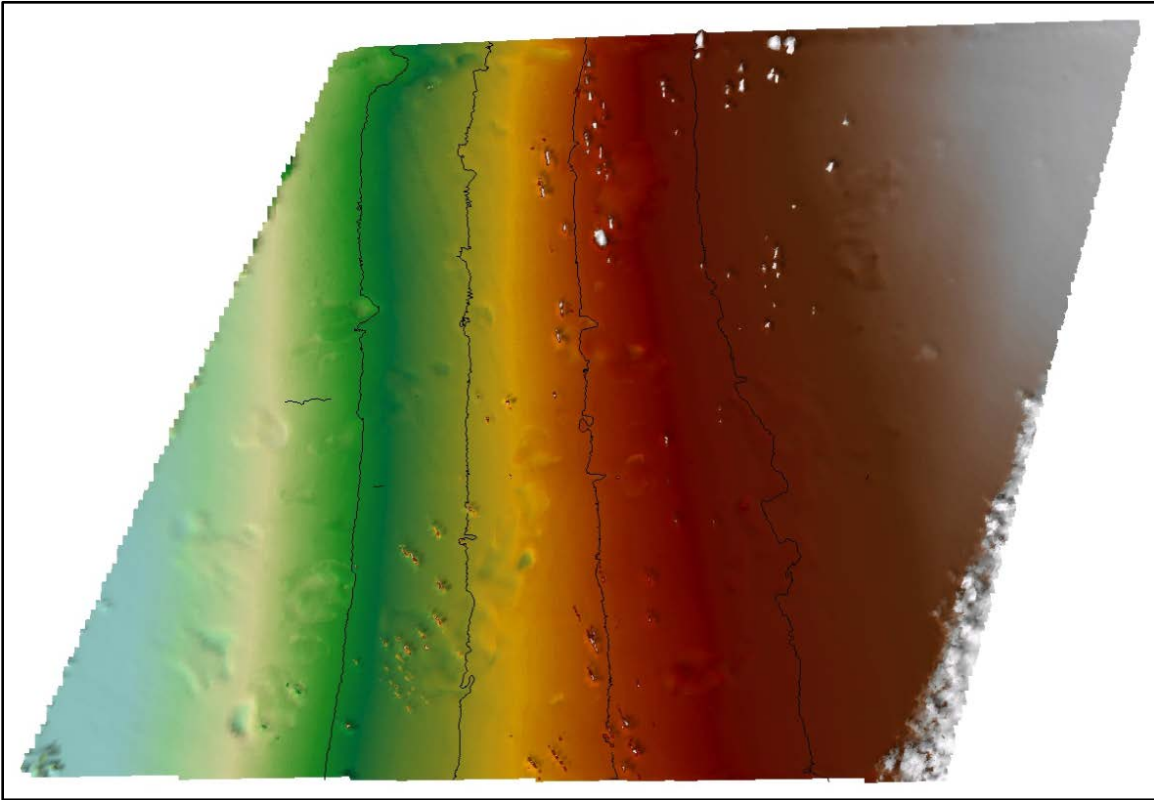
Figure 42: DEM derived from LiDAR data, exported from Quick Terrain Modeler and displayed in ArcGIS Arc Scene. Low-high is from lower left to upper-right. Generally, positive deviations from surrounding bridge deck are returns from passing vehicles, negative deviations are considered to be spalls. Orientation of this scene is similar to the previous LiDAR figures.

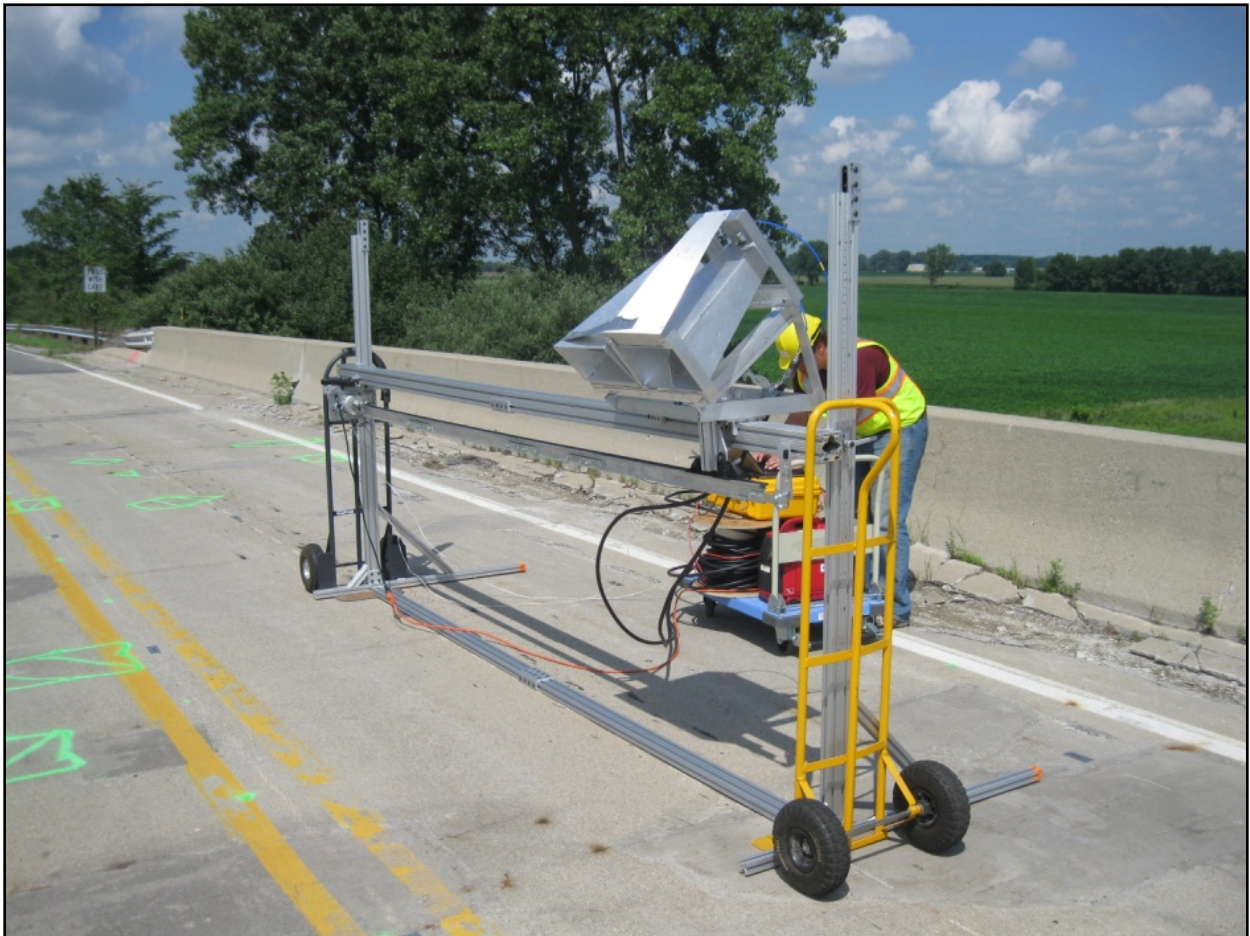
Figure 46: More "mobile" translator apparatus and radar equipment. It is easy to view how such a system could be adapted for use on a moving vehicle.

For the collection on August 2nd, two furniture dollies were employed to roll the translator apparatus from one grid mark to the next. Further, the other equipment (radar, cables, generator, and laptop) was placed on a small wheeled cart. In this way the apparatus and equipment could be much more easily moved along the bridge, allowing for more efficient data collection. The translator apparatus with the furniture dollies is shown in Figure 46. It also provided a concept of operation for how such a system could be adapted for use on a moving vehicle, such as DOT data collection vehicle (see Figure 46).

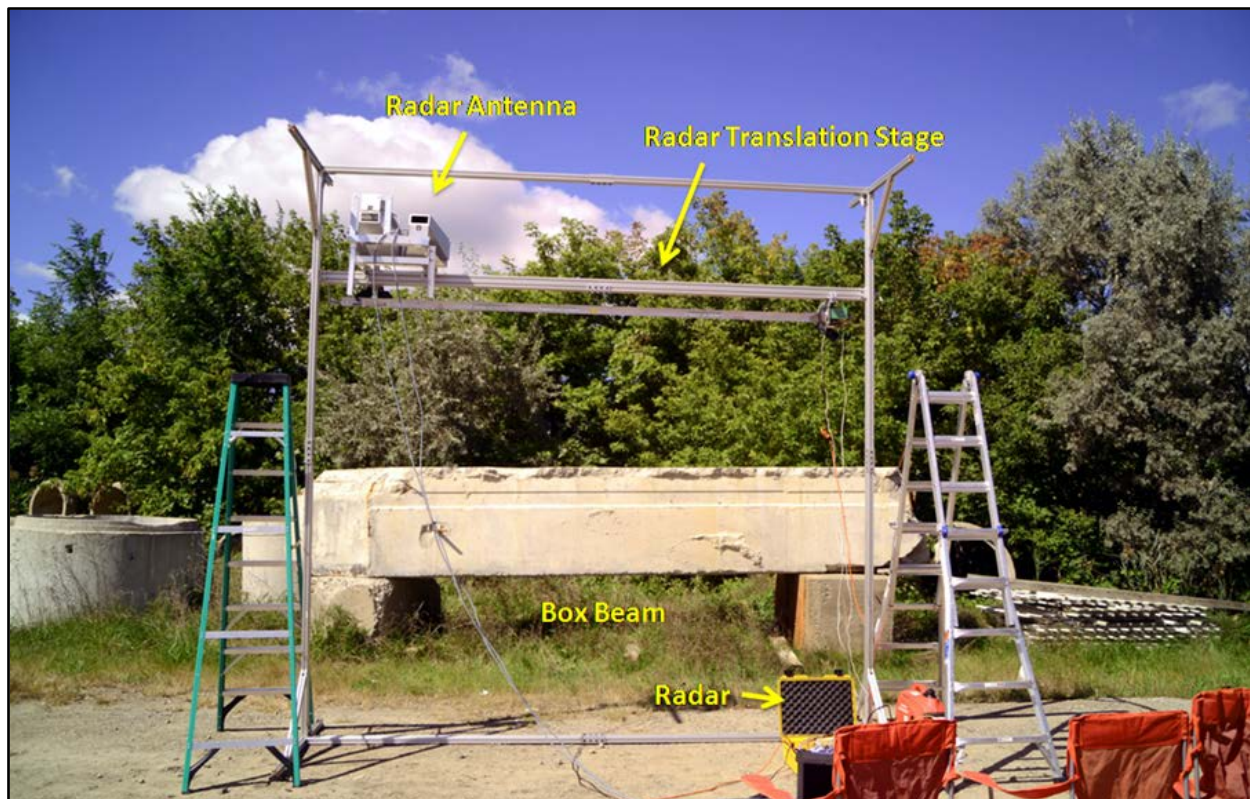
Figure 52: Portable UWBIRS mounted on a 2D translation stage parallel to side of salvaged concrete box-beam at Oakland County Road Commission site in Waterford, MI.

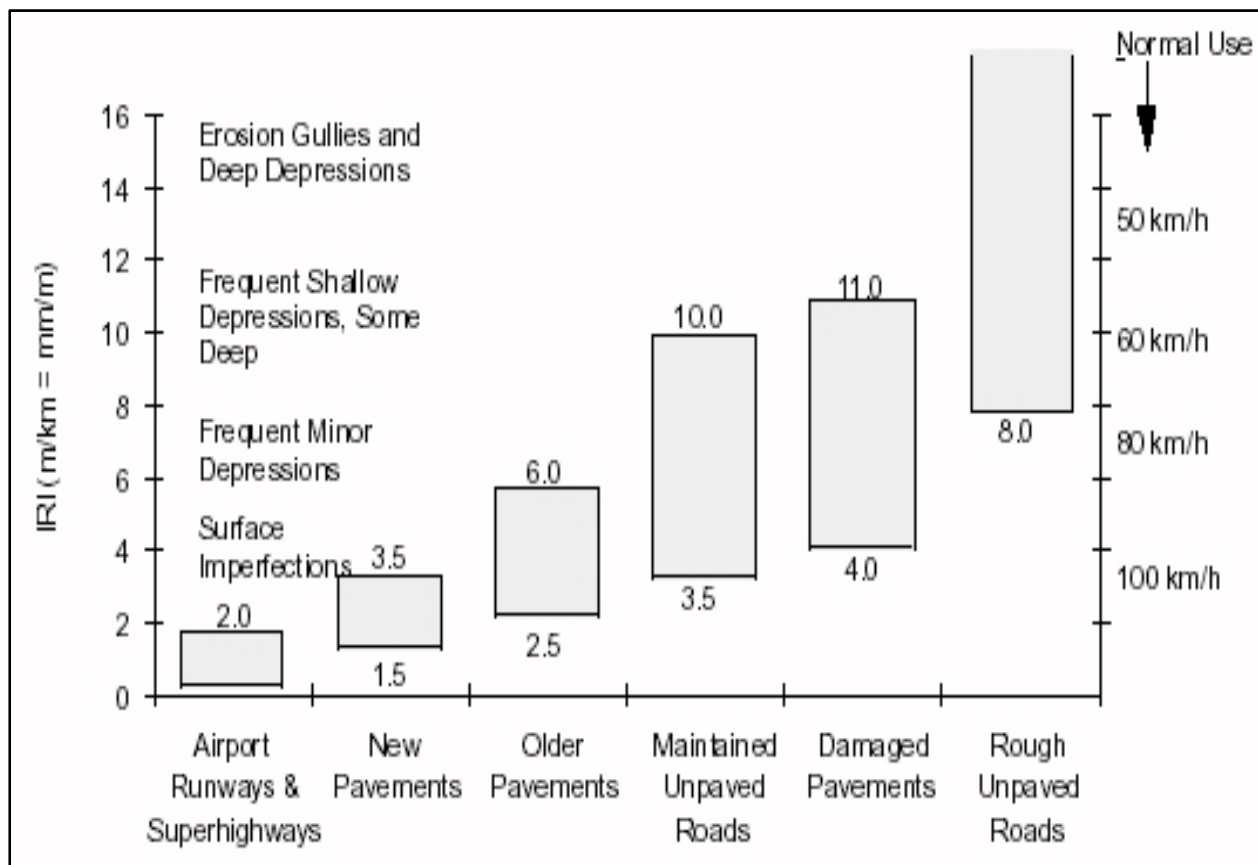
Figure 1: The International Roughness Index graph.

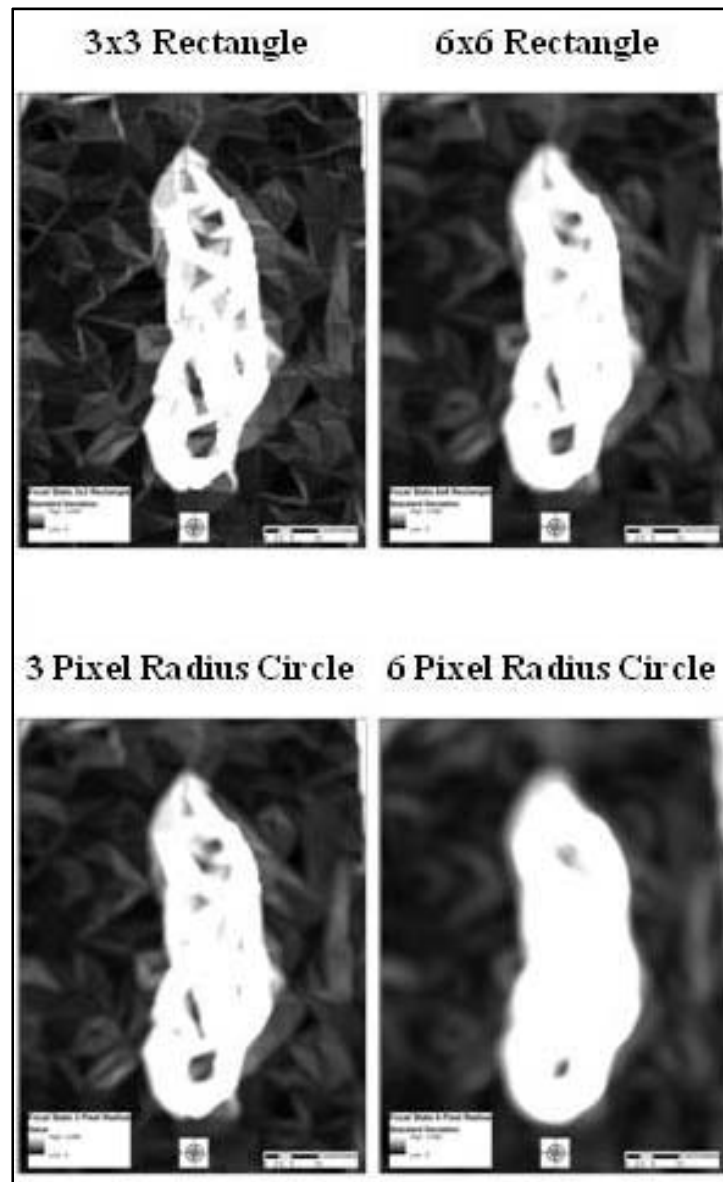
Figure 5: Comparison of the different "neighborhood" sizes and type that can be calculated.

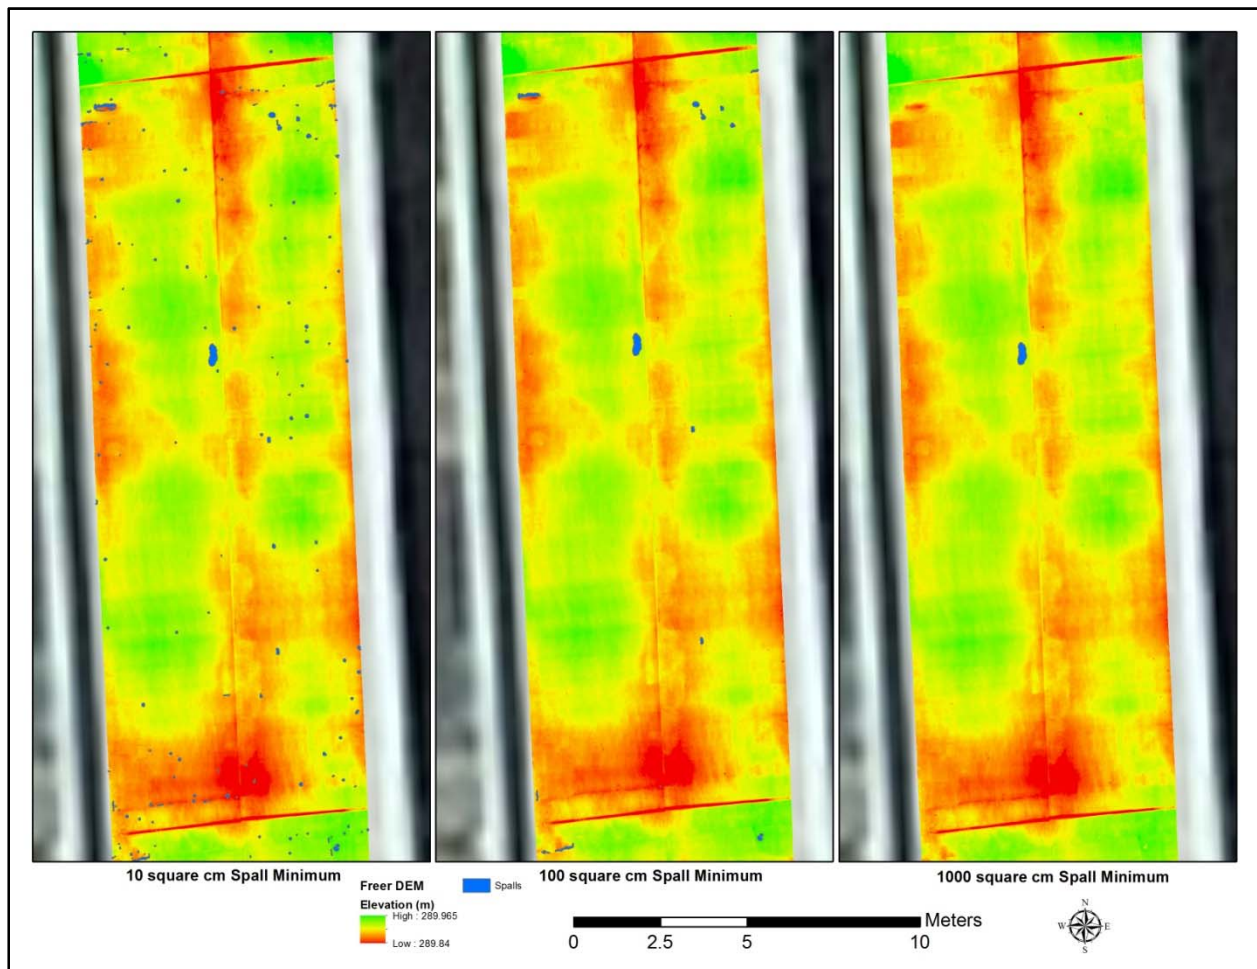
Figure 6: Comparison of three different minimum spall output sizes from the 3DOBS spall detection algorithm.

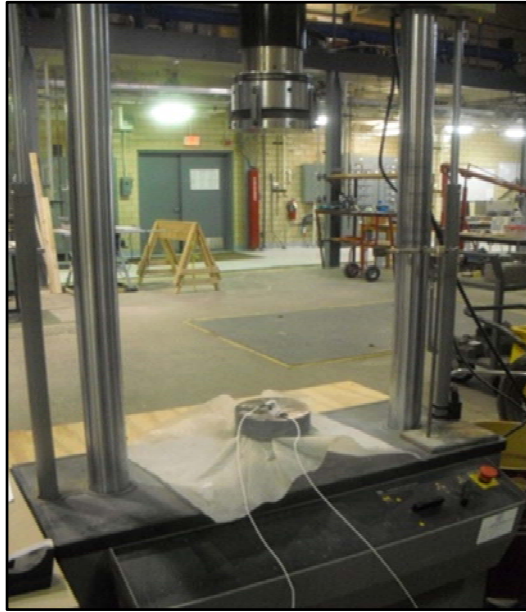
Figure 11: Accelerometers on MTS testing machine.

In previous tests, the 318.25 MTS 810 Material Test System was used for DIC measurements. This testing machine was implemented again to monitor movement with a PCB Piezotronics 333B50 piezoelectric accelerometer and transform (integrate) those readings into displacement. Measuring this data can enable a measurement of environmental noise (i.g., vibration or movement on the camera) that can be factored out to capture the true bridge movement measurement (see Figure 11).

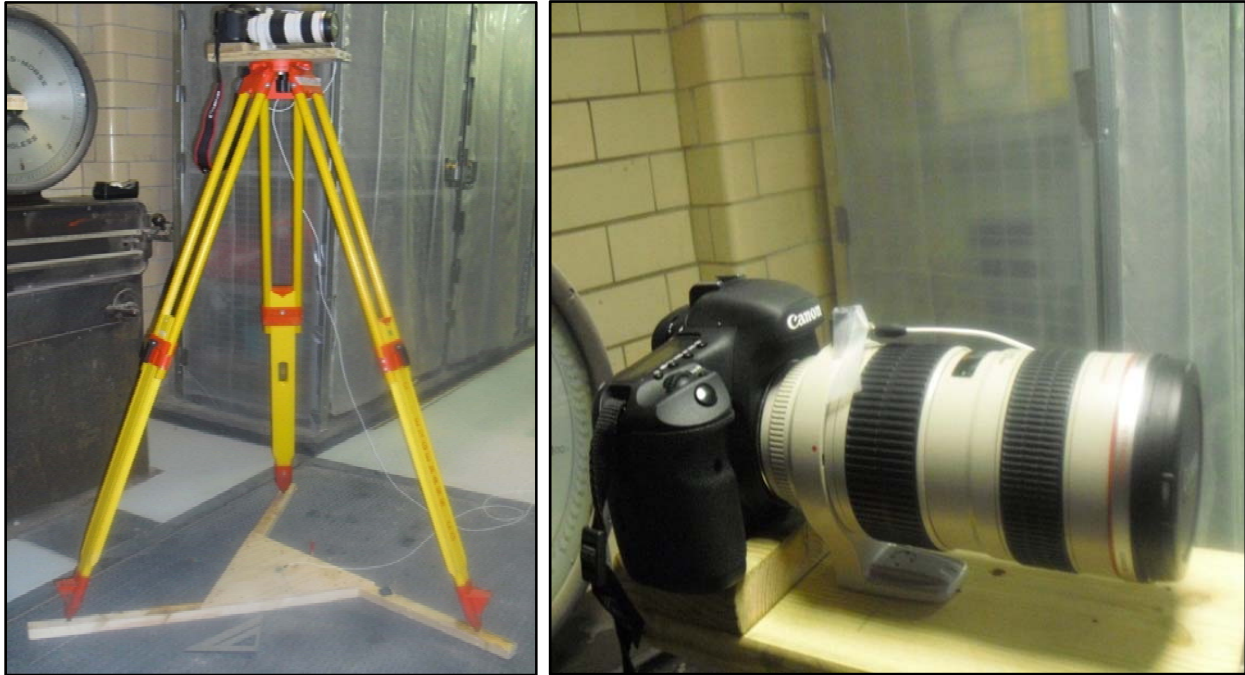
Figures 14 & 15: Camera on stable tripod and detailed of mounted accelerometer.

As the generic method for capturing motion into displacement measurements on the MTS system, this was further configured for the camera-lens system. The camera-lens system (as used in DIC system) was connected with an accelerometer in order to measure the excessive movement endured and computed the movement as displacement. In this setup, a more stable and heavier surveying tripod as well as a wooden base ensuring a flat secure platform for the camera–lens system was employed. An additional accelerometer was also placed at the bottom of the tripod for location comparisons at the top and bottom of the tripod. These figures of the tripod and camera-lens setup can be shown in Figures 14 and 15.
