**BRIDGE CONDITION ASSESSMENT
USING REMOTE SENSORS**

Volume II of II – Appendices

An Evaluation of Commercially Available Remote Sensors for Assessing Highway Bridge Condition

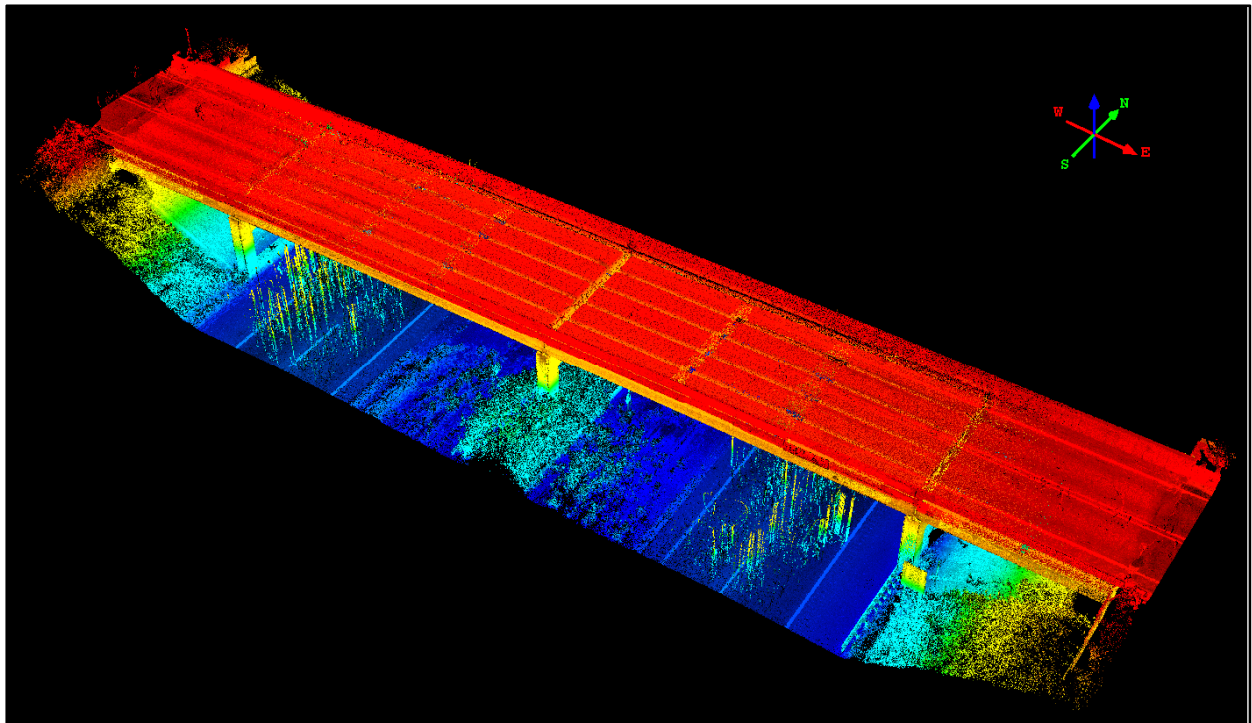
Figure 18: Registered, geo-referenced LiDAR point cloud of the Willow Road as collected by MDOT for this project. Point elevation (color) and intensity are displayed. This LiDAR point cloud contains more than 186 million points. The Willow Road bridge is approximately 209 ft long (63.7 m). Applied Imagery Quick Terrain Modeler software was used to generate the point clouds and DEMs.

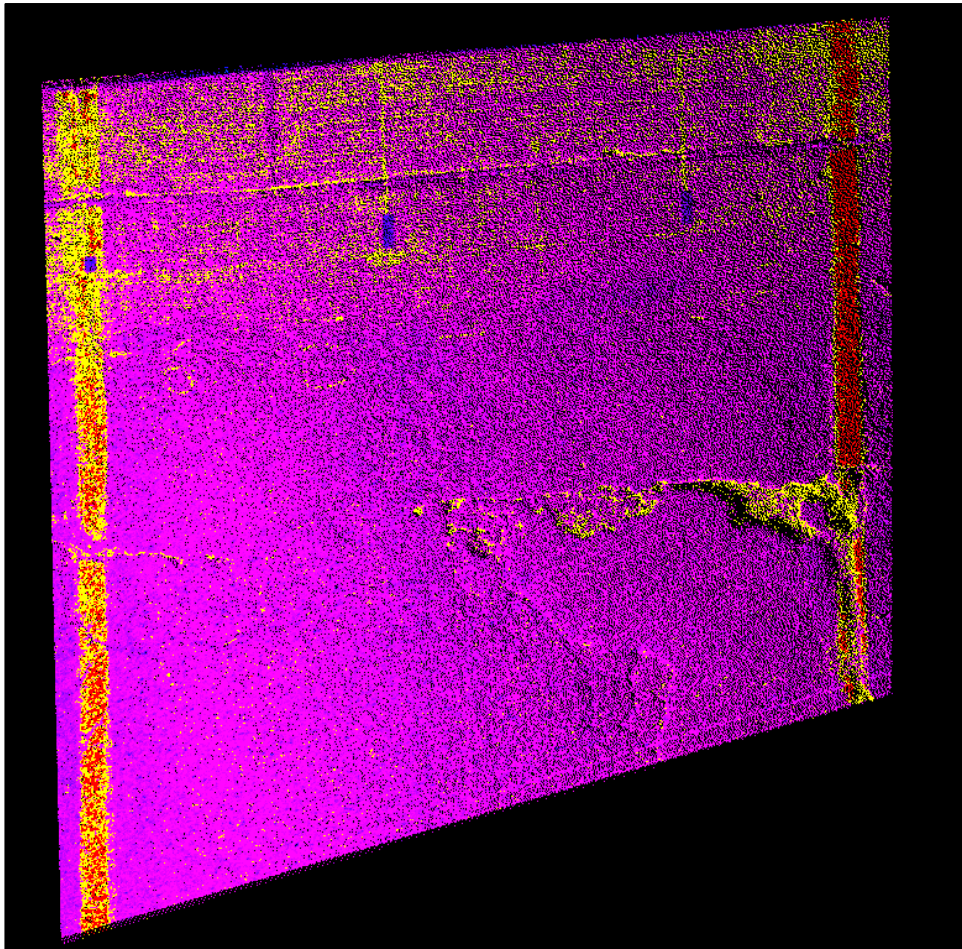
Figure 19: TopoDOT data of Willow Road bridge subset deck extraction, color intensity display.

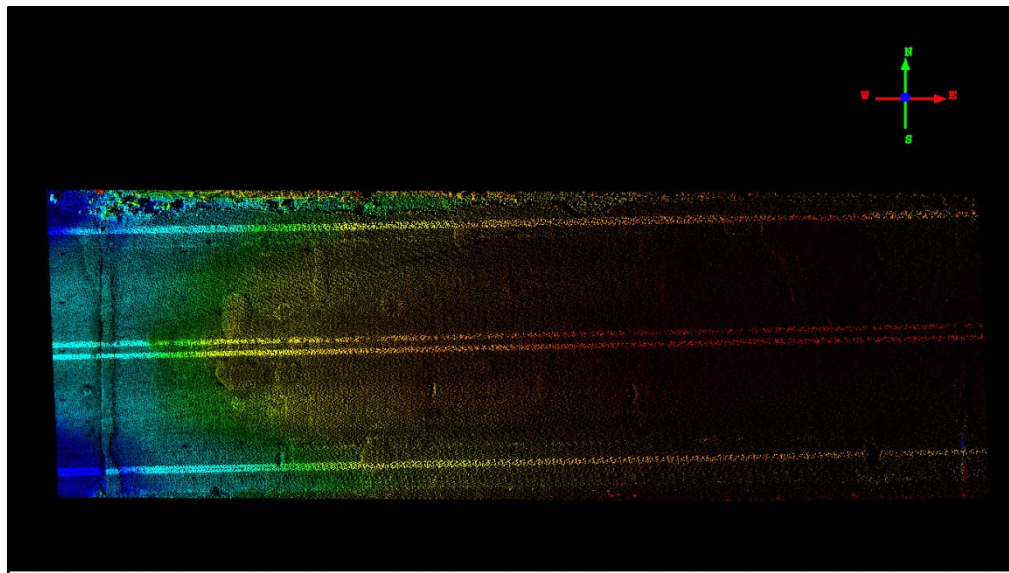
Figure 24: LiDAR intensity and elevation data displayed together provide a clearer picture of the condition of the bridge deck. This segment of the bridge deck is approximately 77 ft long. Total elevation change from left (low) to right (high) is 0.71 ft.

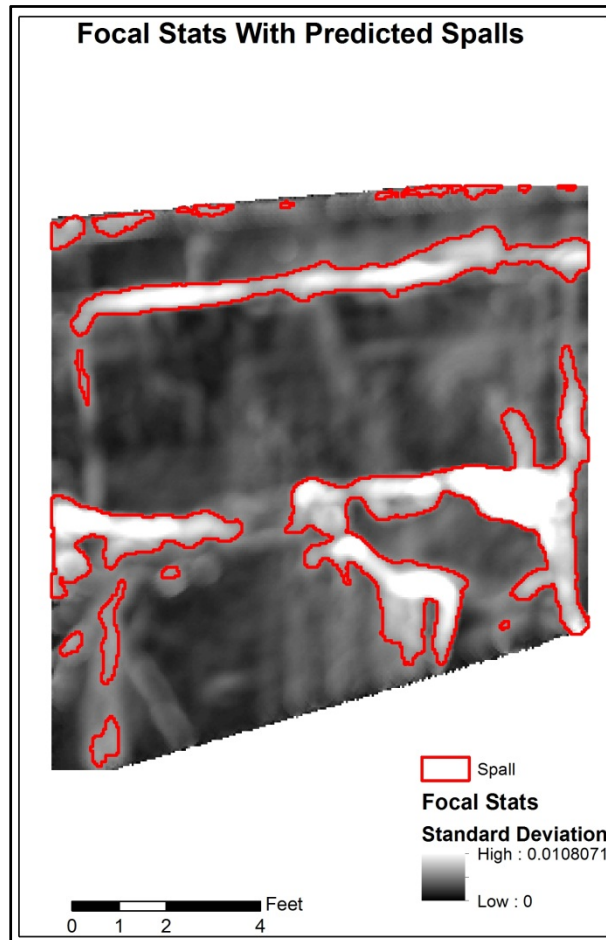
Figure 25: Willow Road subset deck focal statistic algorithm output highlighting predicted spall regions.

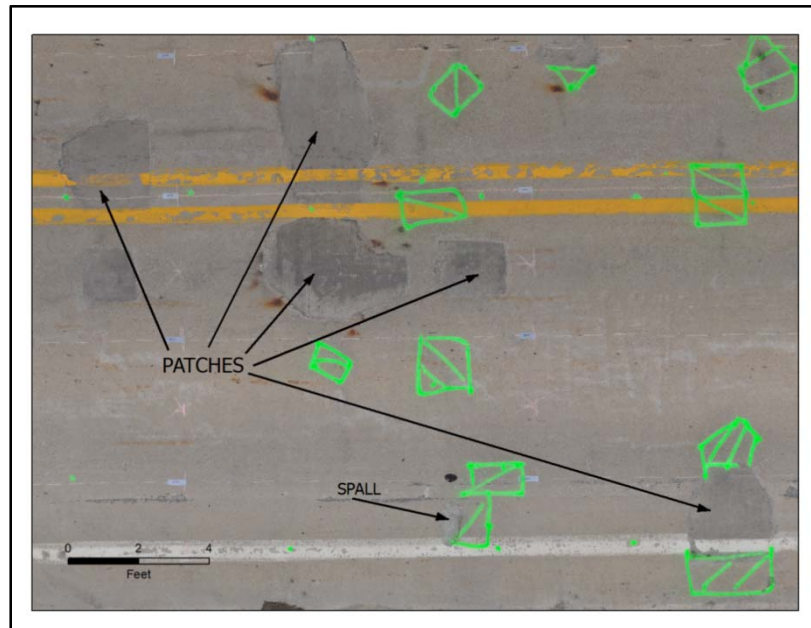
Figure 26: Section of the ortho-photo of the Willow Road bridge deck illustrating patches and a spall. The green pavement markings outline areas of subsurface delamination as determined by sounding performed by MDOT bridge inspectors with the hammer (rod) sounding technique.

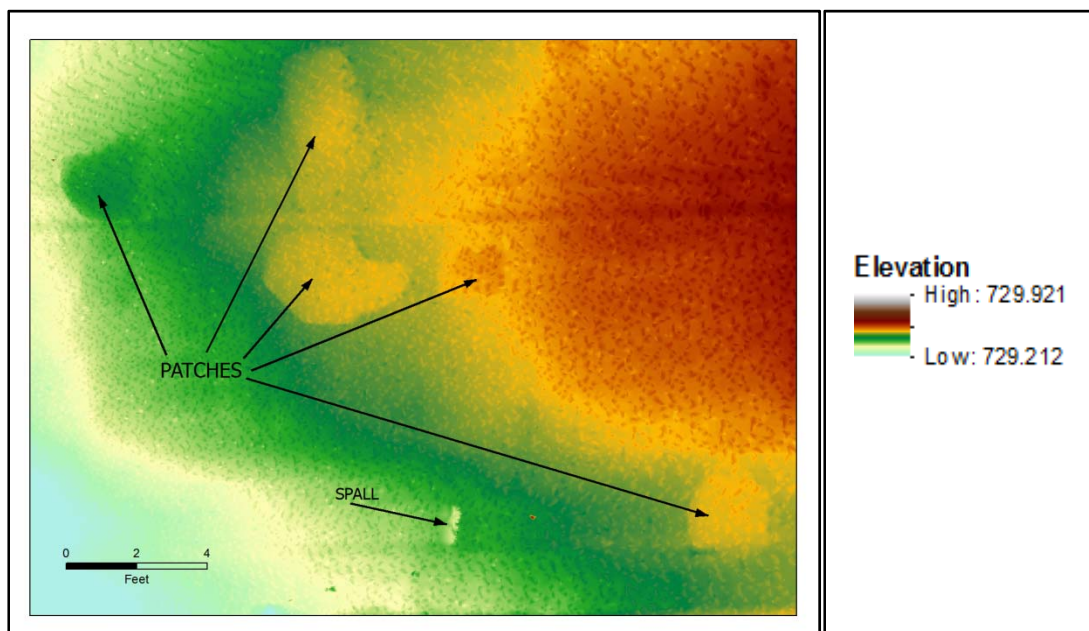
Figure 27: DEM with a color ramp applied of the same area of the Willow Road bridge deck. Note that the higher areas of the concrete patches and missing material from the spall correlate well between the ortho-photo and DEM. The patches (correctly) appear higher than the surrounding bridge deck and the spall appears lower than surrounding deck.

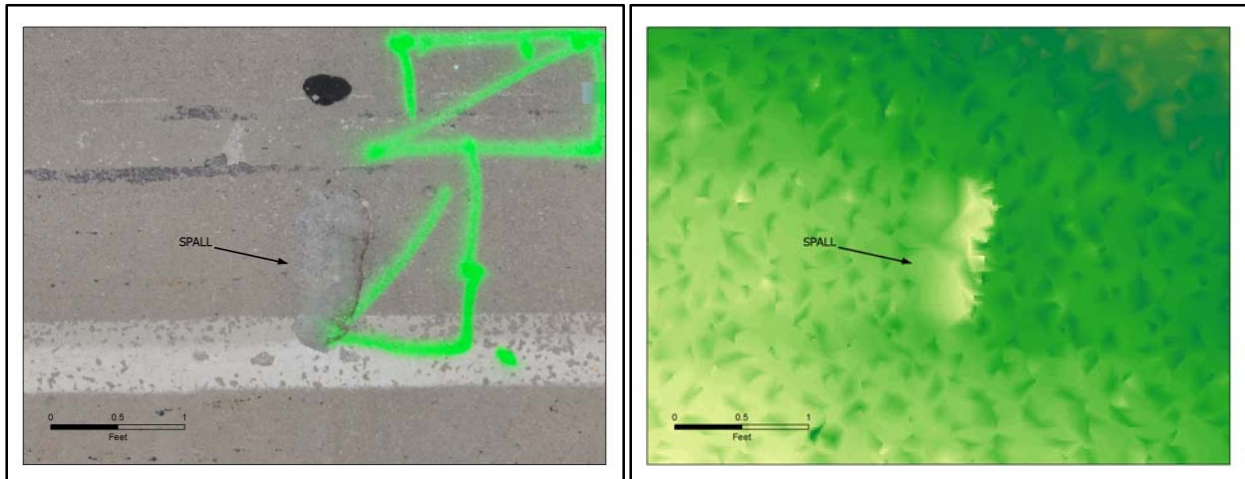
Figure 28: Close up of the spall on the Willow Road bridge deck. The spall is clearly visible in the ortho-photo as well as in the DEM (the light yellow color is lower than the green).
