**BRIDGE CONDITION ASSESSMENT
USING REMOTE SENSORS**

United States Department of Transportation
Research and Innovative Technology
Administration

Michigan Technological University

Volume I of II – Main Body

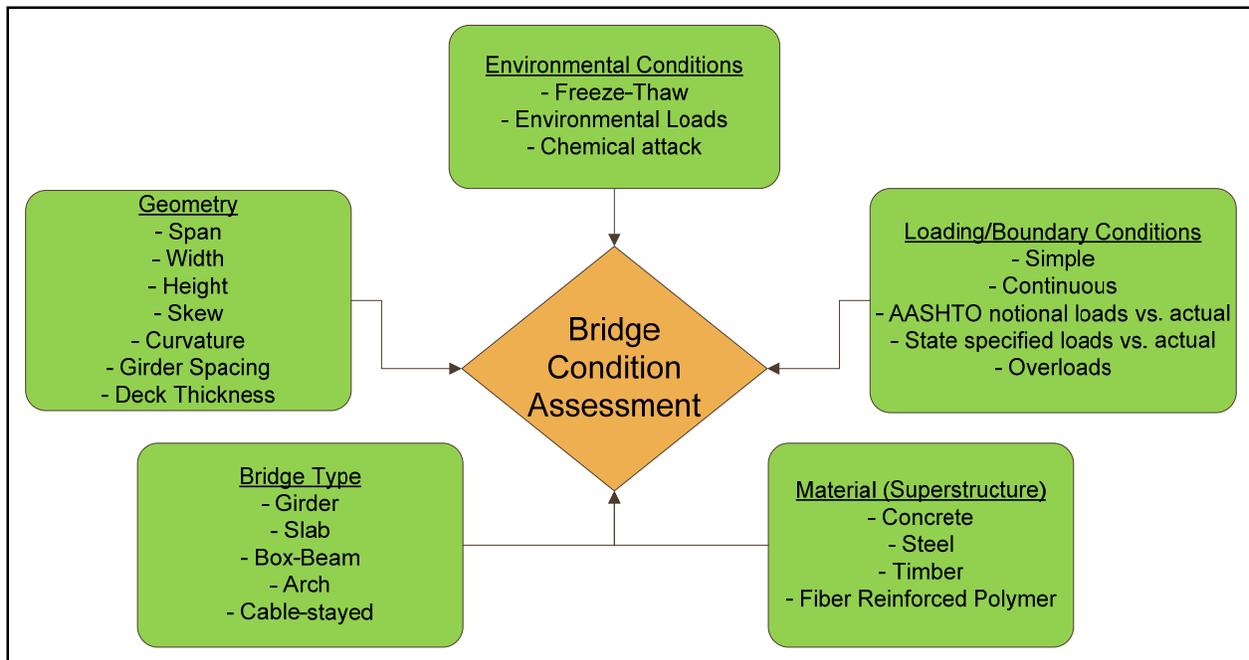
Figure 1-1: Variables influencing bridge behavior.

This knowledge highlights the urgent need for replacing and/or upgrading existing bridge infrastructure and underscores the importance of quality inspection and assessment mechanisms to prioritize these efforts. In recent years, structural health monitoring (SHM) for bridges has adopted the "Level IV" approach with a primary focus of accurately monitoring in-situ behavior to assess in-service performance, detect damage, and determine condition of a structure (ISIS 2001). Recent advances in SHM have included novel sensing technologies and assessment methods such as: wireless sensors, strain sensing films and local damage identification, but a complete solution to the challenges facing our aging infrastructure. SHM is further complicated by the wide degree of variability in bridge types, materials, operating environments, and structural configurations Figure 1-1.

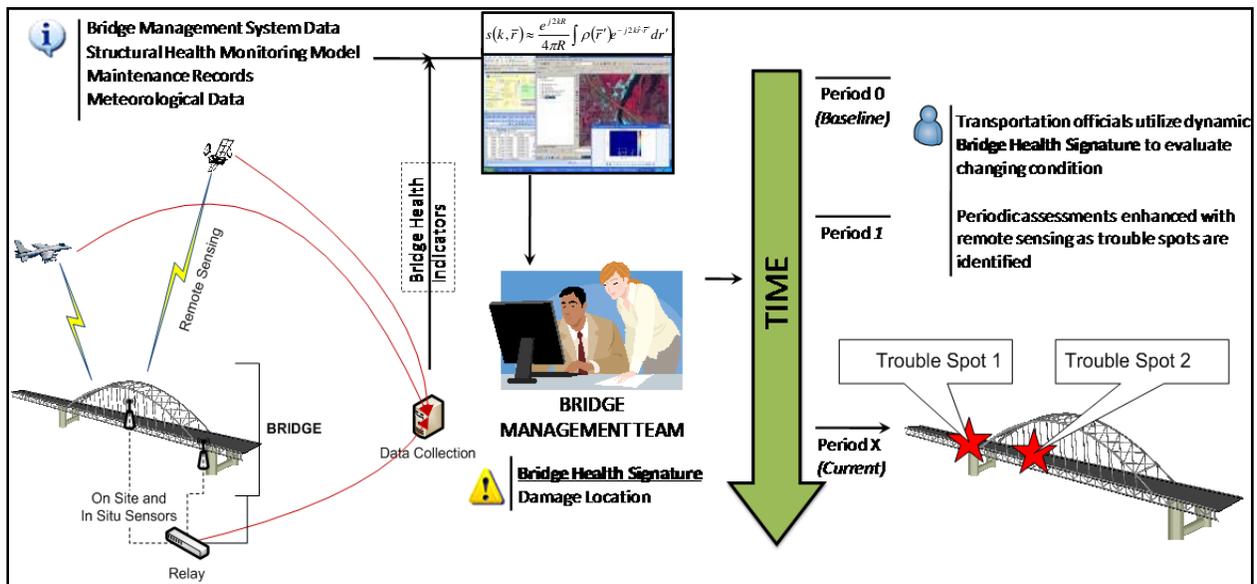
Figure 1-3: Remote sensing operation concept.

A computer-based DSS is a user-friendly web interface software tool, which integrates diverse sensor data and historical information. Monitoring how these signatures change over time will provide state and local engineers with additional information used to prioritize critical maintenance and repair of our nation’s bridges. The ability to acquire this information remotely from many bridges without the expense of a dense sensor network provides more accurate and near real-time assessments of bridge condition. Improved assessments allow for limited resources to be better allocated in repair and maintenance efforts, thereby extending the service life and safety of bridge assets, and minimizing costs of service-life extension. With this approach, it is intended to save tax-payers’ dollars by prioritizing allocated funds and maintaining structural integrity.

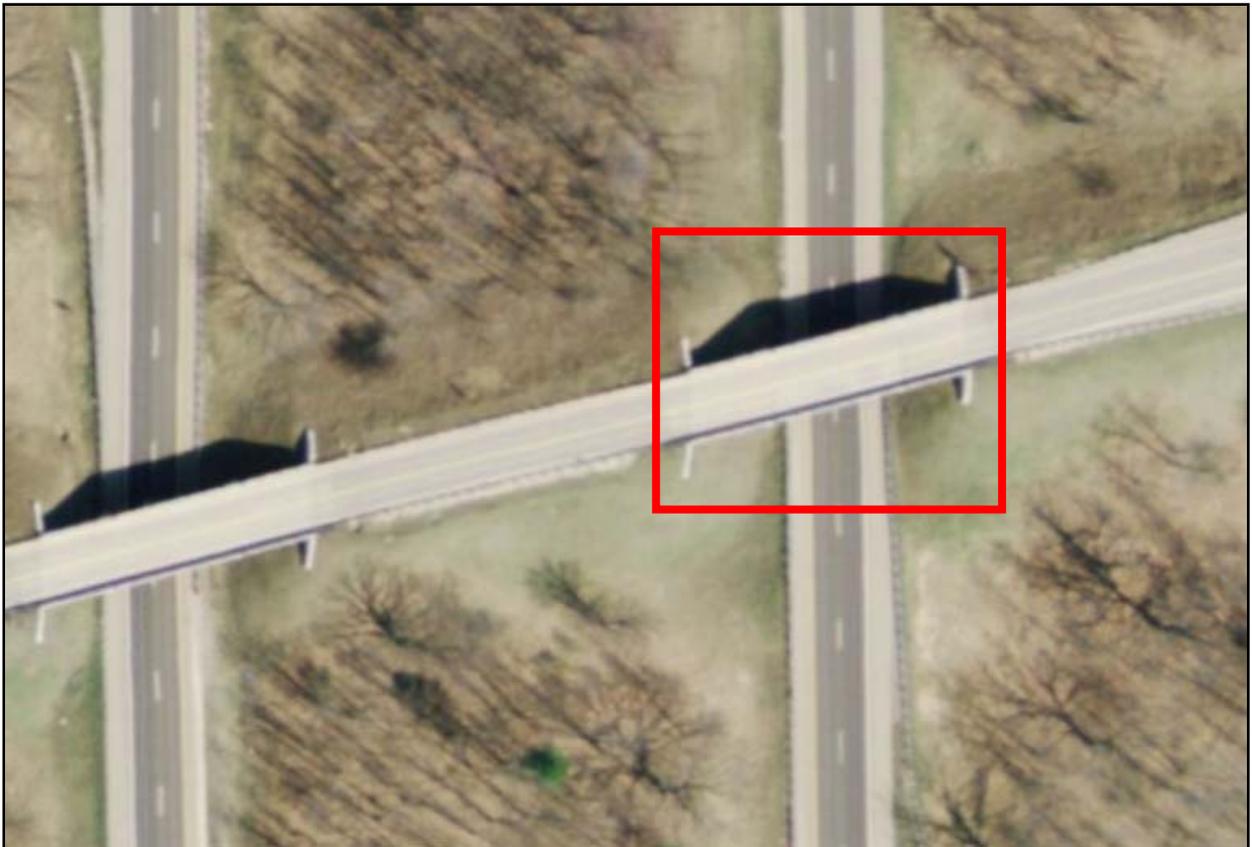
Figure 3-2: "Poor" bridge selection – Mannsiding Road NB.

The field demonstration candidate structure serves Mannsiding Road; a “Major Collector” road. The bridge was constructed in 1966 and is a 3-span prestressed concrete multiple I-beam composite structure. The structure is 130.92 ft in length and 31.17 ft in width, which translates into 26 ft of riding surface. During 1996, the average daily traffic (ADT) over the structure was found to be 1,000 with 3% being commercial (MDOT 2011).

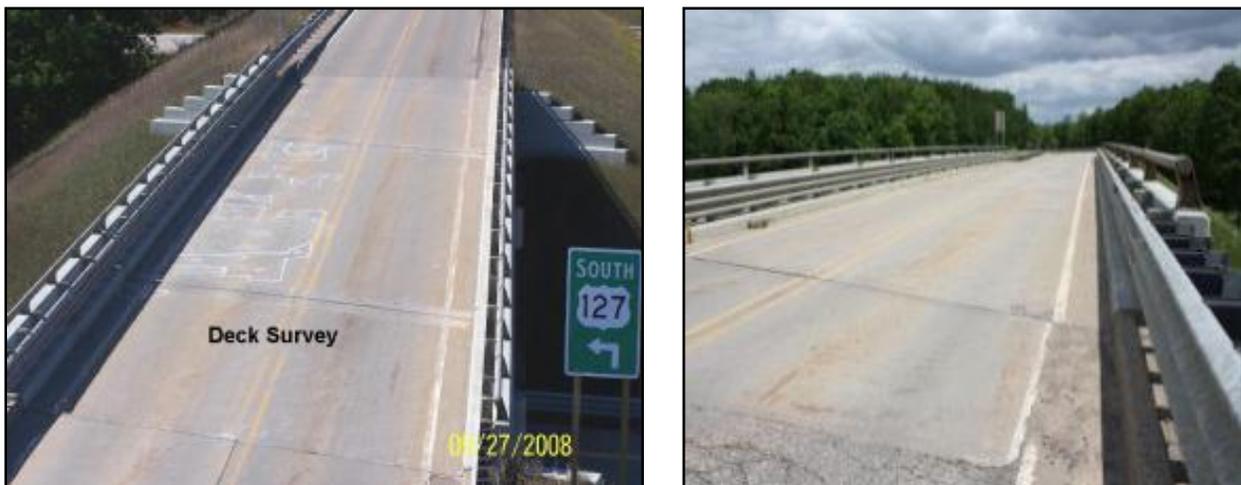
Figure 3-3: Mannsiding Road bridge NB deck condition in 2008 (a) and Mannsiding Road bridge NB deck condition in 2011 (b).

The condition of the concrete deck surfaces, both top and bottom, were an area of major concern. A 2008 MDOT scoping inspection classified the deck with a NBI rating of “4”. The scoping revealed that on the top surface of the concrete deck 176 ft² or 4.4% of the deck was delaminated. Additional testing on the bottom surface revealed that 623 ft² or 15% of the deck was in distress (MDOT 2011). The deck also possessed light scaling throughout and numerous transverse, longitudinal and diagonal cracks were present. Additionally, several high-load hits have resulted in scrapes and spalls of the superstructure underside, but currently there is no sign of exposed reinforcing steel or pre-stressing strands. The bridge is scheduled for complete replacement in 2012/13. Additionally, during the on-site inspection of the selected “Poor” bridge, it was found to have a complementing twin bridge, Mannsiding Road south bound overpass. The Mannsiding Road south bound overpass bridge is described in further detail in the “Supplemental” bridge selection section.

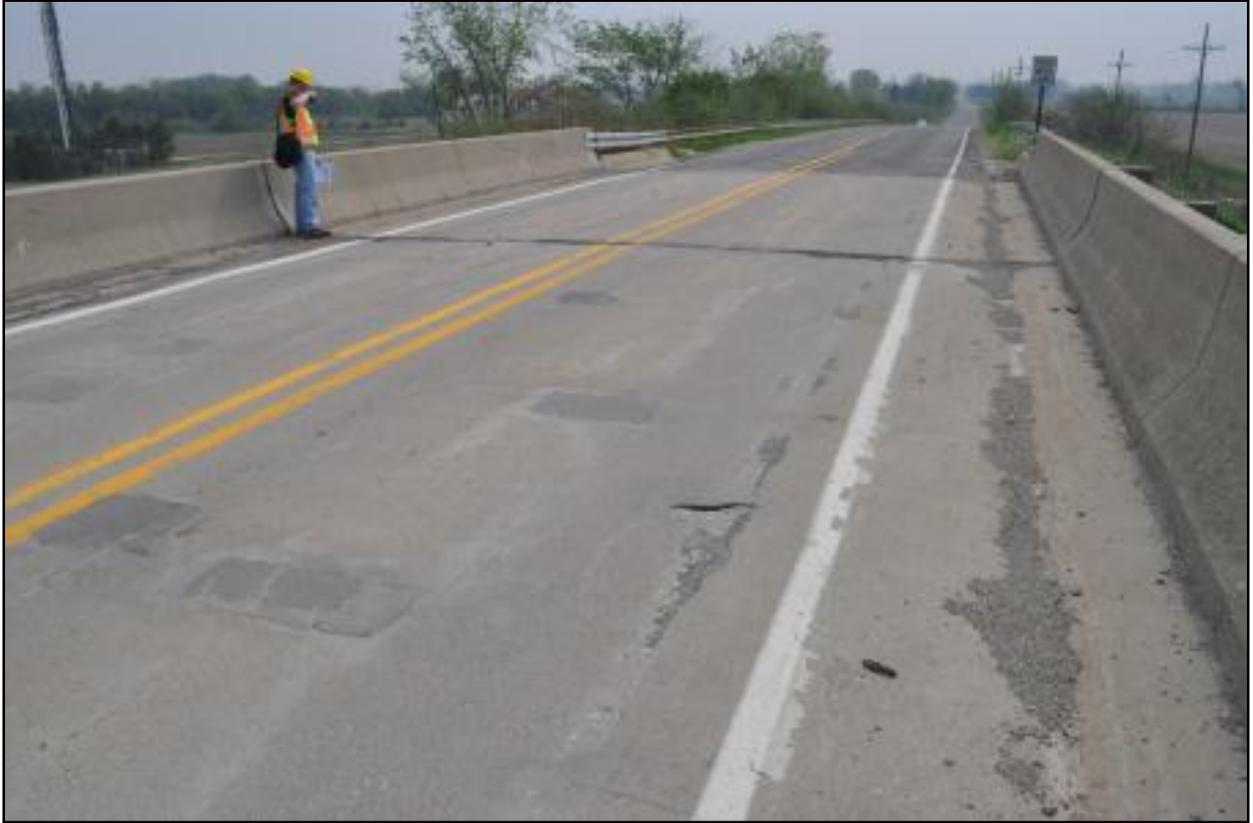
Figure 3-5: Willow Road bridge deck condition.

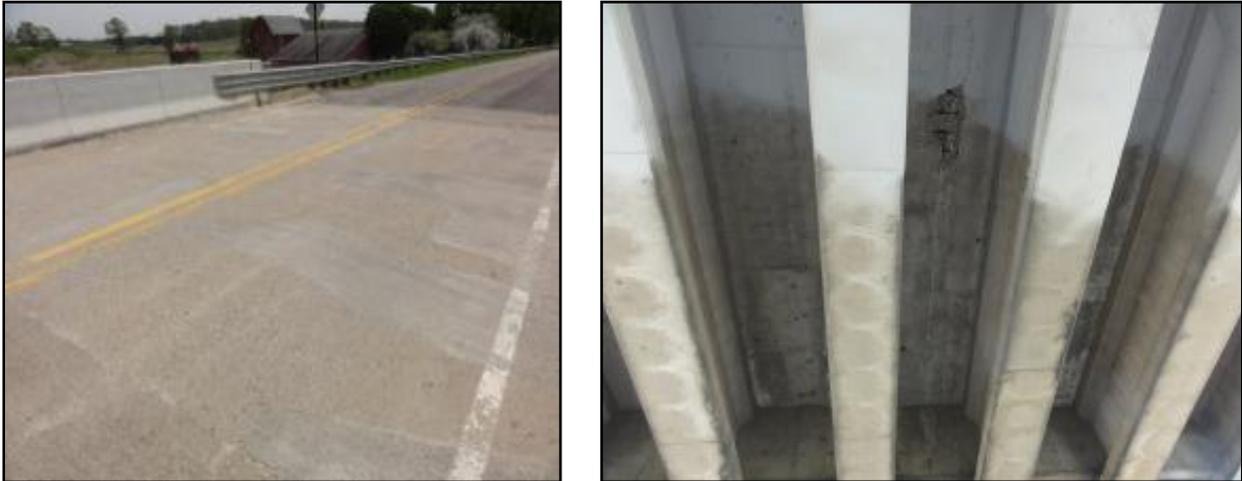
Figure 3-7: Freer Road bridge top and bottom surface conditions.

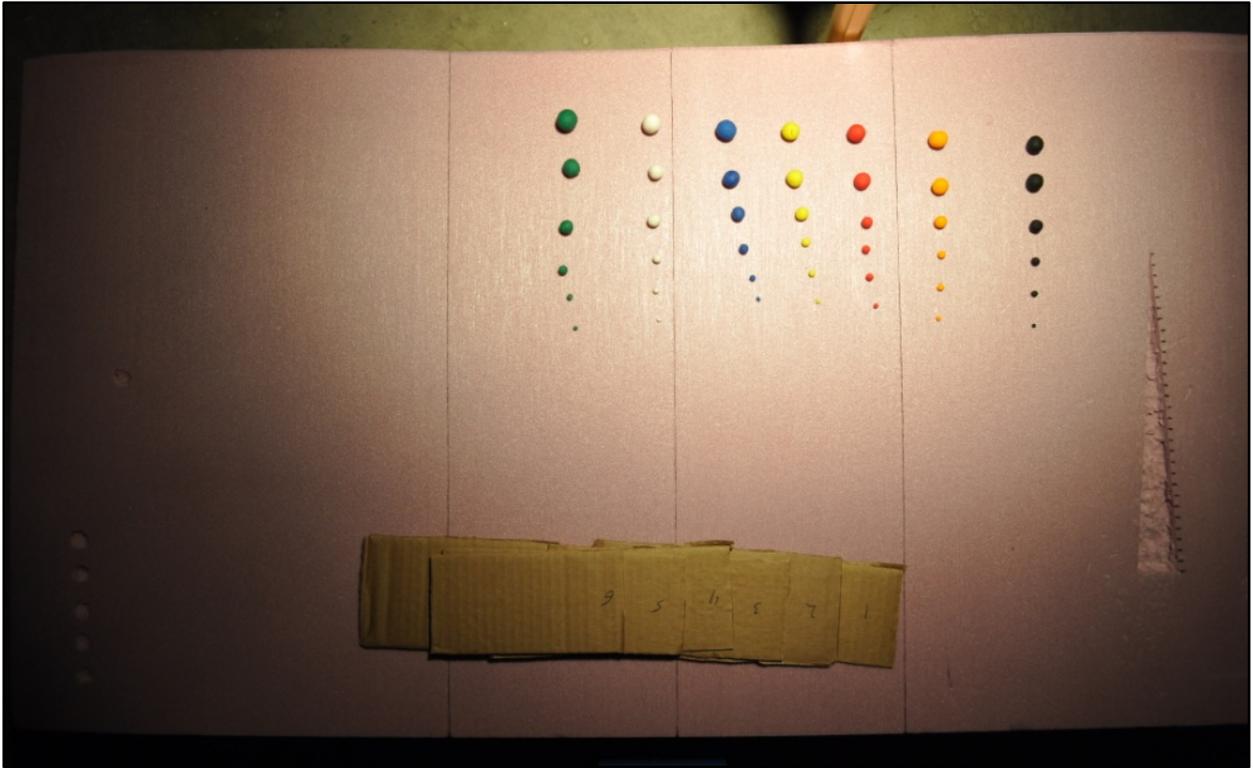
Figure 4-1: Photo taken of the foam board used to determine the restrictions of PhotoScan. The light source is directly overhead simulating conditions around noon where the presence of shadows is reduced.

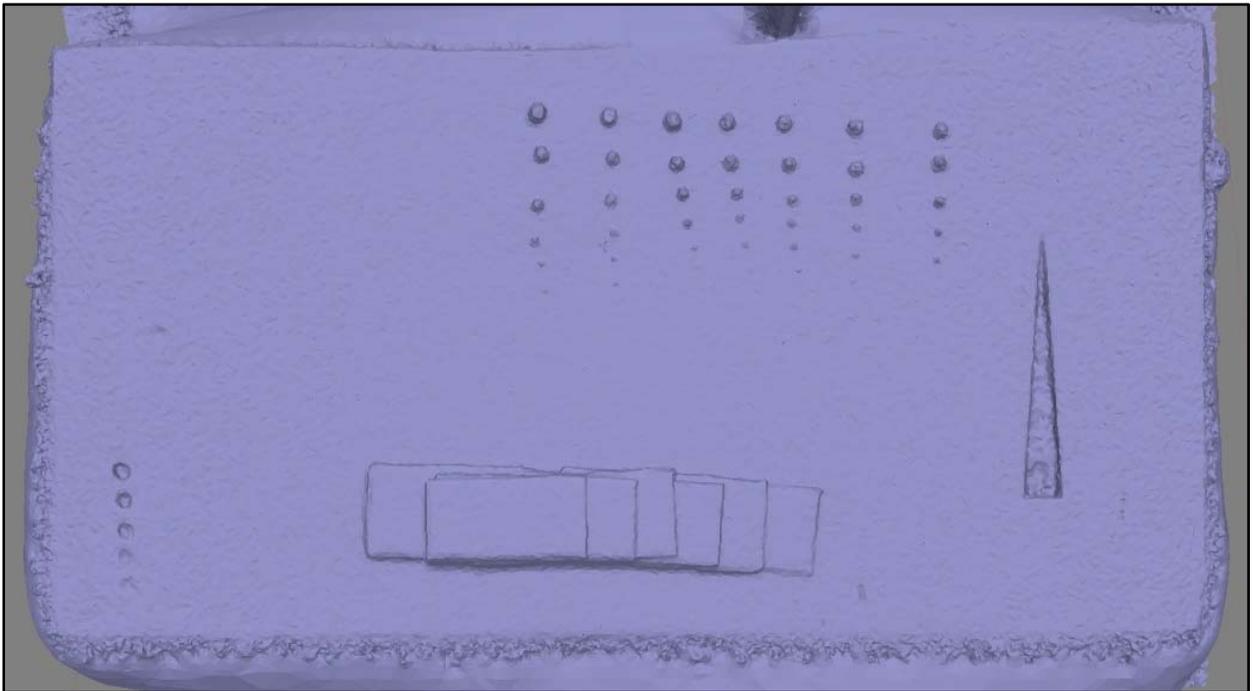
Figure 4-2: The resulting PhotoScan model. A total of five photos were used to generate this model.

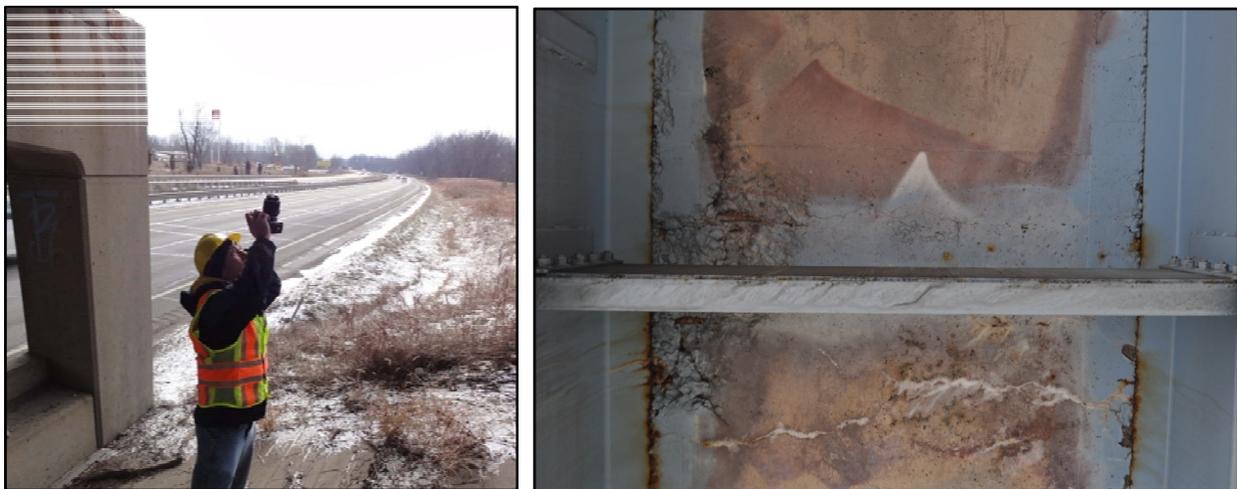
Figure 4-3: Taking photos of the underside of 6 Mile Road bridge over US-23. Image on the right is one of the photos used to generate a 3D model.

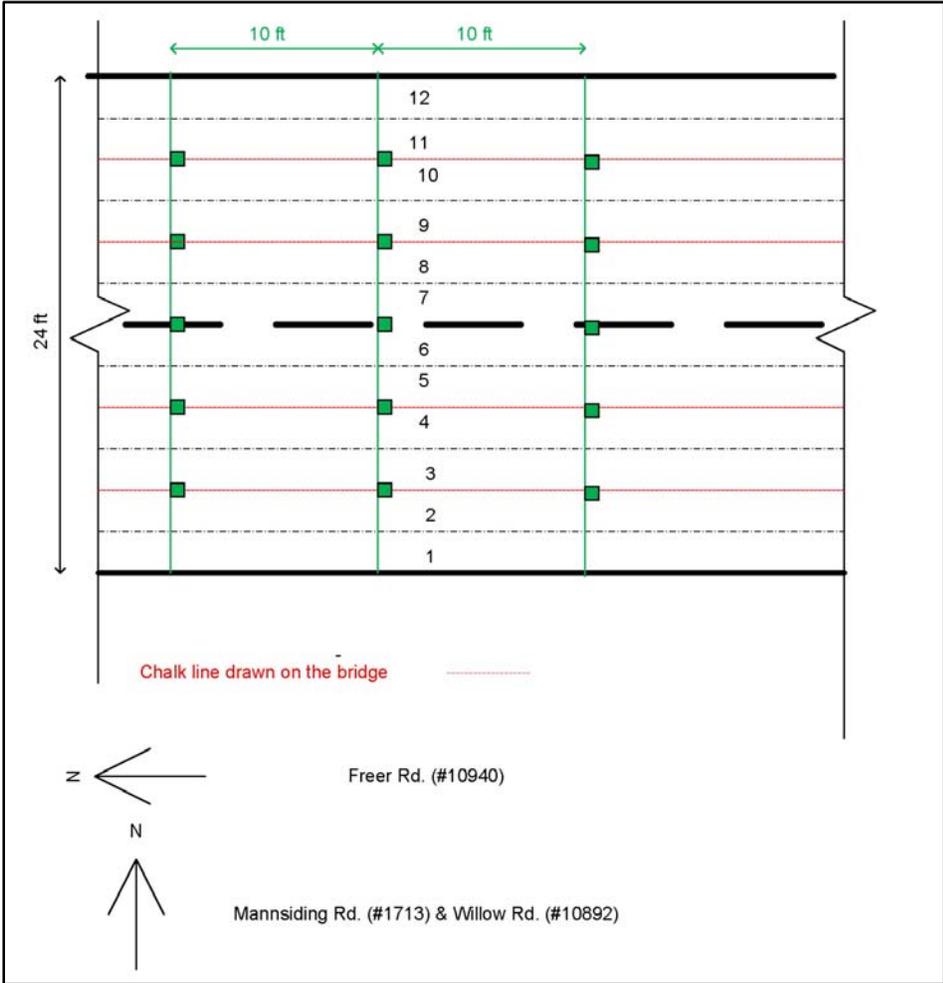
Figure 4-6: Diagram illustrating the grid pattern used for reference on all field demonstration bridges. The chalk line on the bridge deck was used for the Thermal IR data collects.

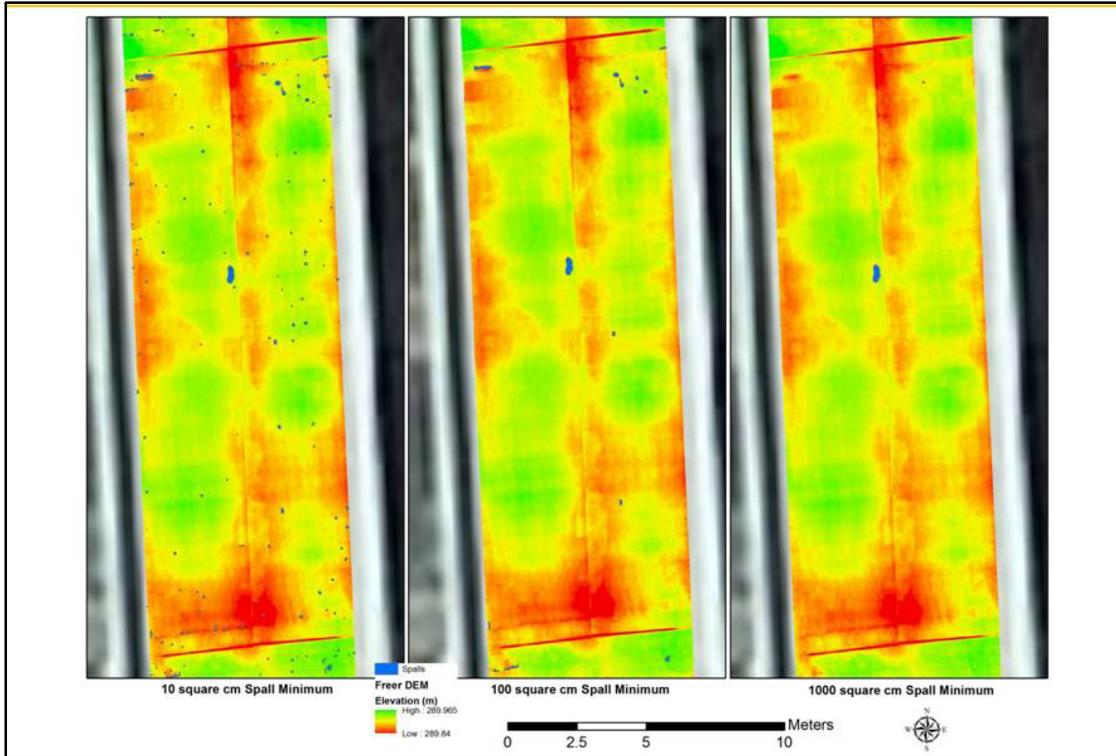
Figure 4-8: Differences in minimum spall sizes as from the spall detection algorithm. Starting on left, the images depict spalls larger than 10 cm², 100 cm², 1,000 cm² respectively. Data from Freer Road bridge.

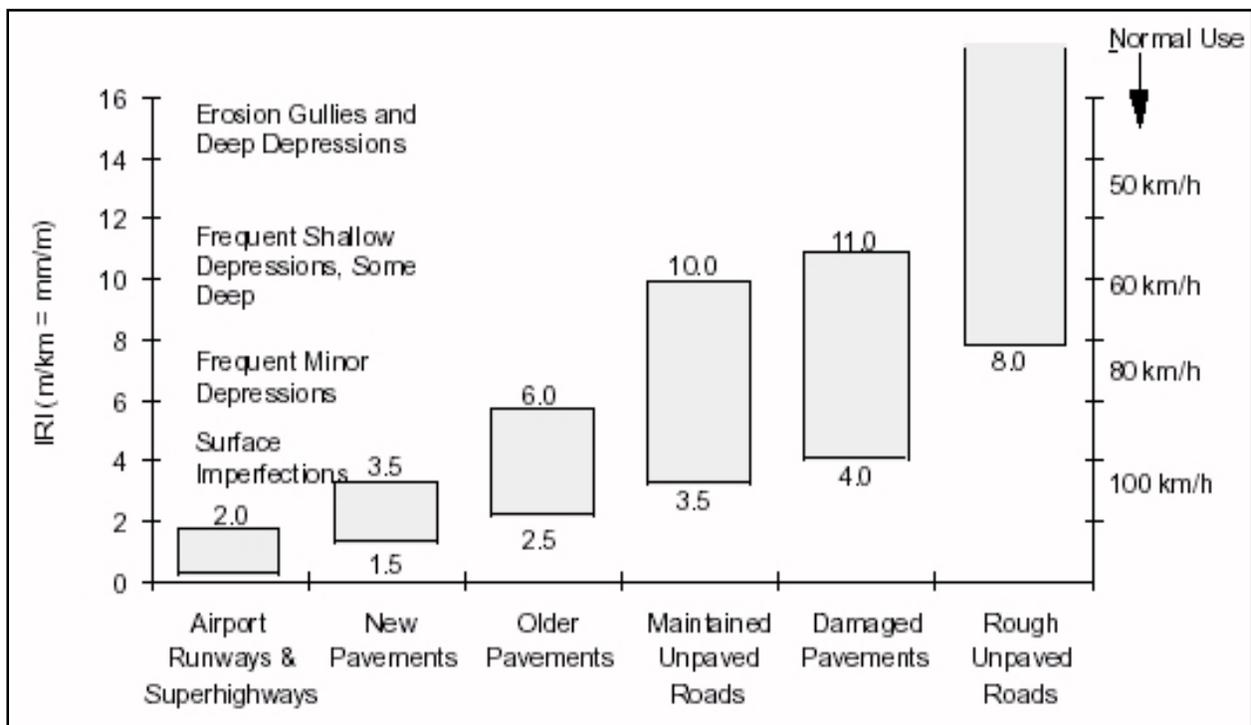
Figure 4-10: The IRI condition rating graph.

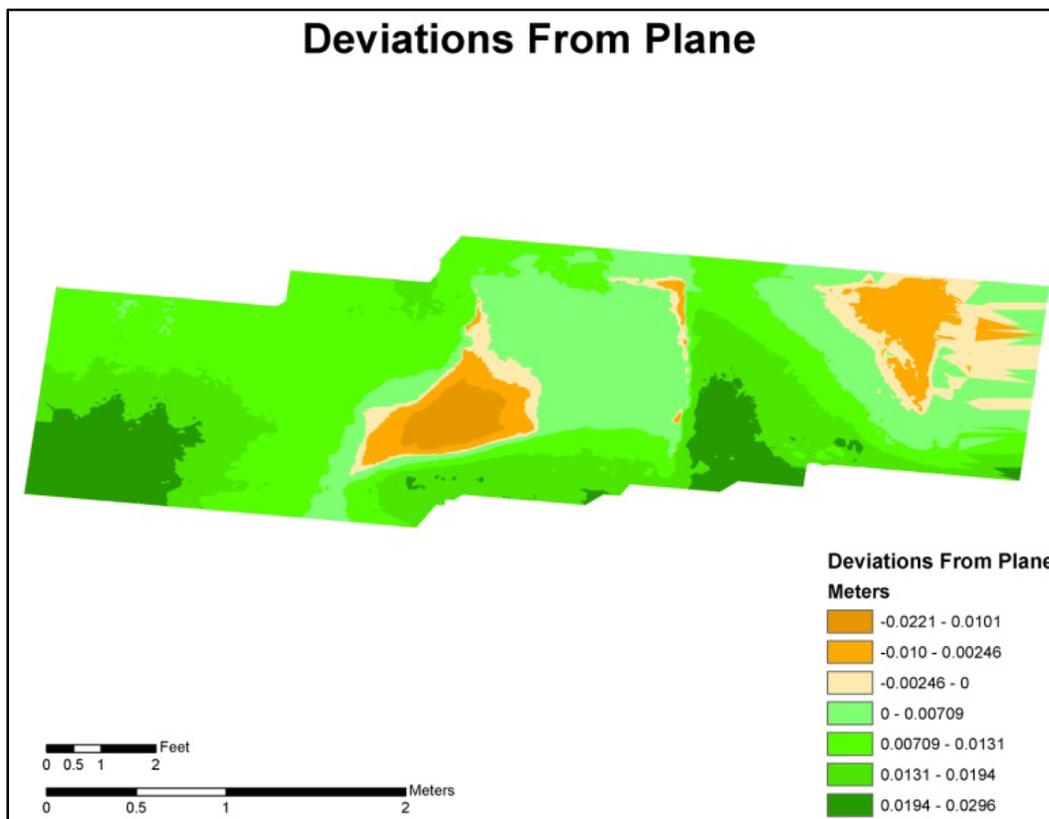
Figure 4-12: The deviations from a plane represent the elevation of a perfectly smooth surface. The values are in meters above and below the plane. The spall that was analyzed is clearly displayed.

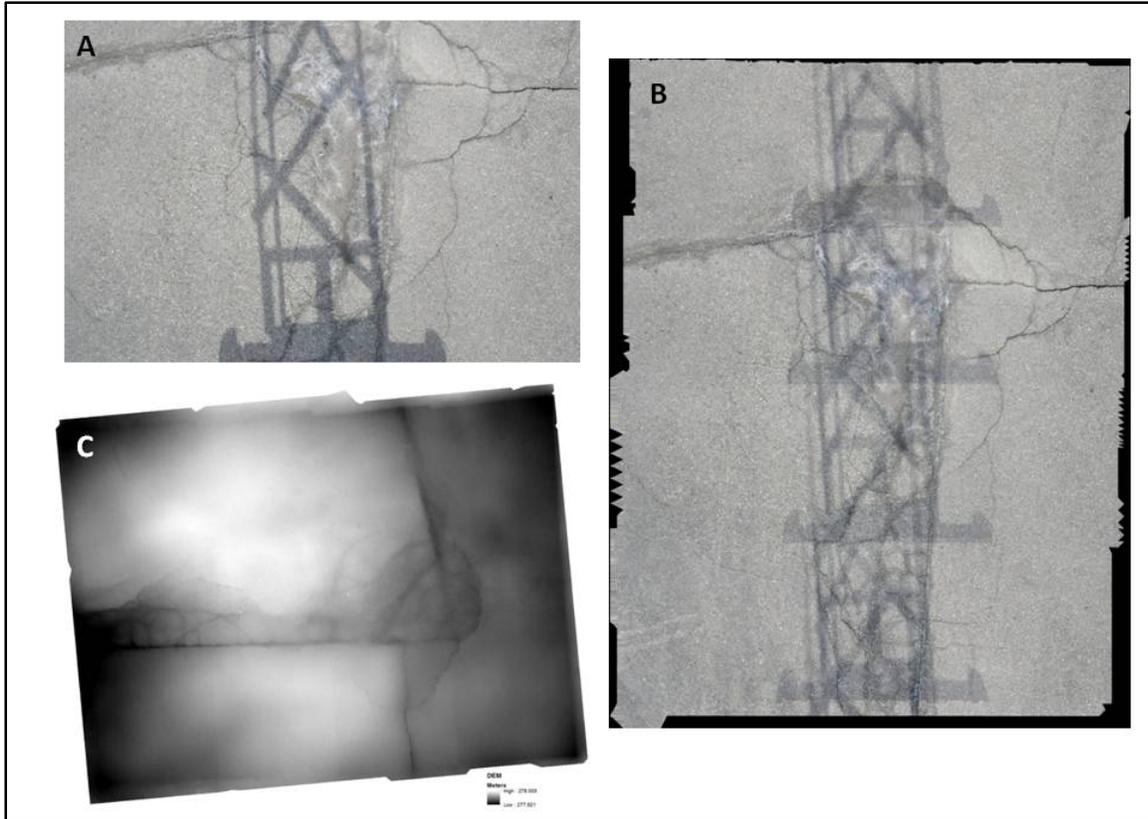
Figure 4-13: Photos captured by 3DOBS contained the shadow from the vehicle mount as shown in A. Despite the shadow PhotoScan was able to align the photos (B) and generate an accurate DEM (C) of the parking lot surface.

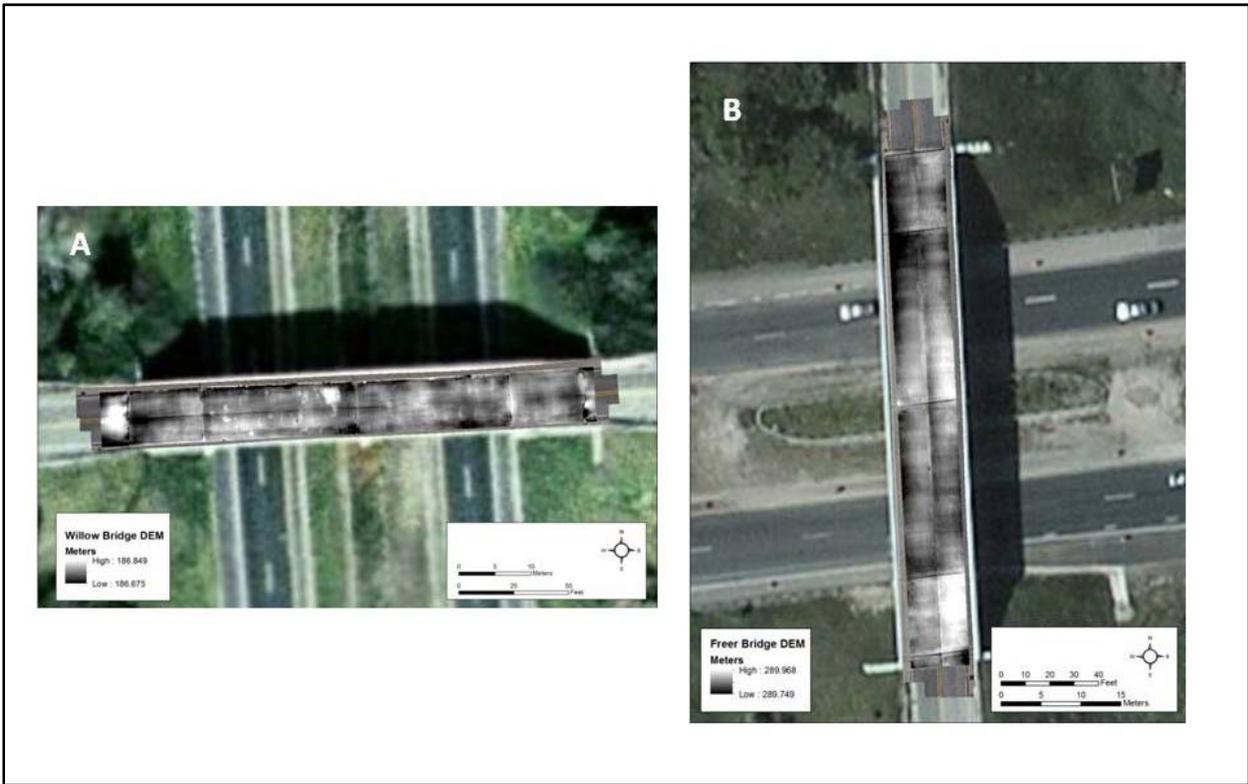
Figure 4-17: DEMs generated by 3DOBS of Willow Road (A) and Freer Road (B) bridges.

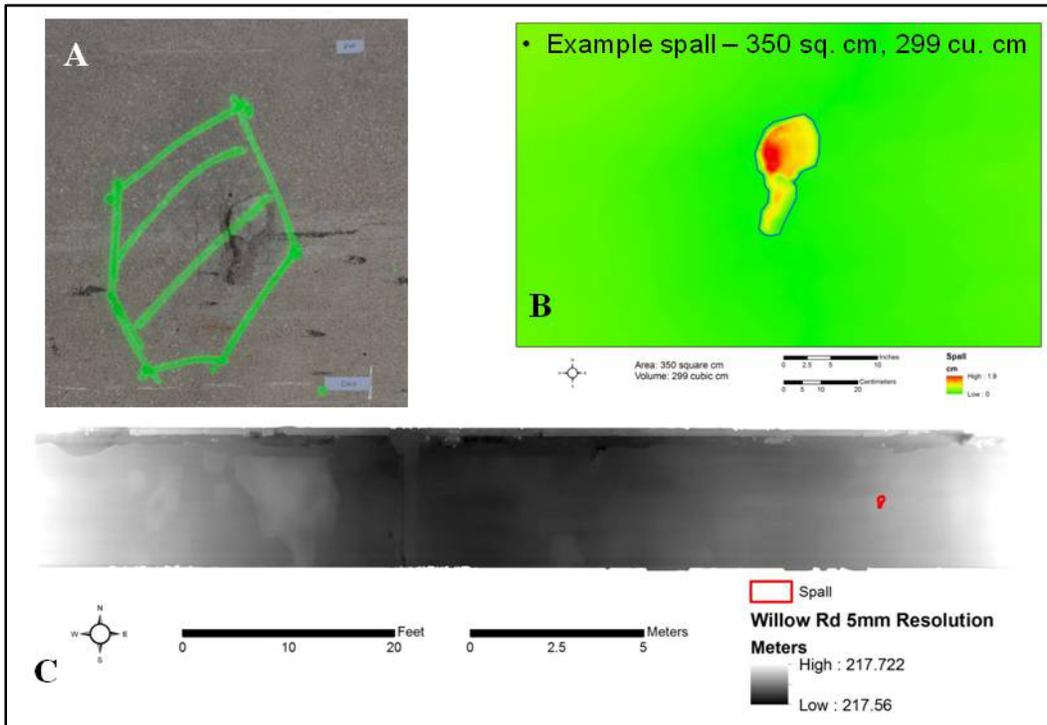
Figure 4-19: An example of manually deriving a spall from 3DOBS data. One of the original photos from 3DOBS is shown in image A and the digitized spall is shown in image B. An overview of the DEM of the lane the spall was found in is displayed in image C.

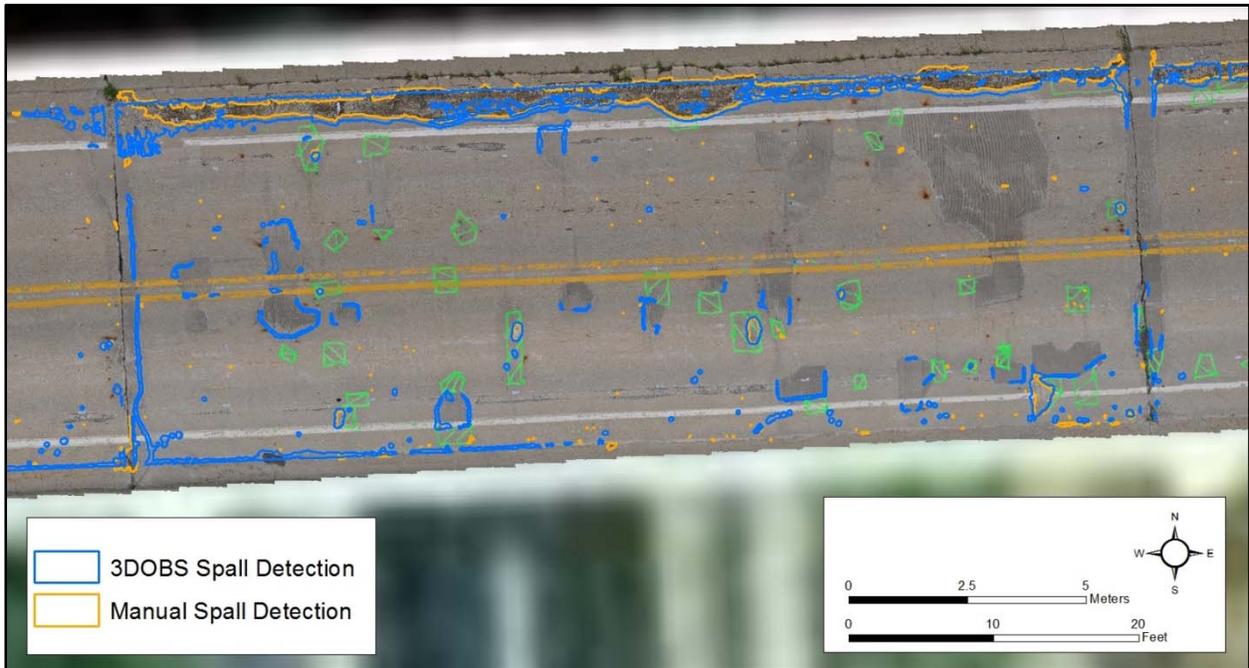
Figure 4-20: A Willow Road bridge comparison of 3DOBS detected spalls (blue polygons) and manual digitizing of spall locations (orange polygons). The green polygons were painted on to the bridge deck by MDOT personnel and represent delaminated areas as detected by the hammer sounding.

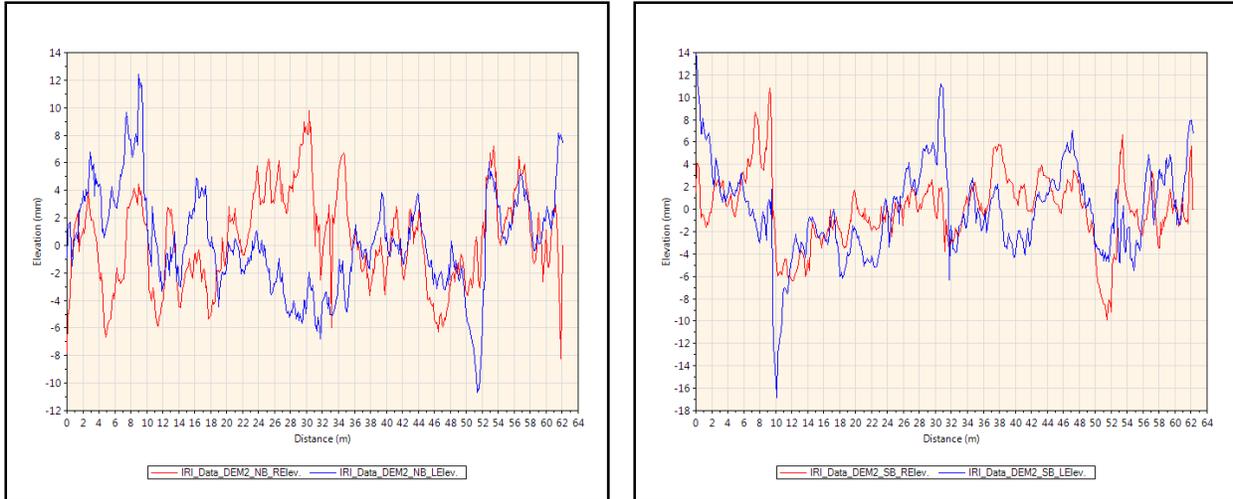
Figure 4-21: The longitudinal profiles of the NB (left) and SB (right) lanes of the Freer Road bridge.

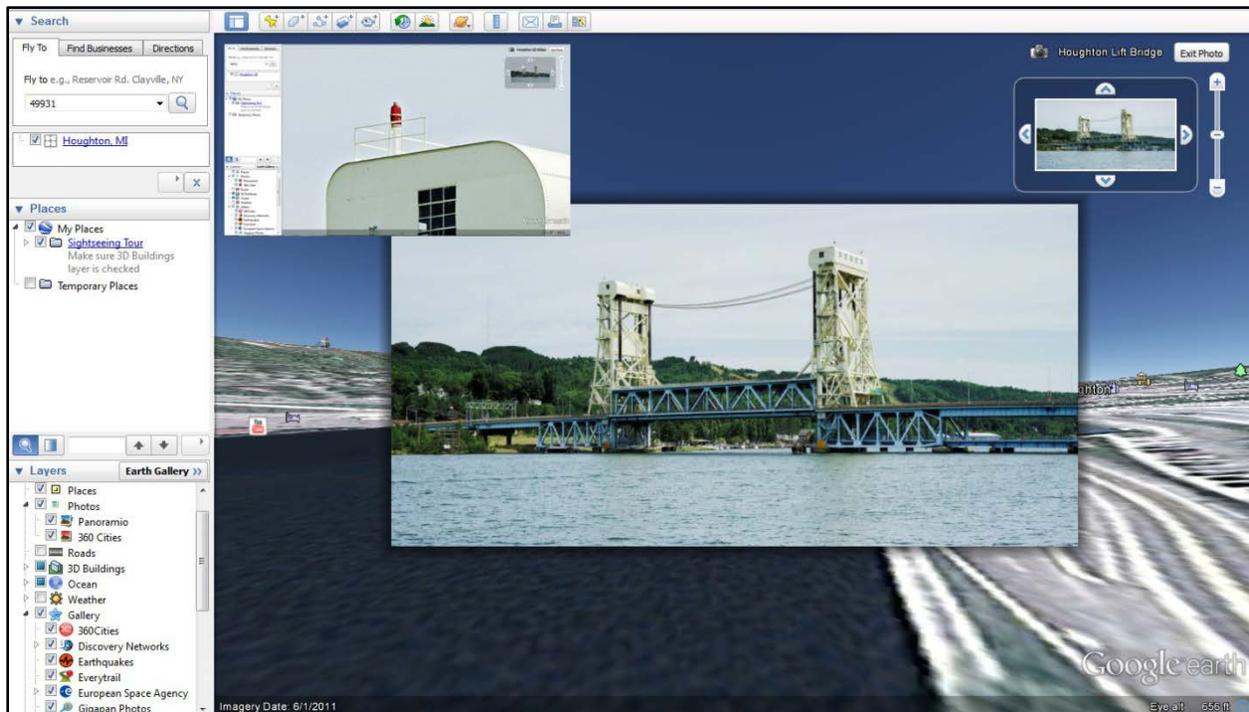
Figure 6-1: Example of GigaPan image for the Portable Lake lift-bridge; the same high resolution is available through the web and Google Earth at all parts of the bridge.

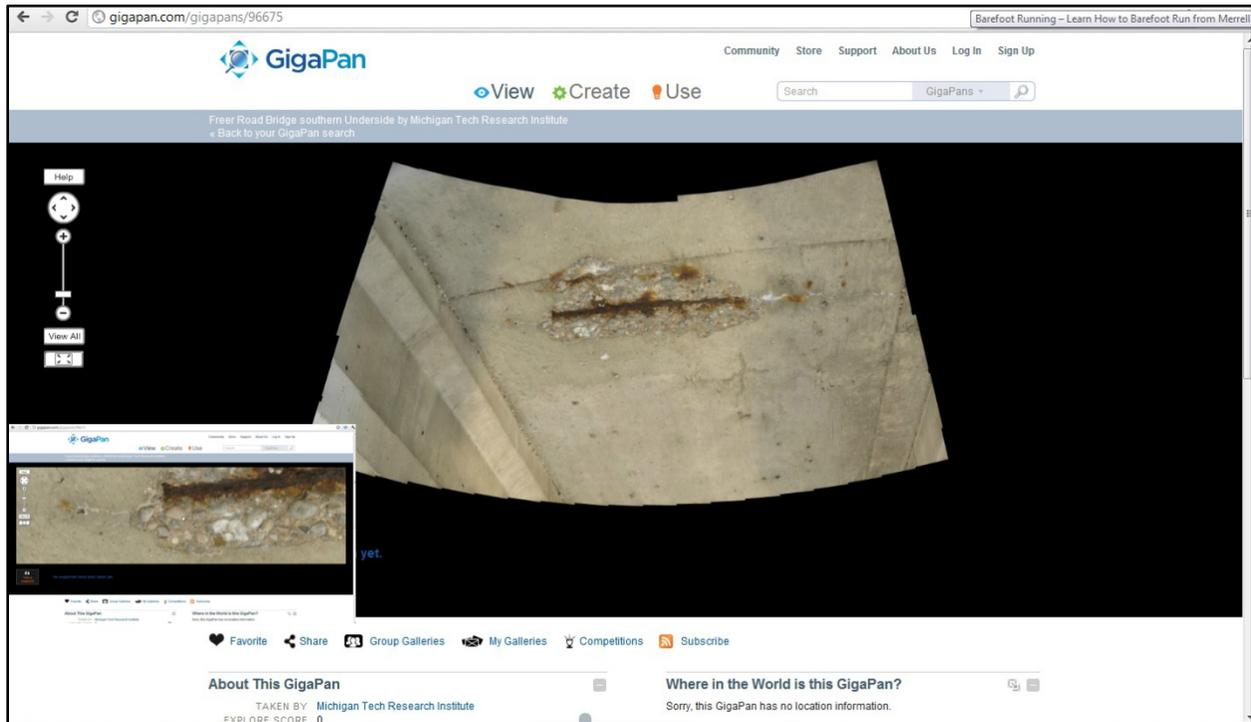
Figure 6-2: Example GigaPan image collected to test imaging of areas of deterioration on the underside of a Michigan bridge.

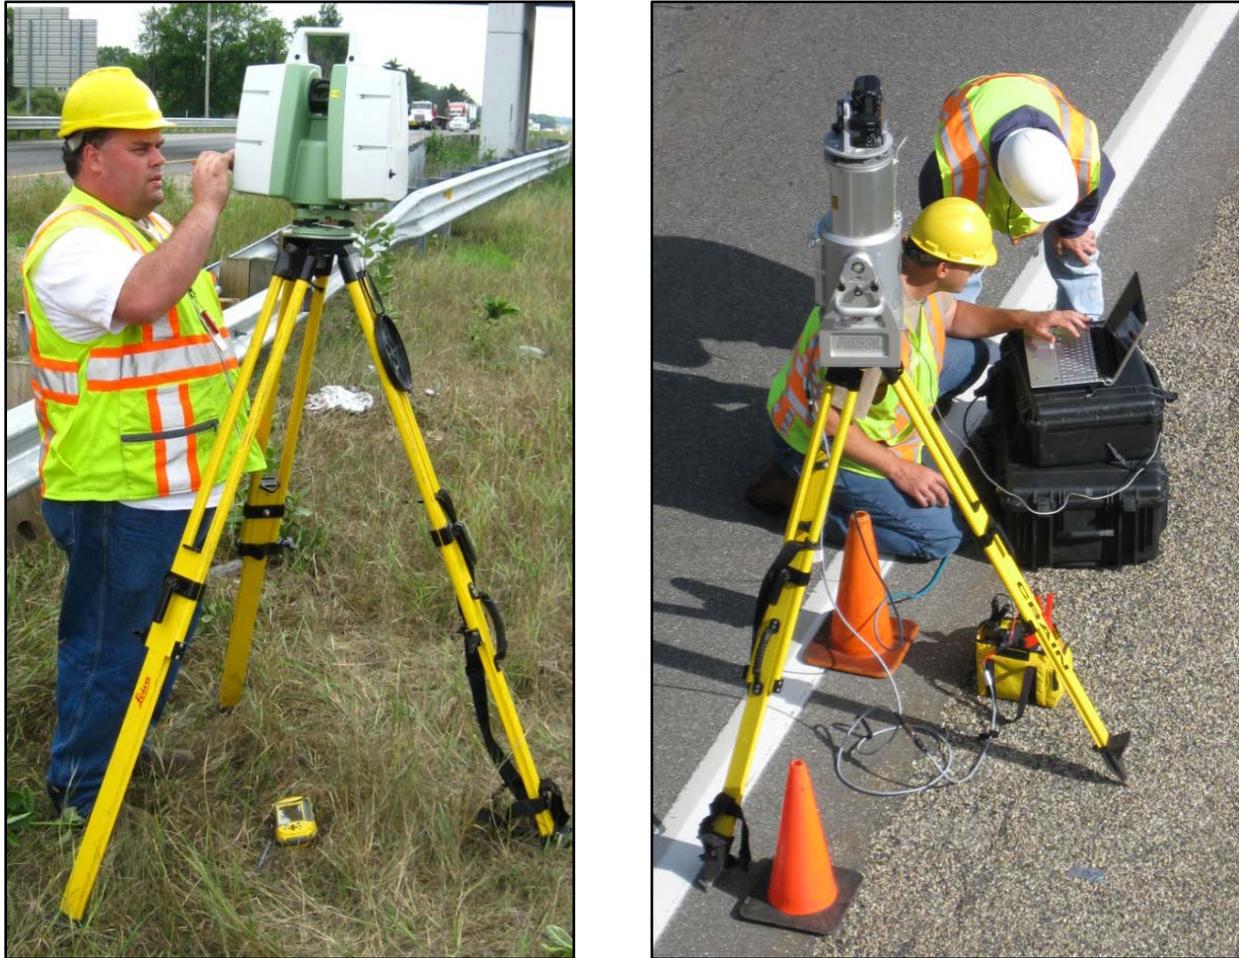
Figure 7-4: Typical terrestrial LiDAR units; MDOT’s ScanStation C10 and MTU’s Riegl LMS-Z210ii.

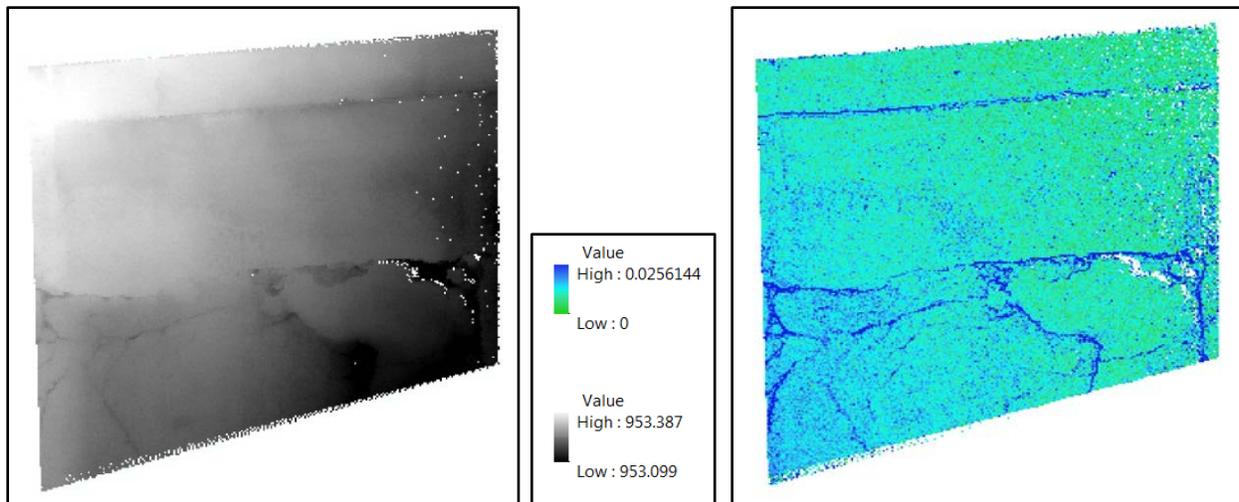
Figure 7-8: ArcGIS ArcMap Willow Road bridge subset deck DEM displaying point elevation (ft) for a LiDAR subsection displayed as a greyscale DEM (left) and a symbolized raster (right). Bridge deck features such as cracks can easily be seen the symbolized raster LiDAR image at right.

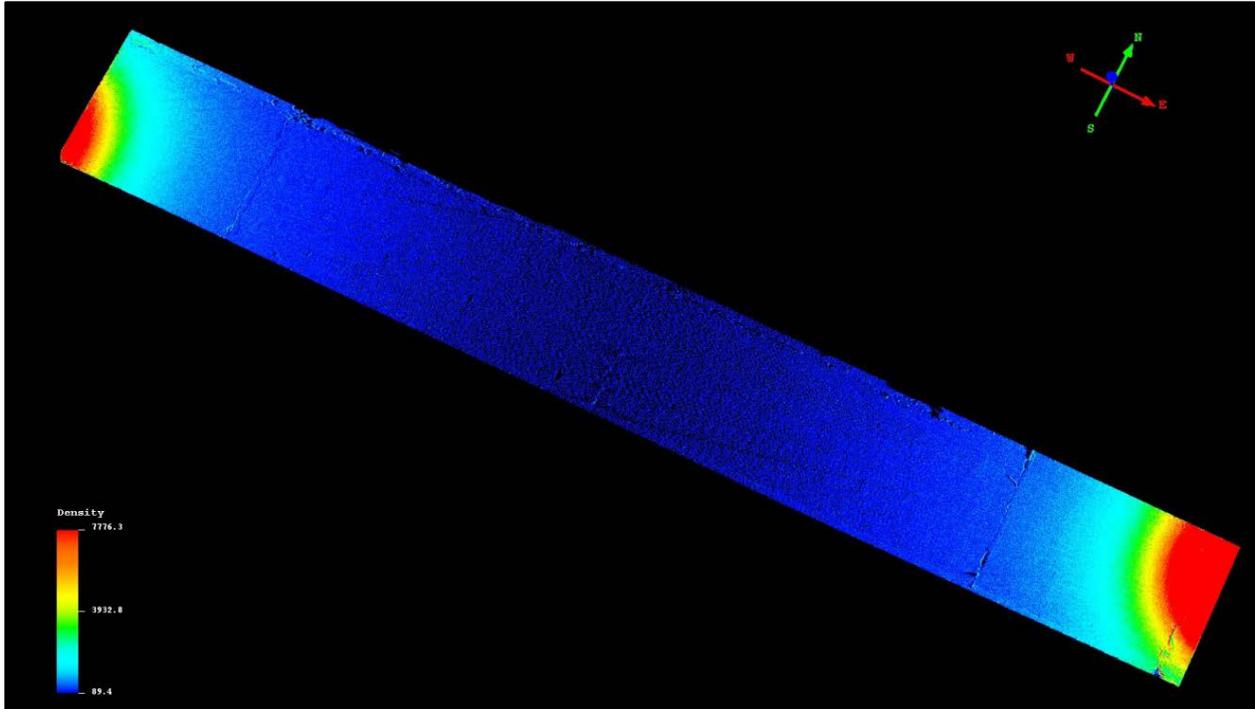
Figure 7-9: Point cloud density image of Willow Road bridge span over US-23. Note the dramatic fall-off in density of points from ends to center (red to blue, high to low). Features in the blue central areas are unlikely to be able to be resolved successfully.

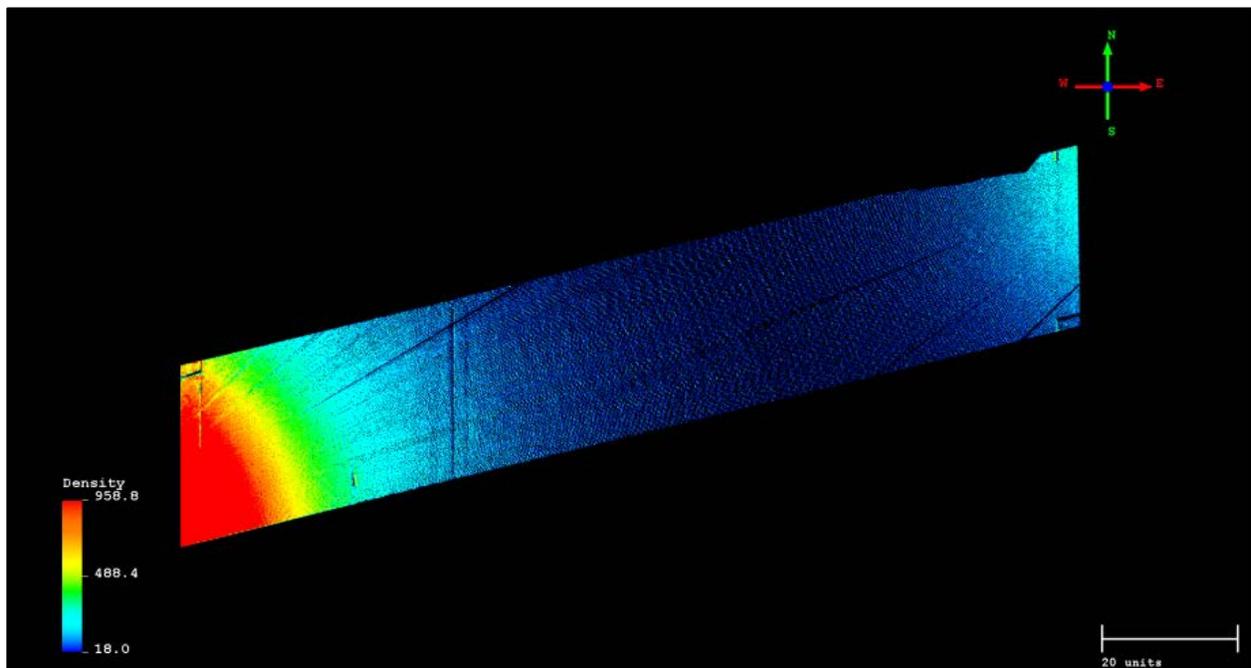
Figure 7-10: Mannsiding Road bridge over US-127 NB point cloud density texture for visual representation.

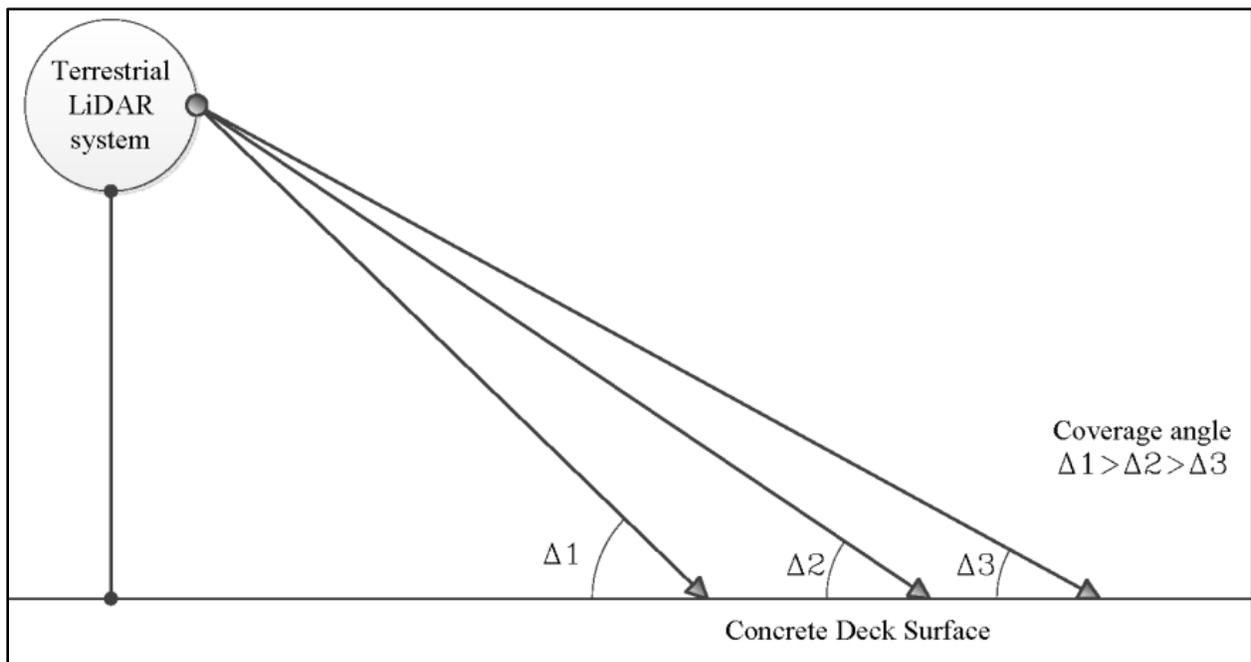
Figure 7-18: Visual representation of the reduction in coverage angle over distance.
