**BRIDGE CONDITION ASSESSMENT
USING REMOTE SENSORS**

United States Department of Transportation
Research and Innovative Technology
Administration

Michigan Technological University

Volume I of II – Main Body

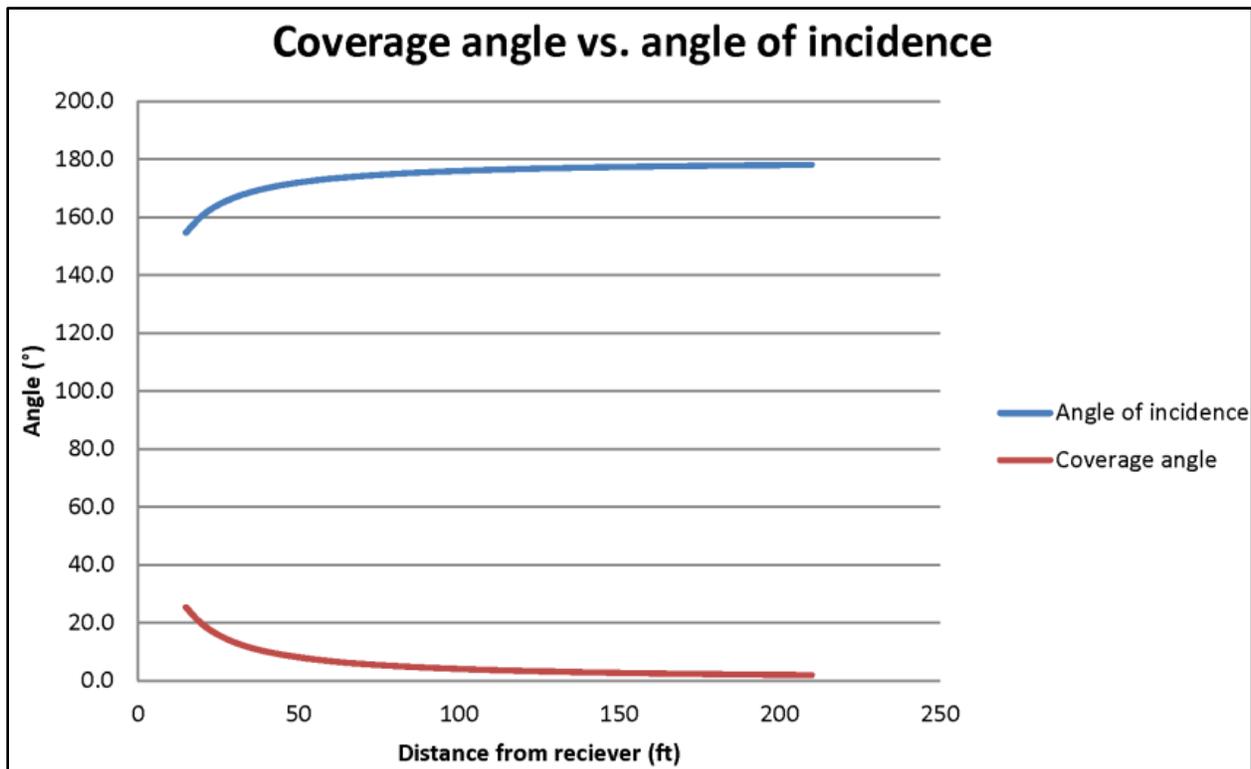
Figure 7-19: The coverage angle and angle of incidence as the distance from the scanner increases.

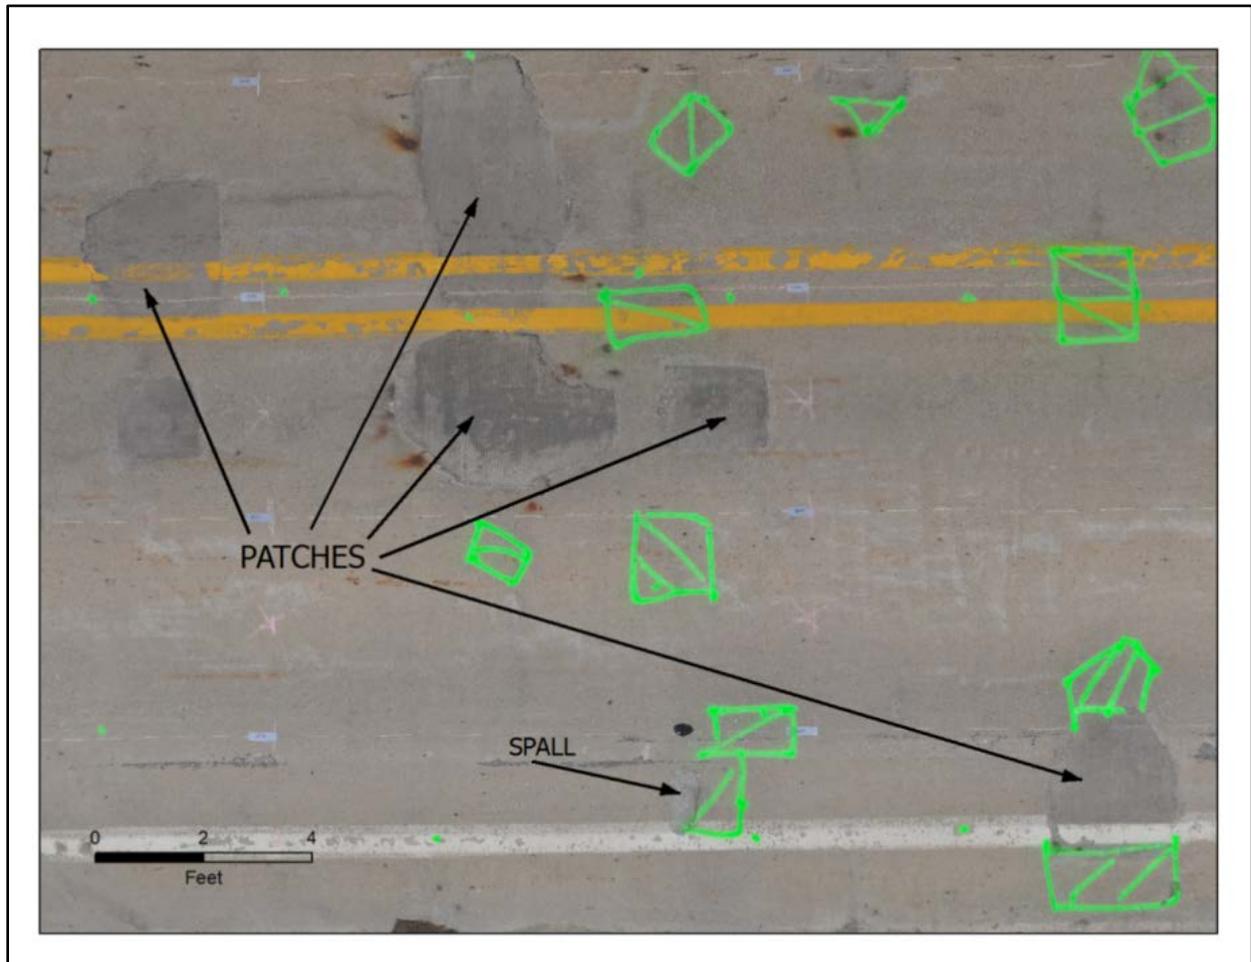
Figure 7-20: Section of the ortho-photo of the Willow Road bridge deck illustrating patches and a spall. The green pavement markings outline areas of subsurface delamination as determined by inspection performed by MDOT bridge inspectors using the hammer (metal rod) sounding technique.

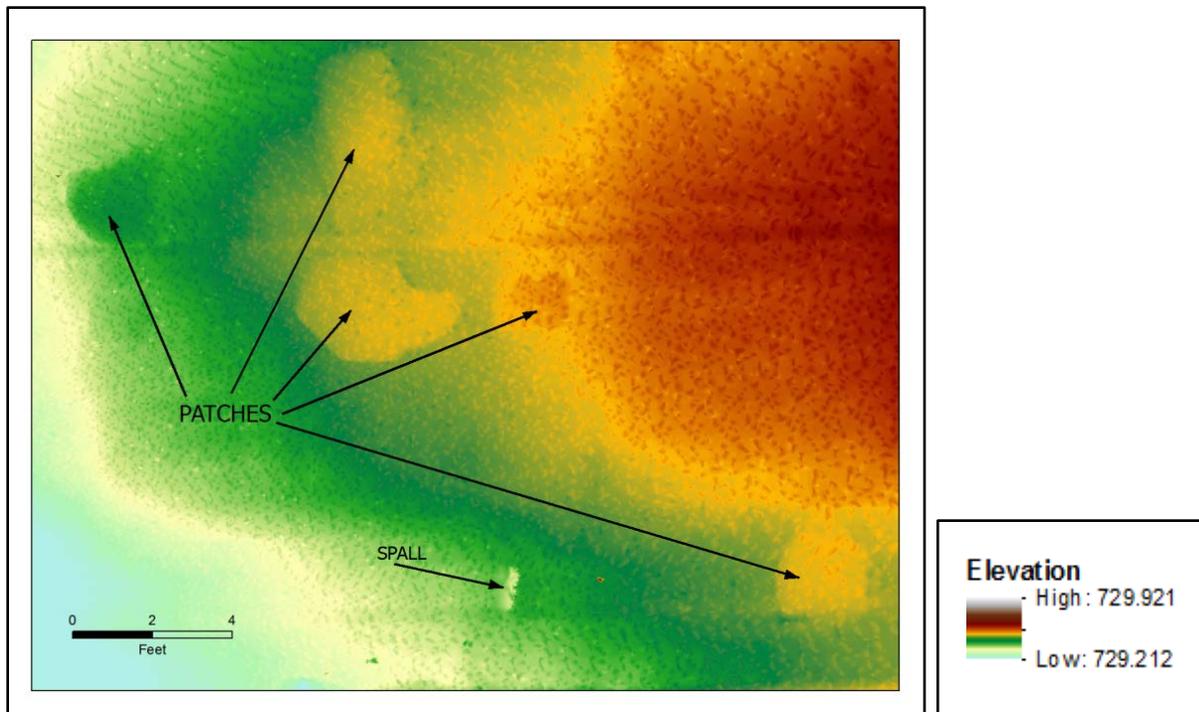
Figure 7-21: DEM with a color ramp applied of the same area of the Willow Road bridge deck. Note that the higher areas of the concrete patches and missing material from the spall correlate well between the ortho-photo and DEM. The patches (correctly) appear higher than the surrounding bridge deck and the spall appears lower than surrounding deck.

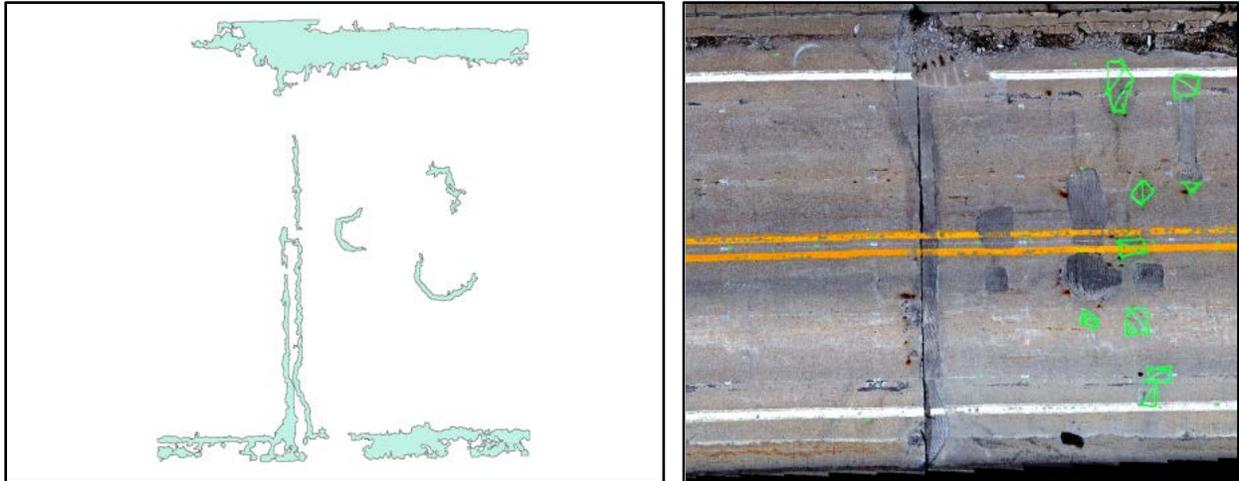
Figure 7-27: Comparison of the results of the spall detection algorithm (left) to a high-resolution composite image of the bridge deck taken with 3DOBS.

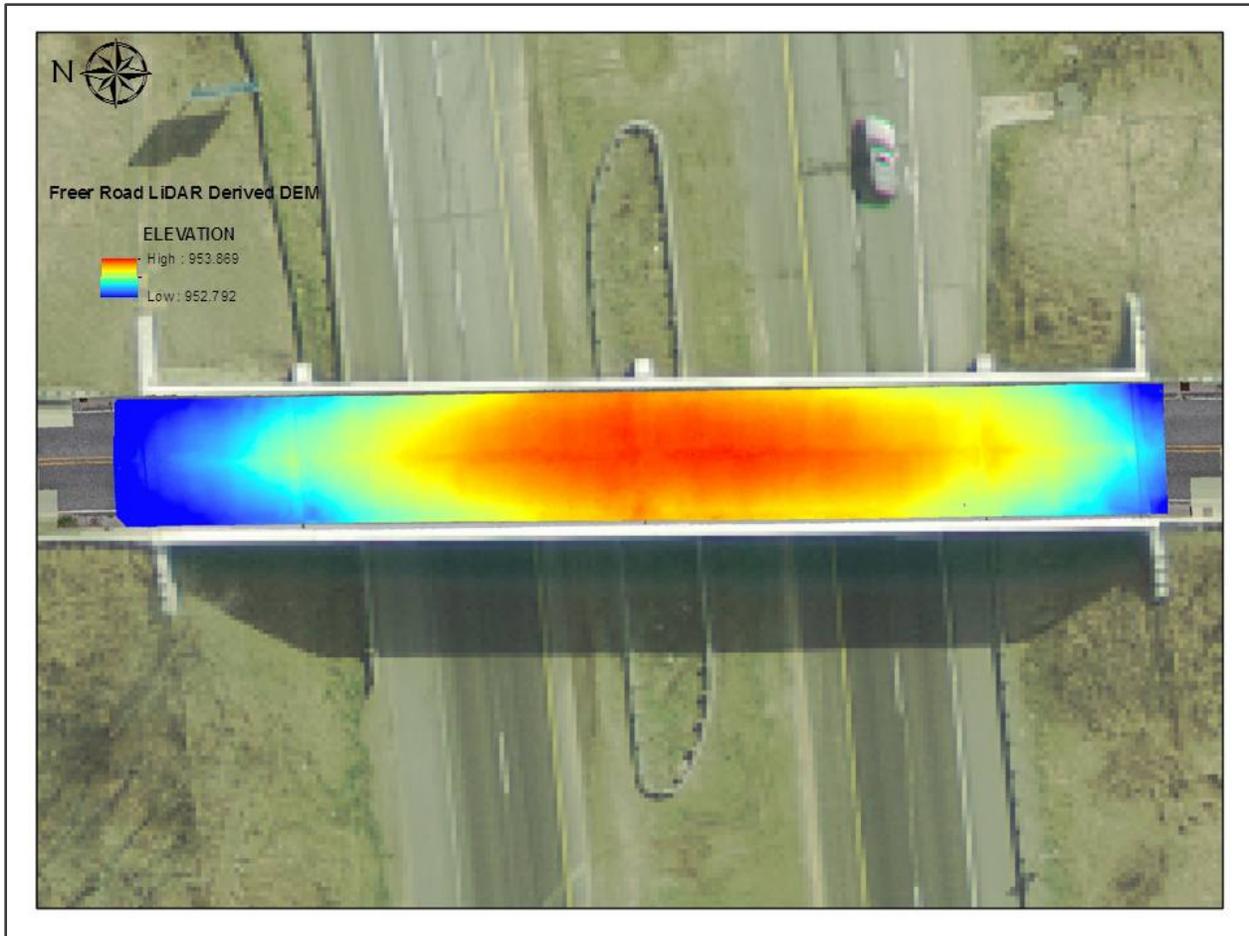
Figure 7-28: The Freer Road bridge deck DEM over one foot per pixel aerial imagery and the high resolution orthophoto of the Freer Road bridge deck. The DEM is approximately 220 ft long with a spatial resolution of 3 cm per pixel.

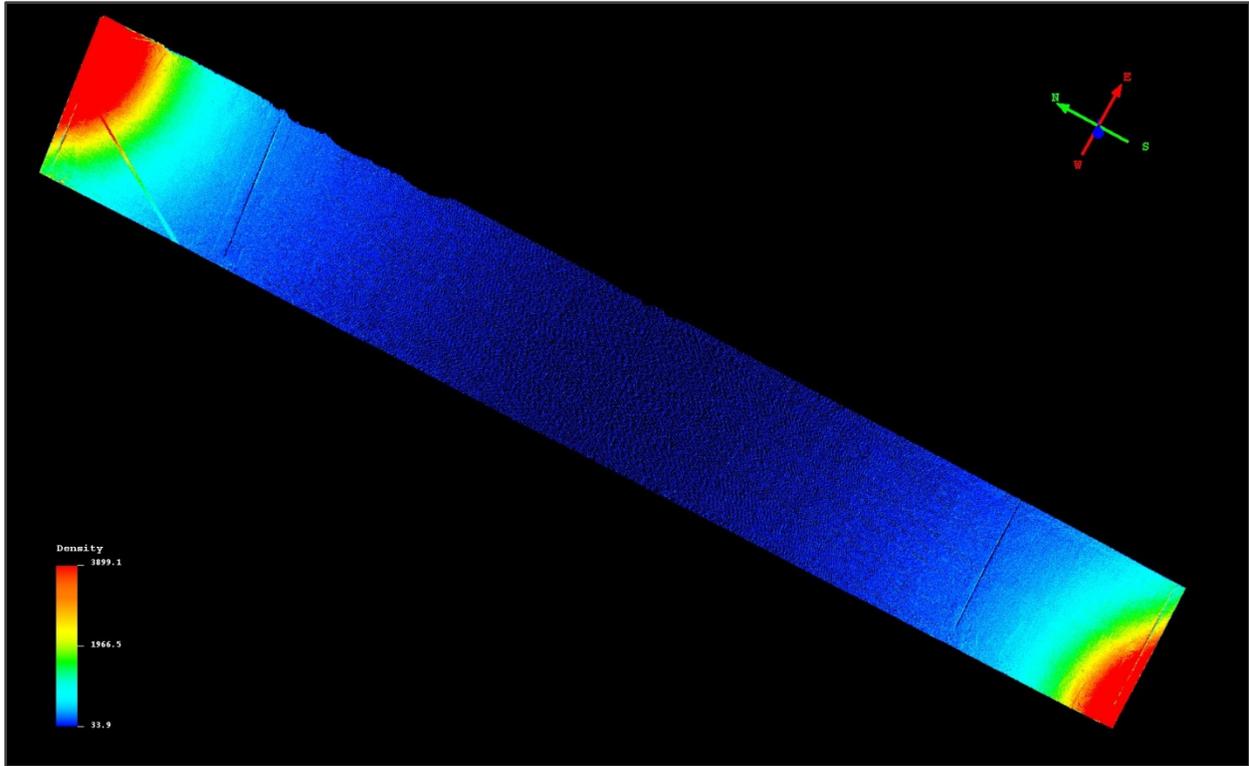
Figure 7-29: Freer Road bridge deck point cloud density map. The rapid falloff in point cloud density (red high density to blue low density) with distance from the LiDAR scanner is clearly visible.

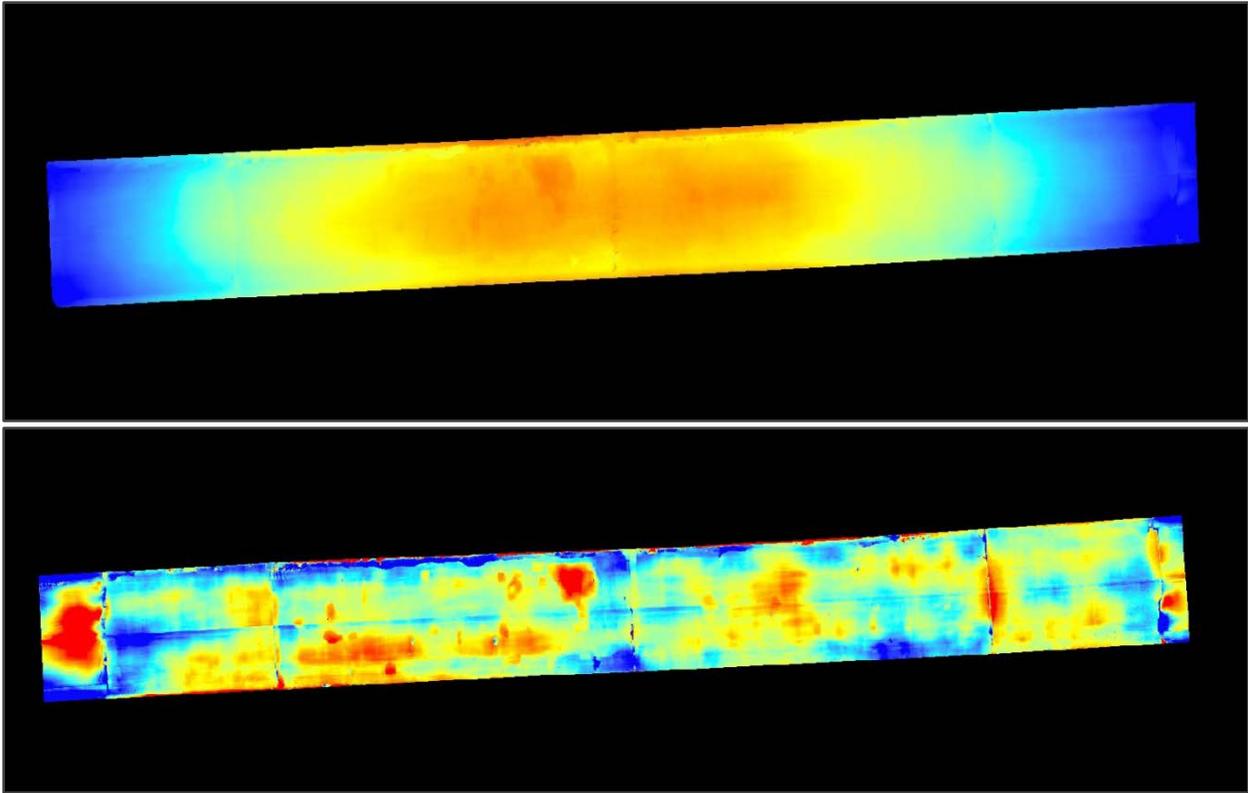
Figure 7-30: A comparison of DEMs derived from LiDAR data (top) and the 3DOBS close range photogrammetry system (bottom).

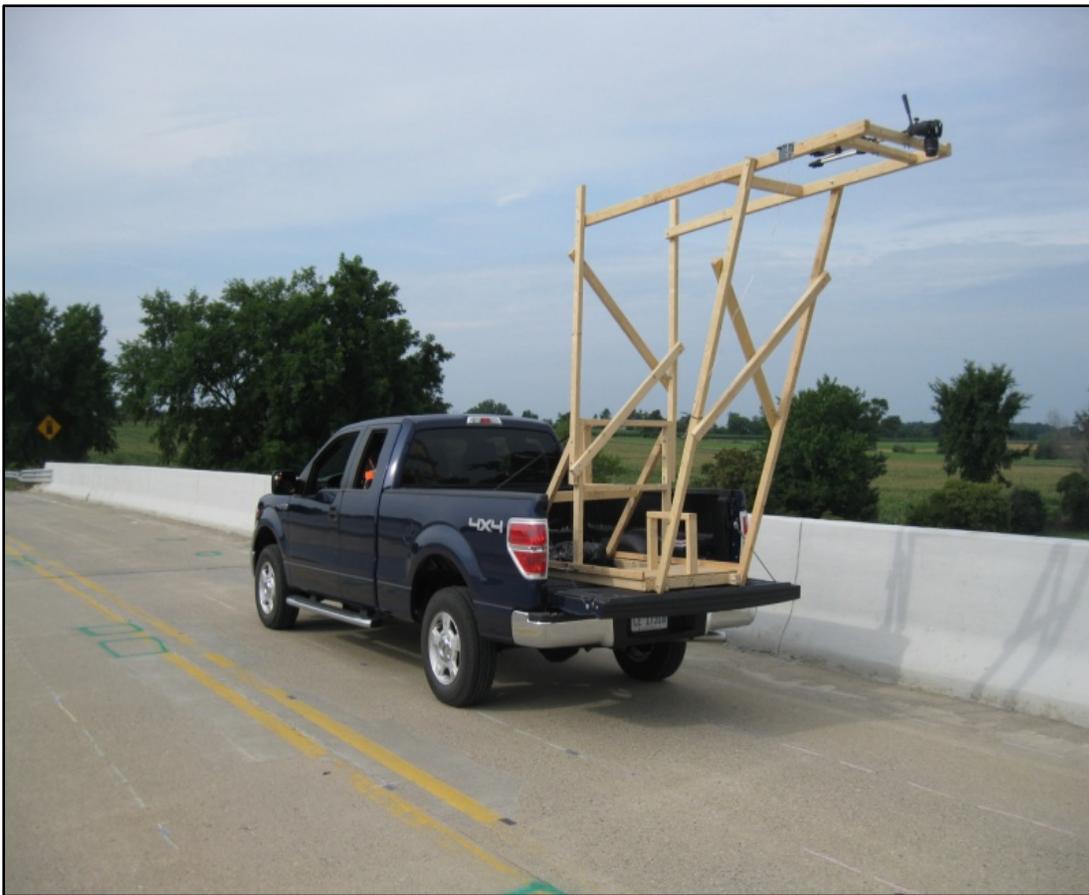
Figure 7-31: 3DOBS data collection system field demonstration

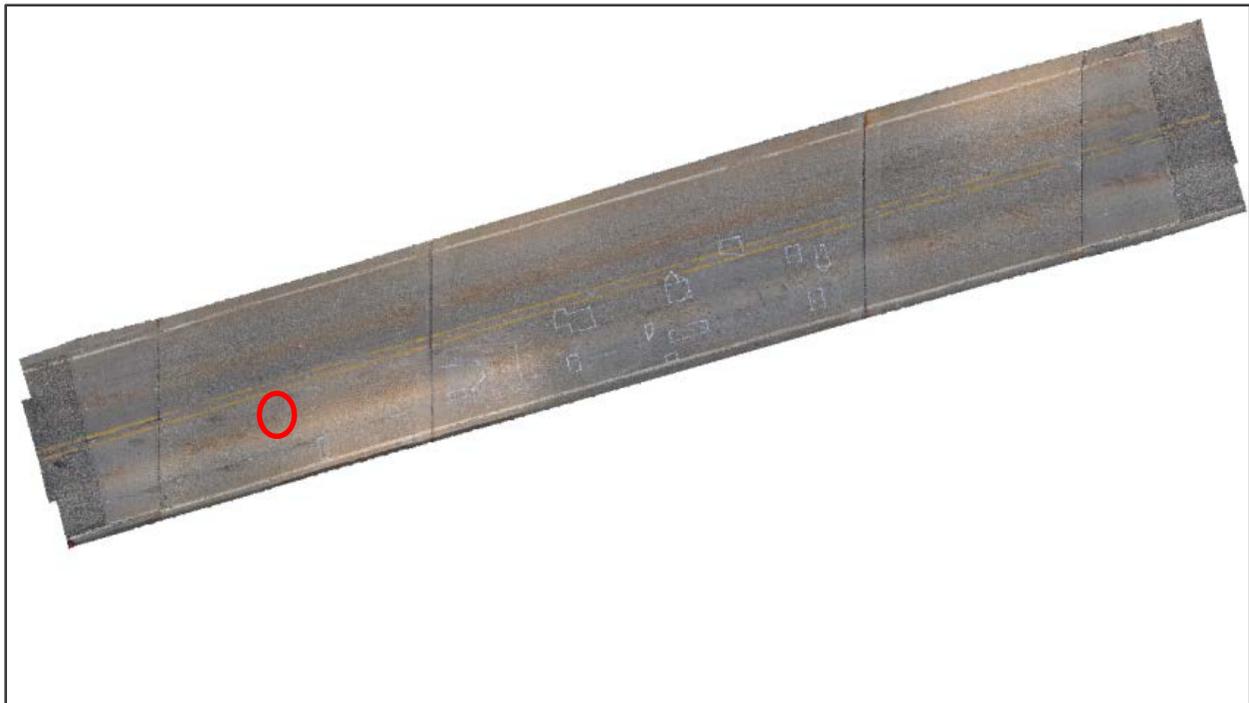
Figure 7-32: Optical image of Mannsiding Road NB showing evaluated spall location.

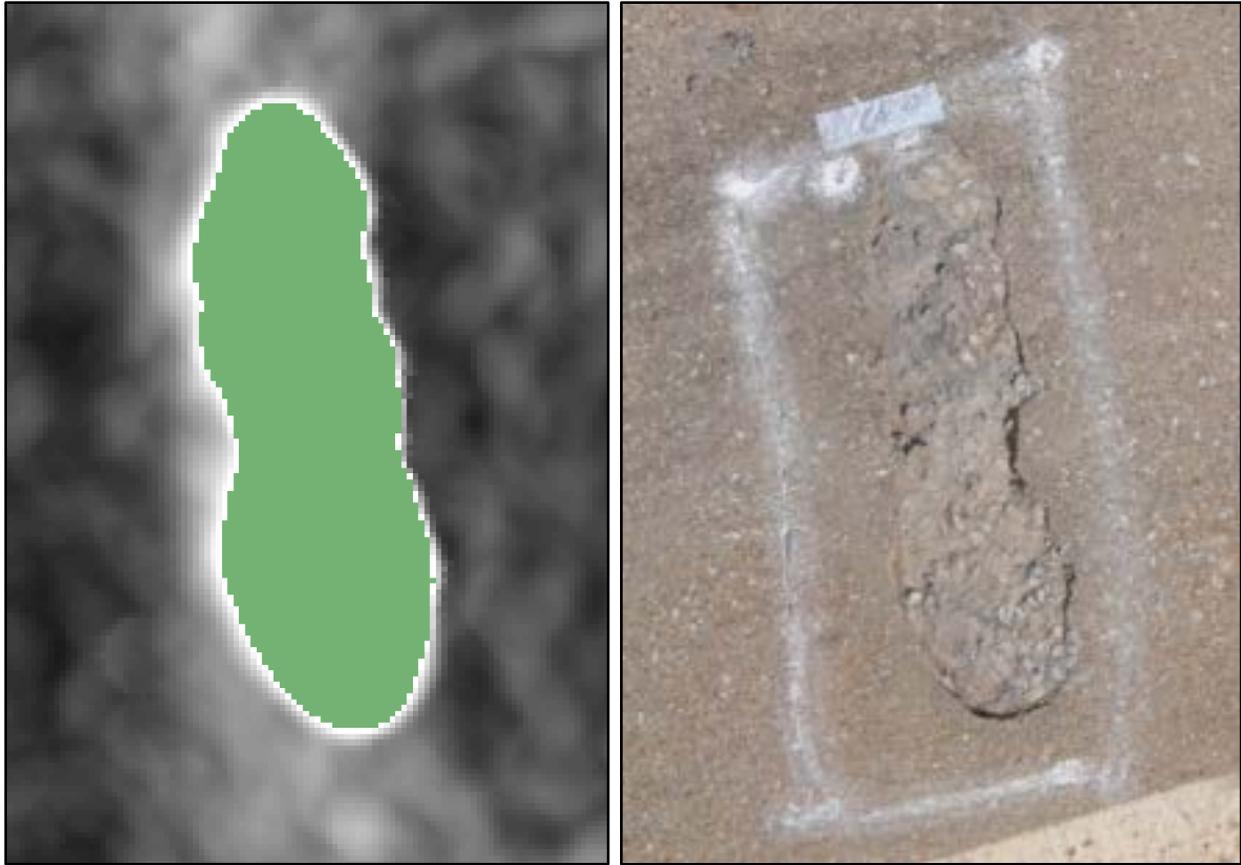
Figure 7-33: Optical image and the predicted spall area image for visual comparison.

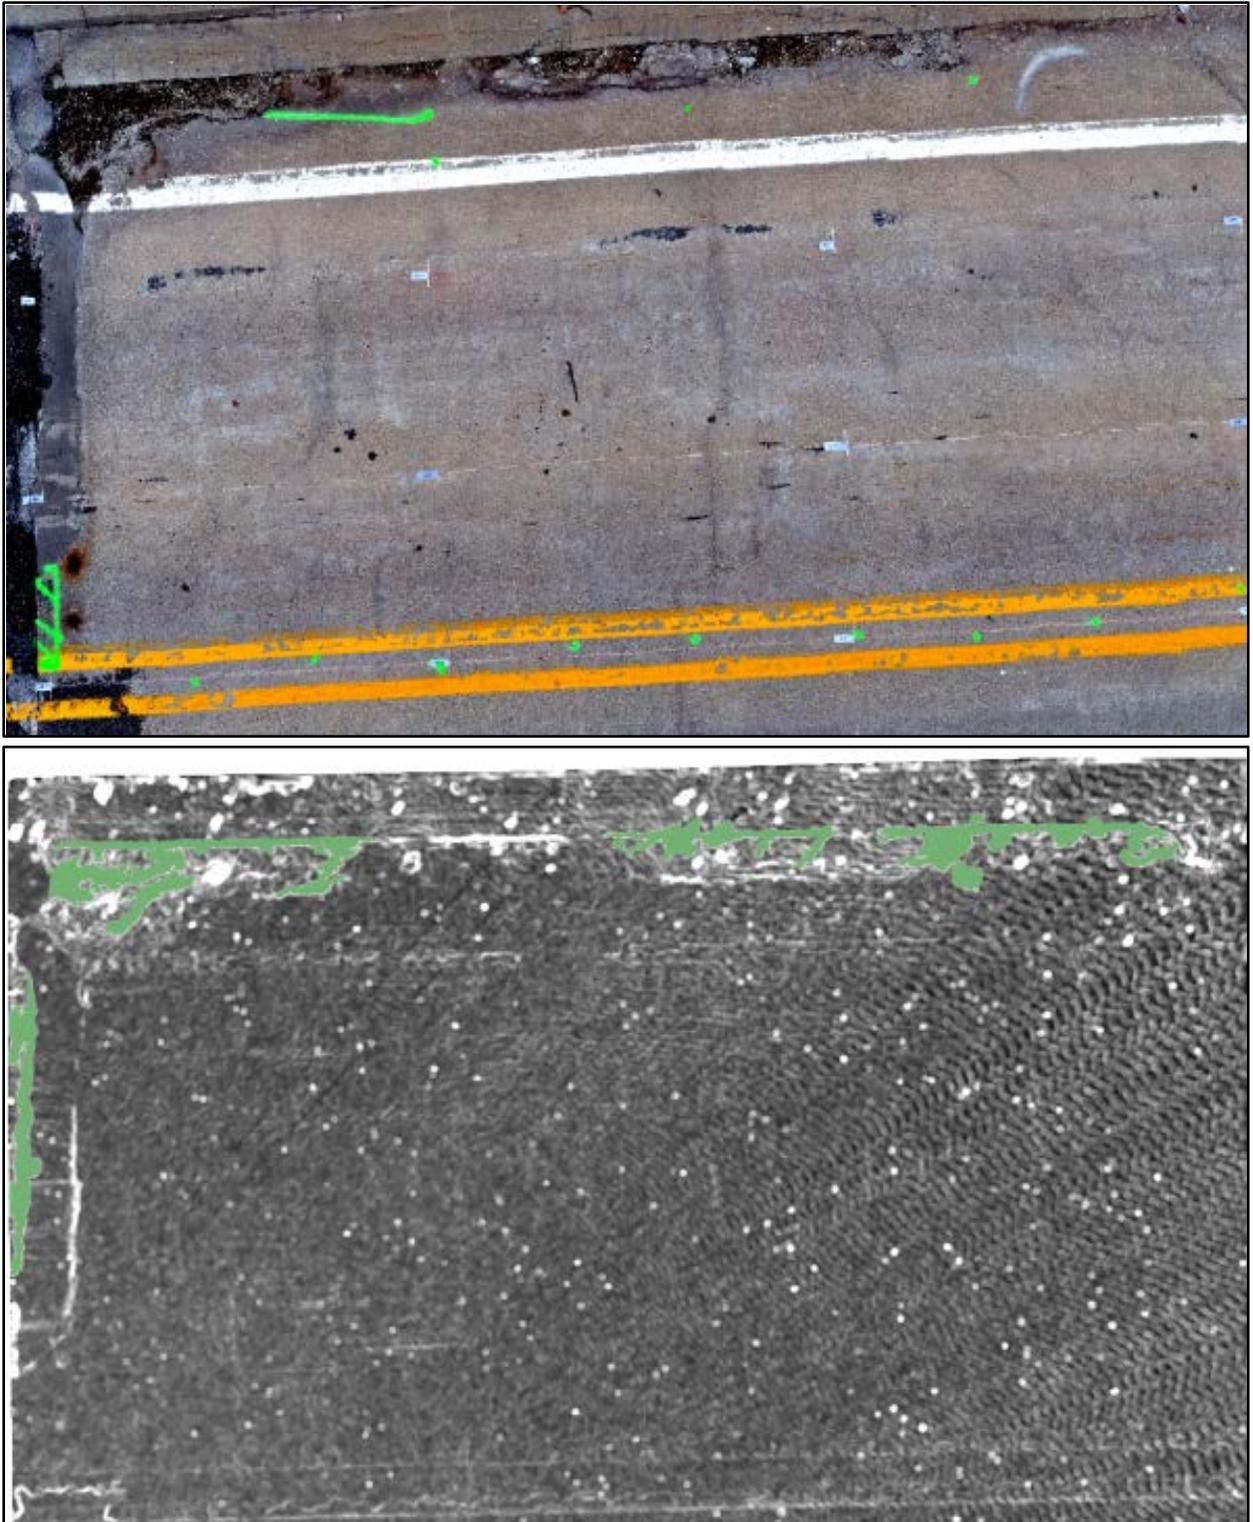
Figure 7-35: Optical image and the predicted spall area image for visual comparison.

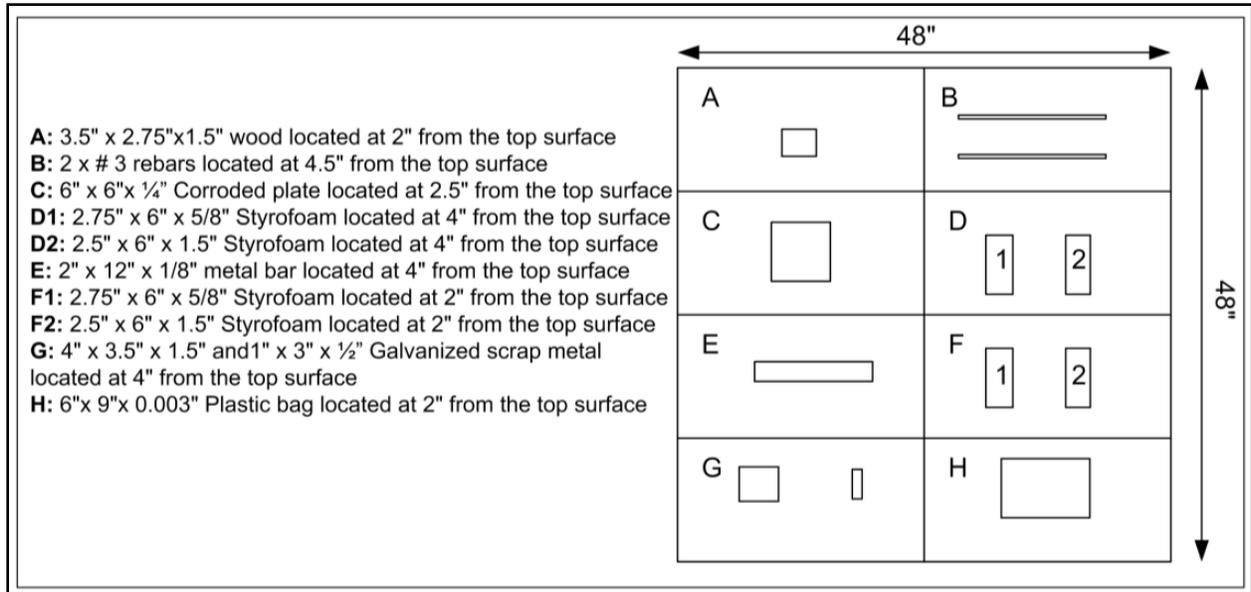
Figure 8-1: Layout plan of 48 x 48 x 6 in slab with simulated defects.

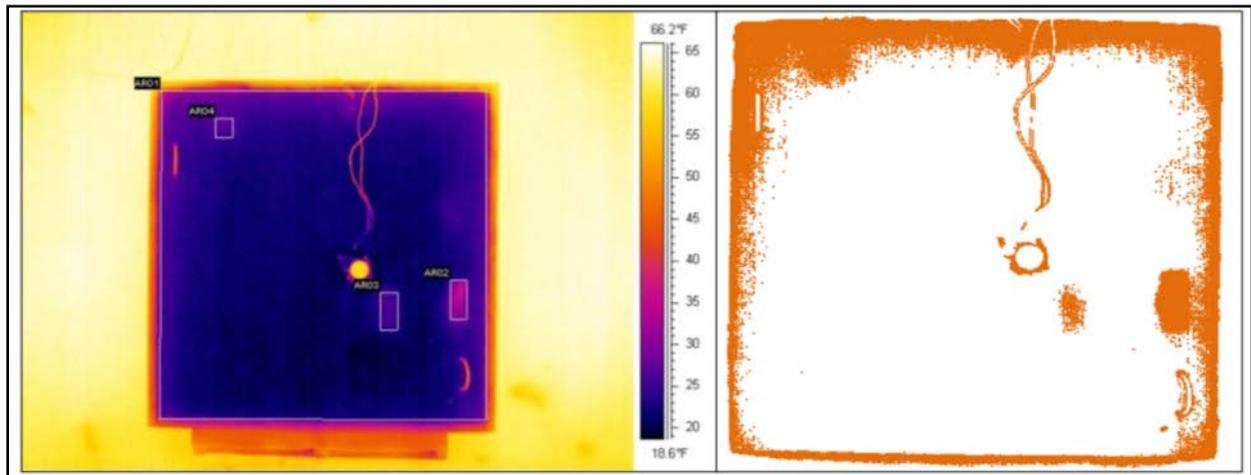
Figure 8-4: Thermal IR image and the associated Excel spreadsheet.

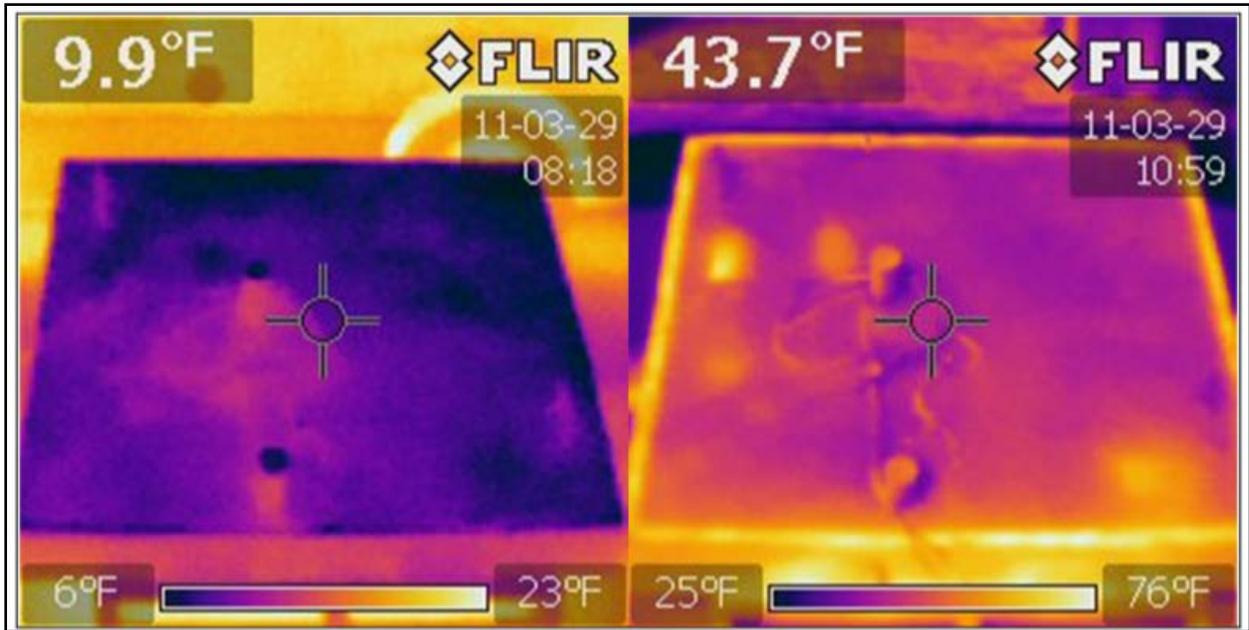
Figure 8-5: Comparison of images of the concrete slab with simulated delaminations, captured at 8:18 am and 10:59 am.

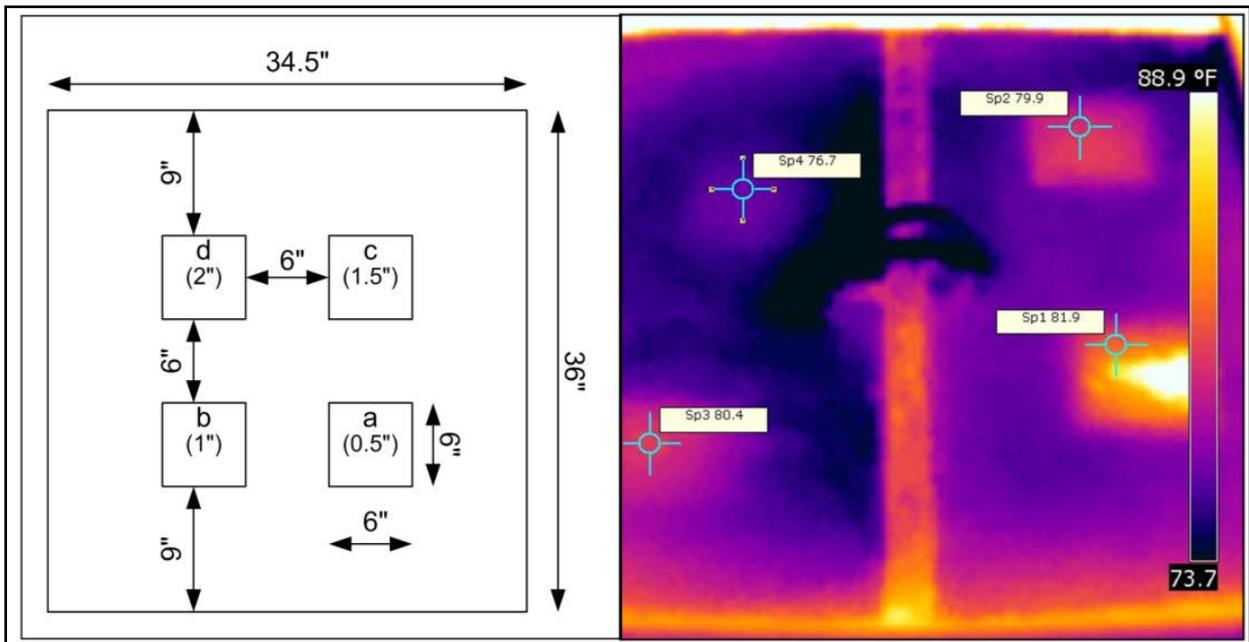
Figure 8-6: Plan layout of the concrete slab with simulated delaminations and the thermal IR image showing the temperature data placed at different depths; 0.5, 1, 1.5 and 2 in.

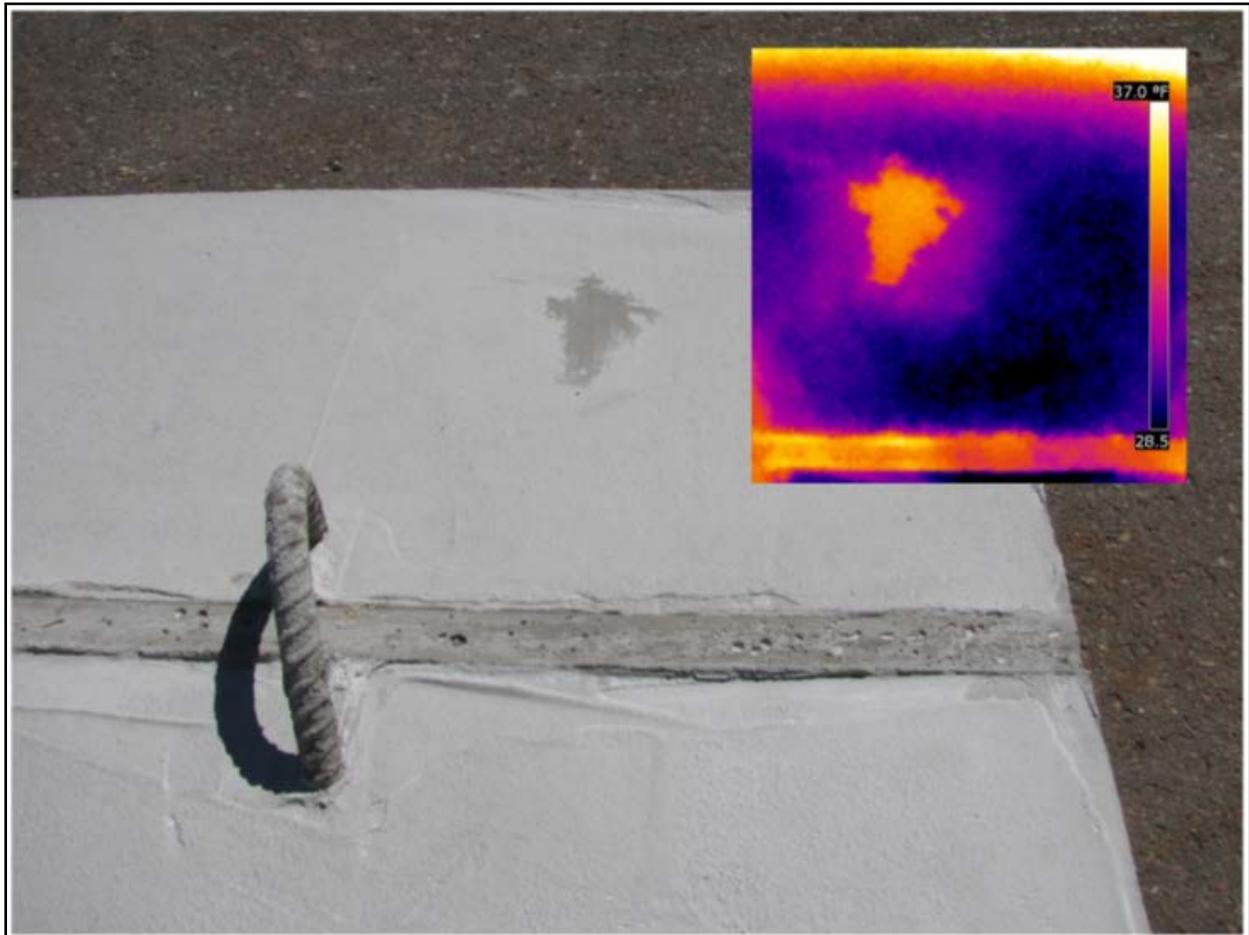
Figure 8-7: Thermal IR image of the chemical staining on the concrete specimen.

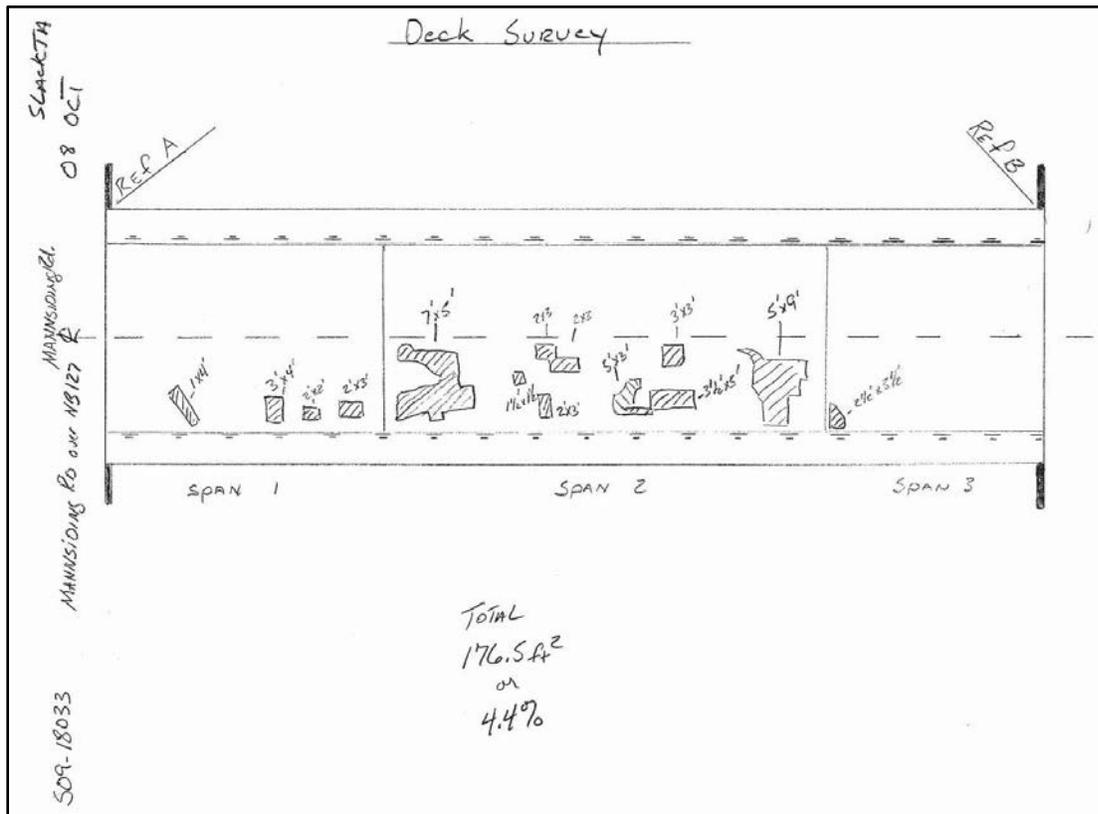
Figure 8-19: Deck survey map for Mannsiding Road Bridge NB developed by MDOT in 2008.

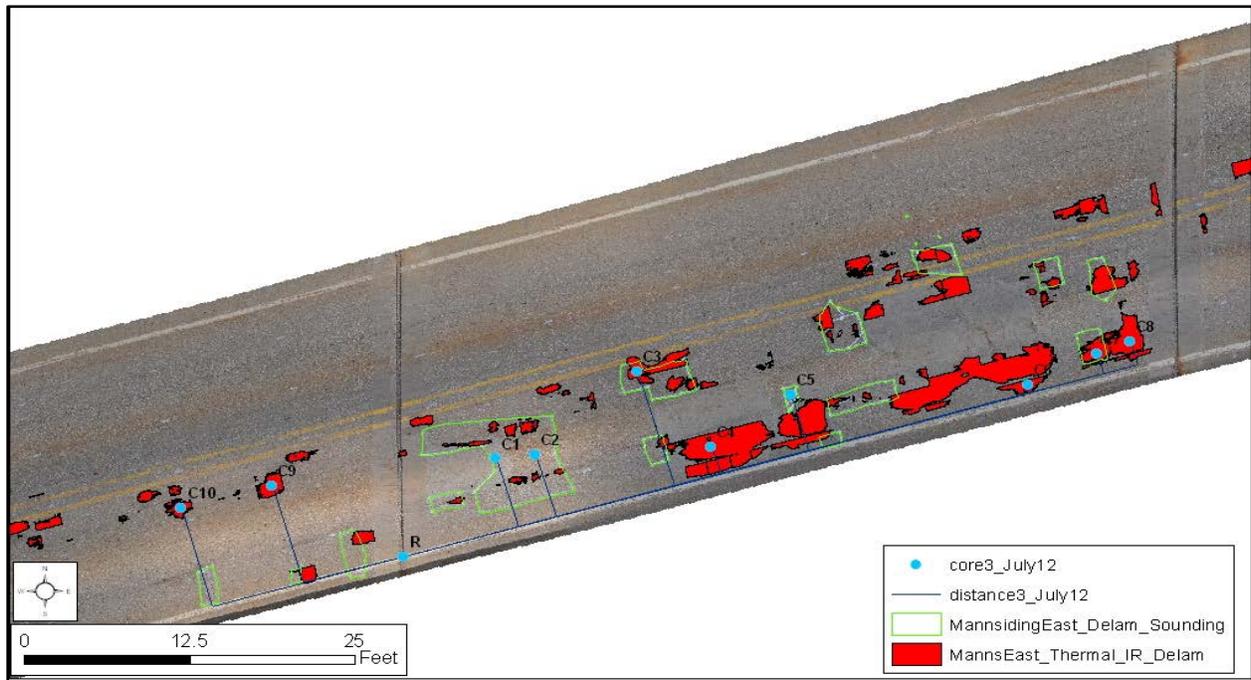
Figure 8-20: Coring plan (blue dots) for Mannsiding Road bridge.

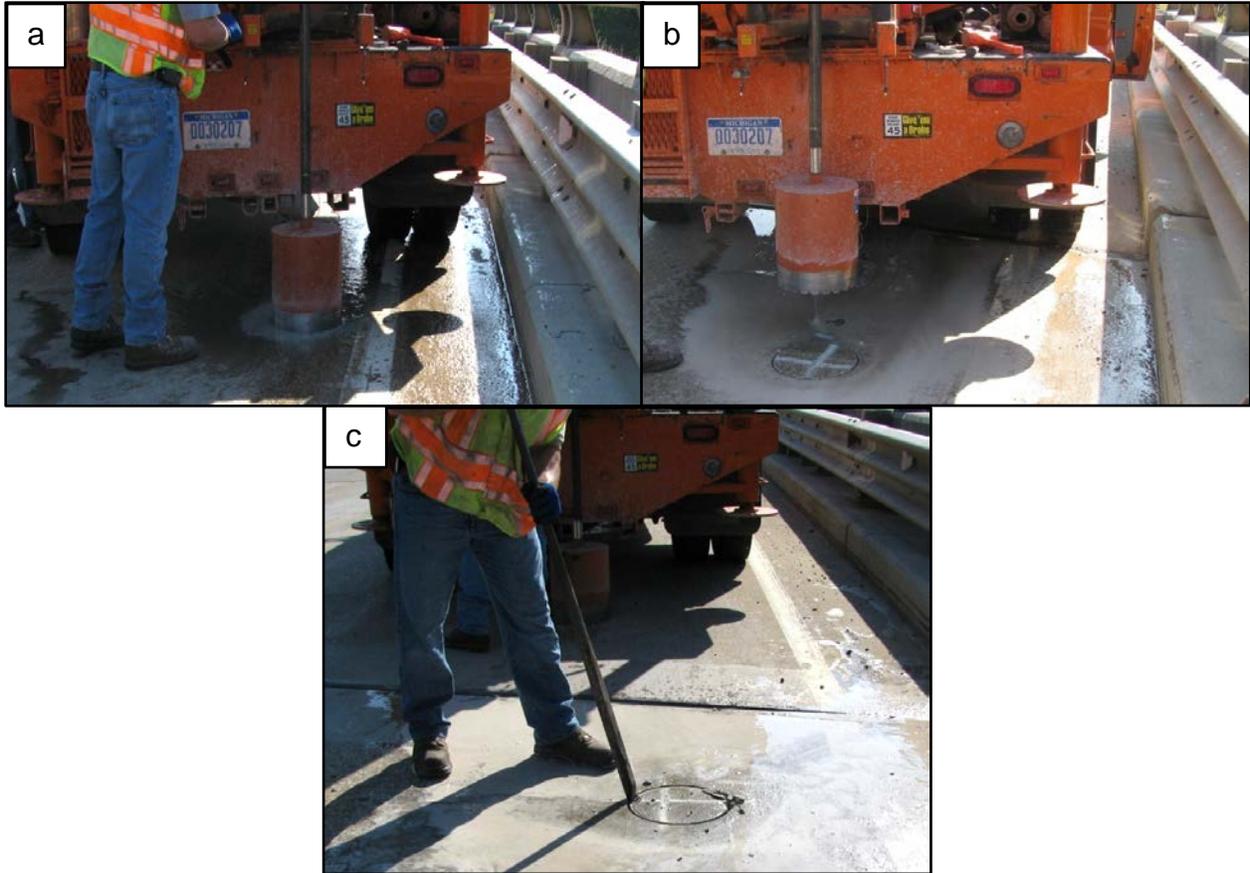
Figure 8-21: Drilling a core on the bridge deck (a), pulling out the drill (b), and pulling out the core with a pry bar (c).

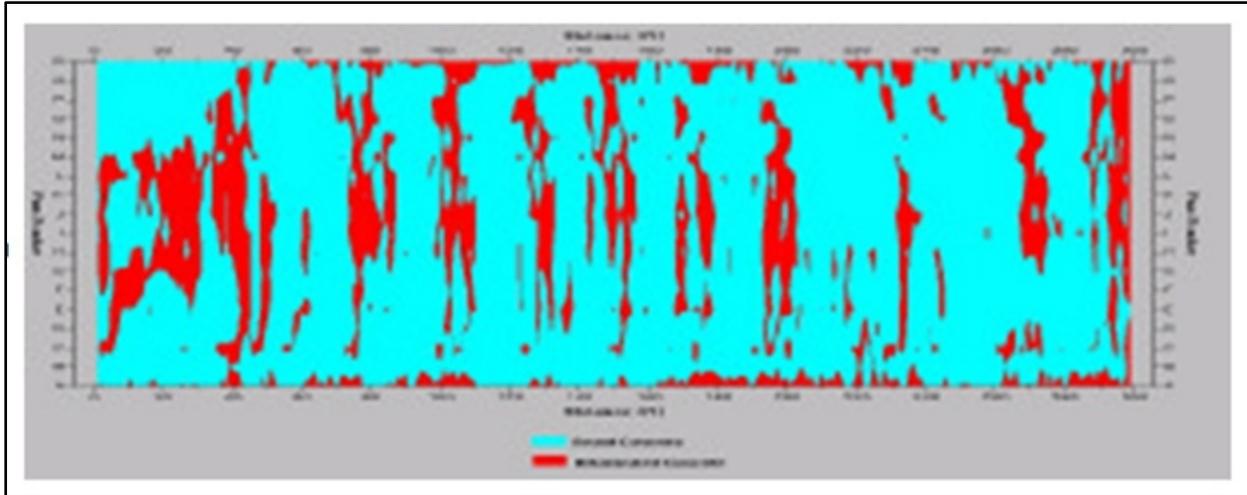
Figure 10-1: Typical GPR bridge deck delamination map produced with IRIS hardware and software. Red areas show locations of delaminated concrete.

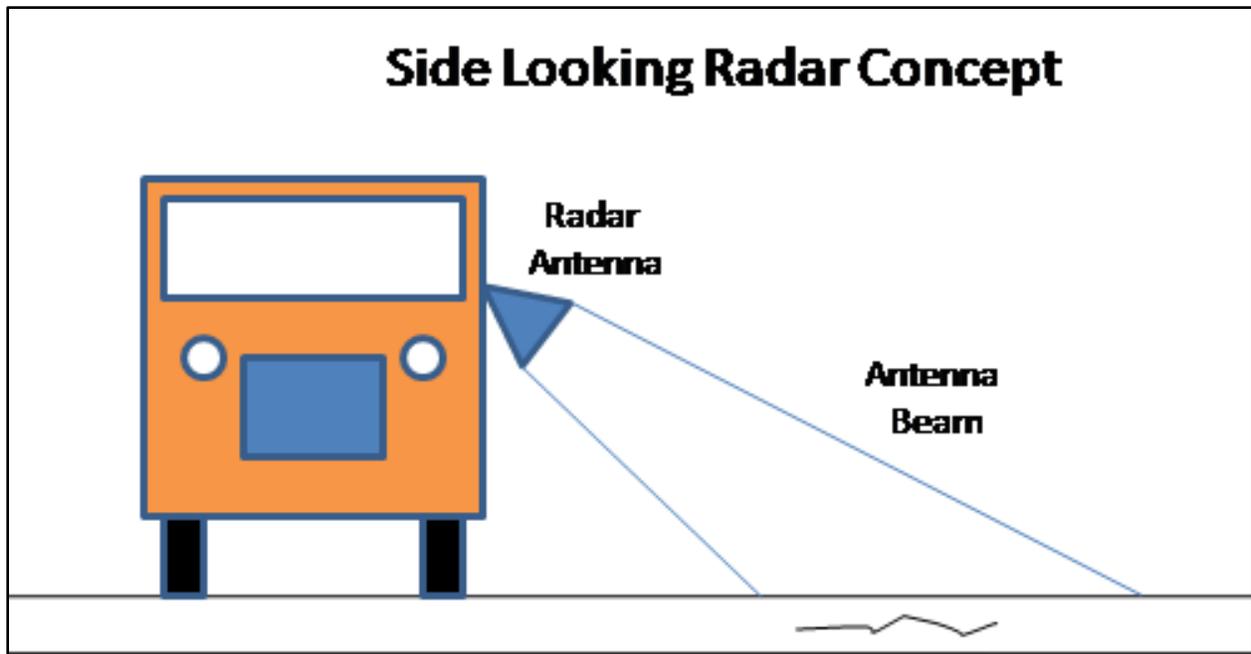
Figure 10-2: Side looking RaDAR concept.

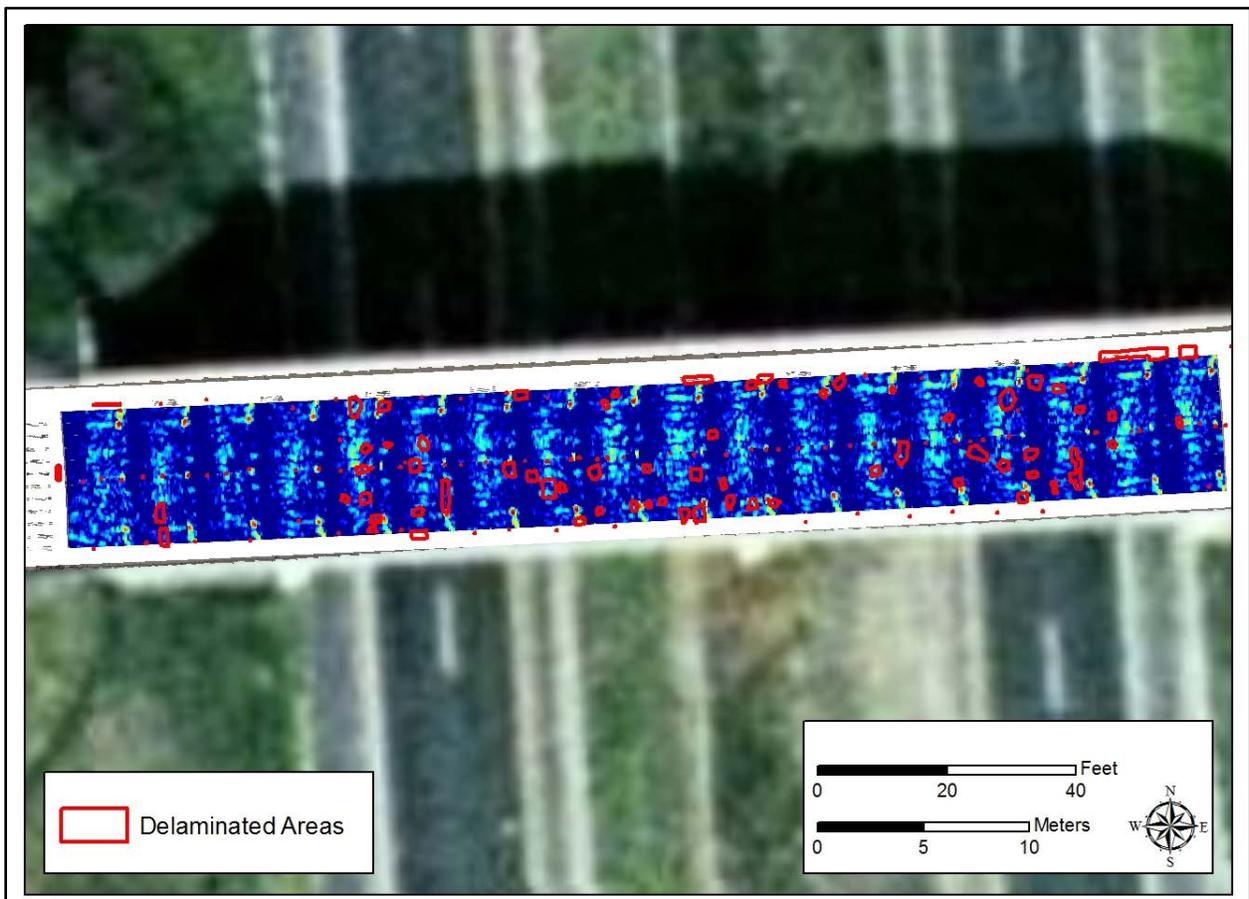
Figure 10-10: Image of Willow Road bridge with georegistered RaDAR image overlaid on optical image. The red outlines indicate suspected areas of delamination.

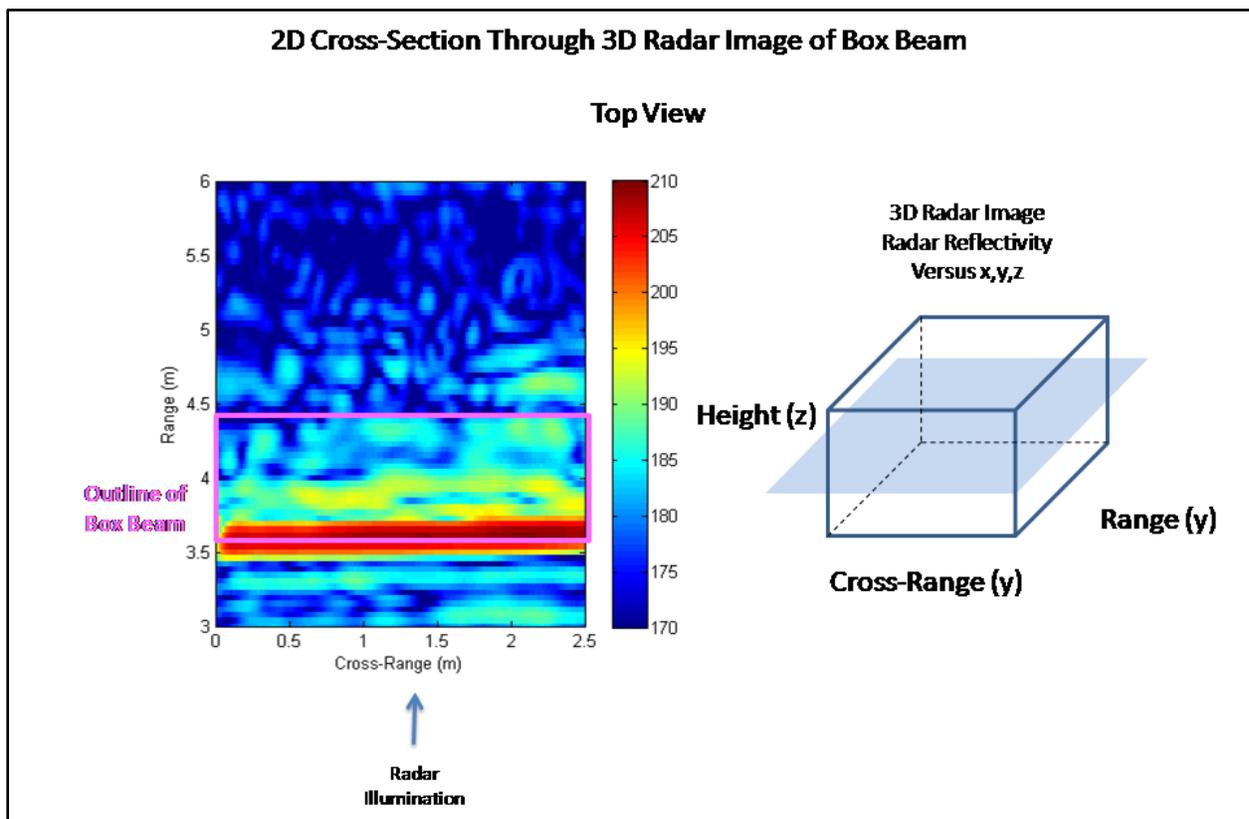
Figure 10-15: 2D cross section through the 3D RaDAR image of the box beam viewed from the top of the box beam.
