**BRIDGE CONDITION ASSESSMENT
USING REMOTE SENSORS**

United States Department of Transportation
Research and Innovative Technology
Administration

Michigan Technological University

Volume I of II – Main Body

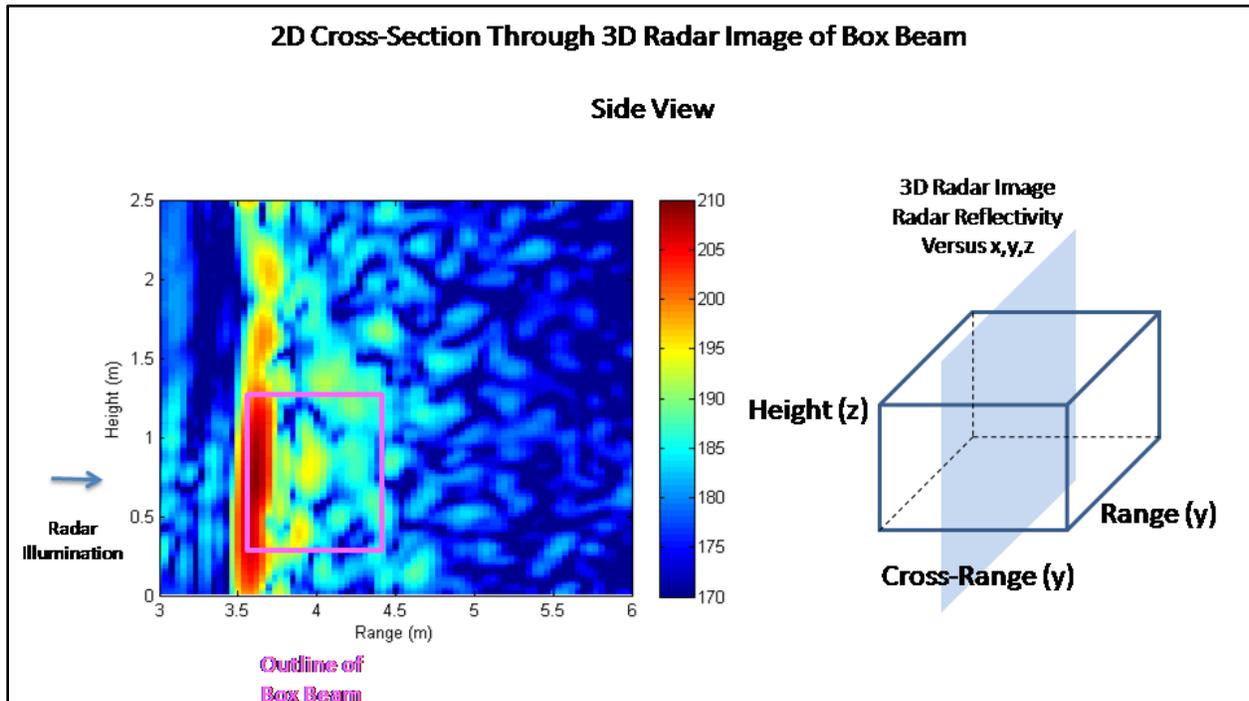
Figure 10-16: 2D cross section through the 3D RaDAR image of the box beam viewed from the end of the box beam.

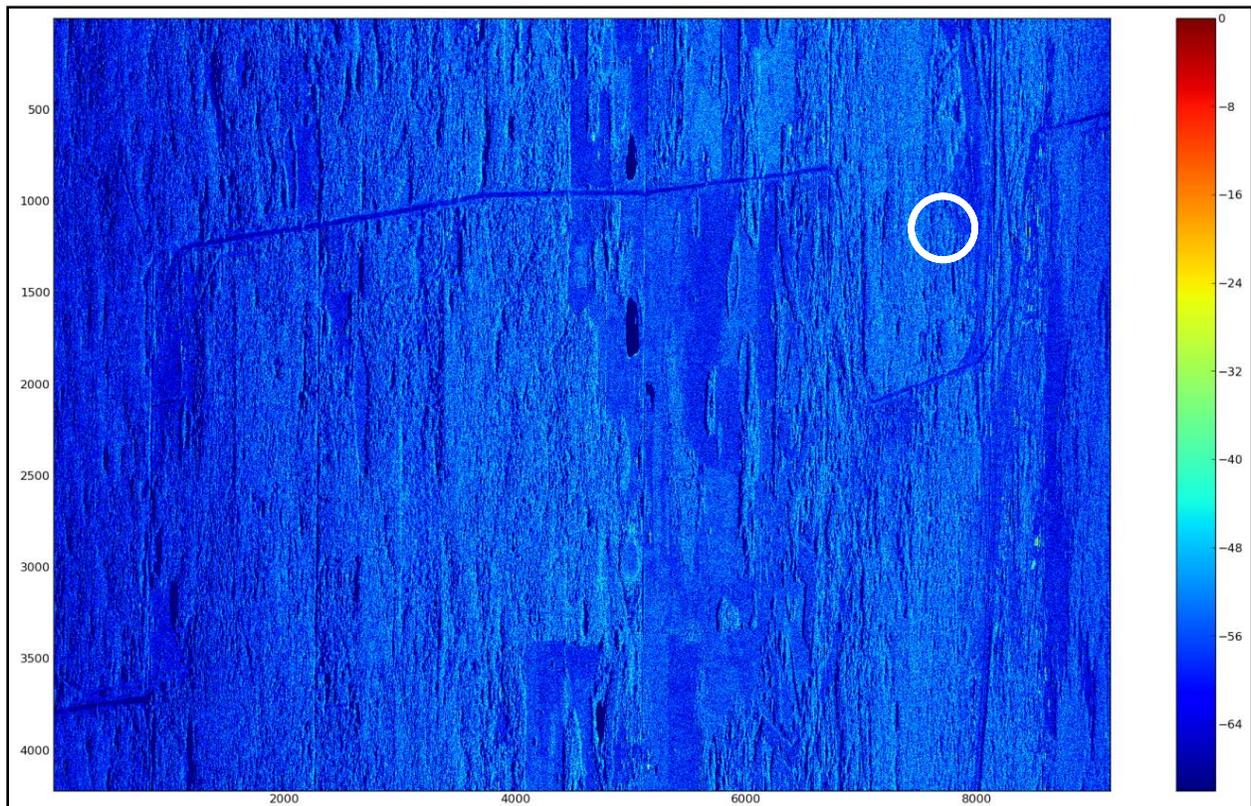
Figure 11-2: SAR image of Mannsiding Road and its wide surroundings where Mannsiding Road NB has been circled in white; color bar shown with dB scaling.

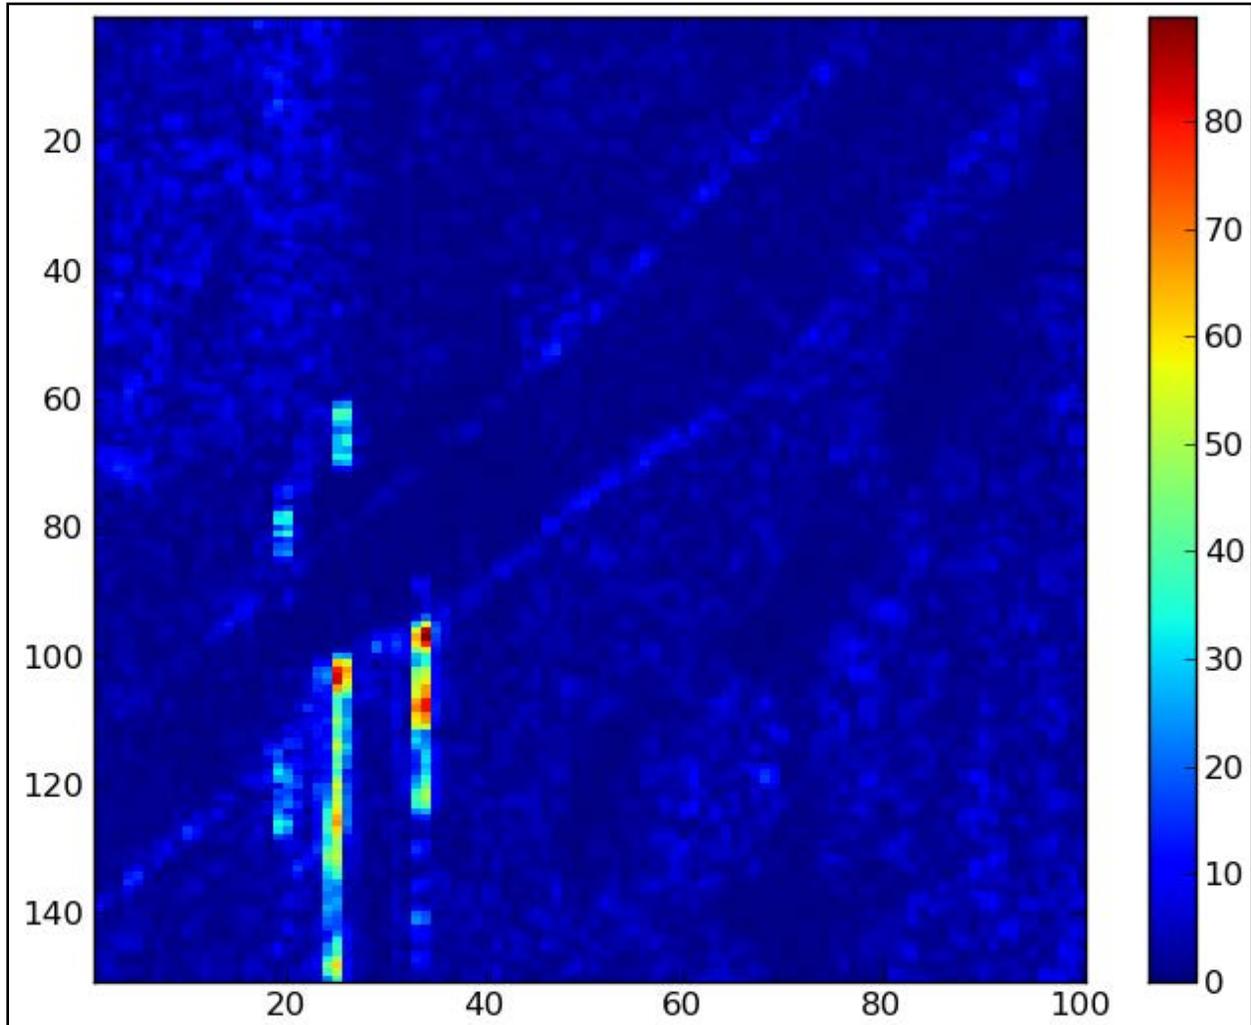
Figure 11-3: Close-up of the Mannsiding Road NB bridge; the bright pixels in vertical lines likely correspond to vehicle traffic beneath the bridge, which can be seen outlined by lighter pixels on the edges of the deck and approach (color bar has arbitrary units).

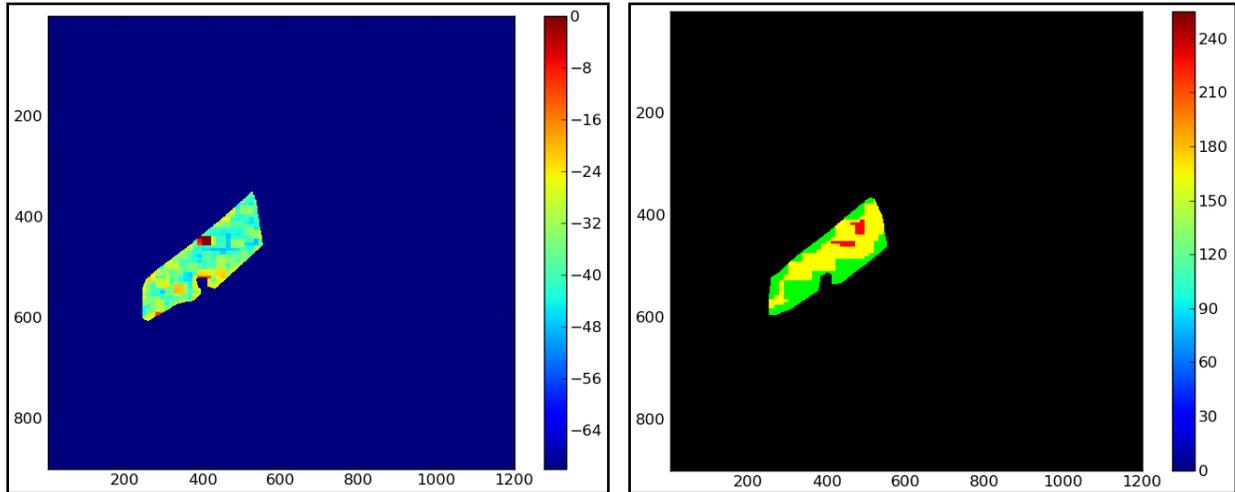
Figure 11-4: Pixels extracted from Mannsiding Road NB image shown after speckle contrast enhancement with dB color scale (left) and after pixel value classification into a "stoplight" decision support image (right).

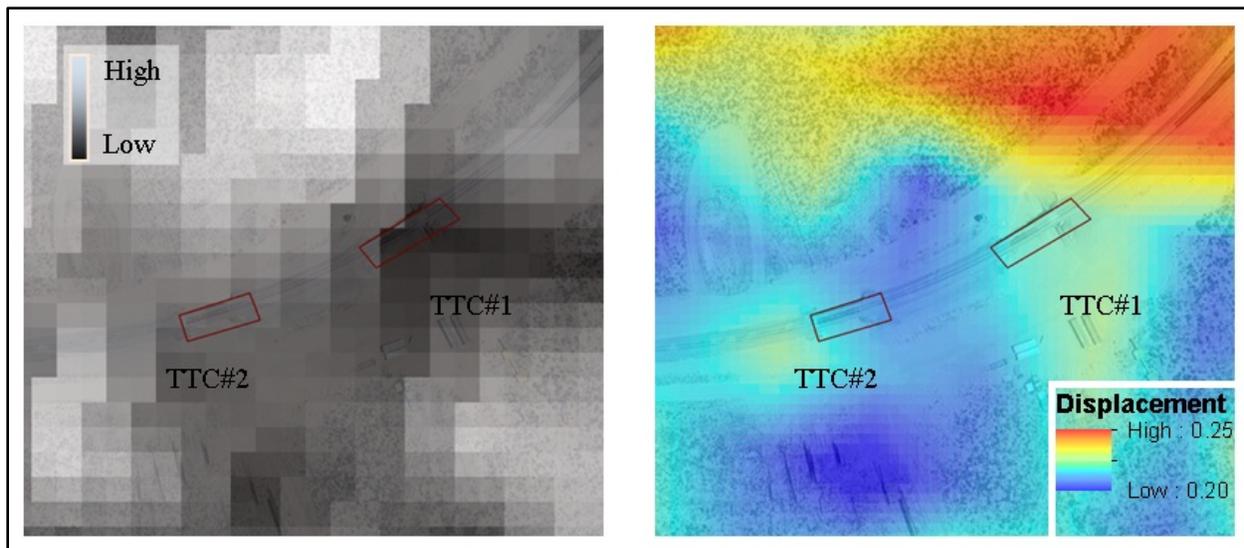
Figure 11-5: TTC bridges – coherence on left image and displacement on right image. Expected change; 10 cm increase (TCC-1) and no change (TCC-2). Observed change; TTC-1 ~0.5 cm increase relative to TTC-2.

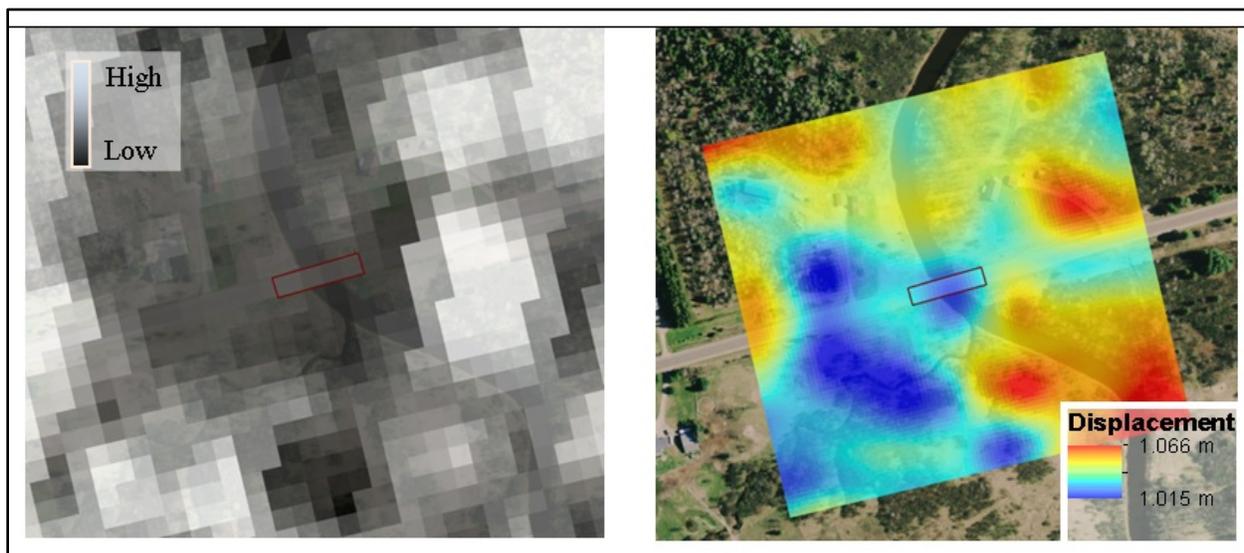
Figure 11-6: Brimley area bridge, Michigan. Coherence on left image and displacement on right image. Expected change; 0-5 cm decrease. Observed change; ~2 cm decrease relative to background.

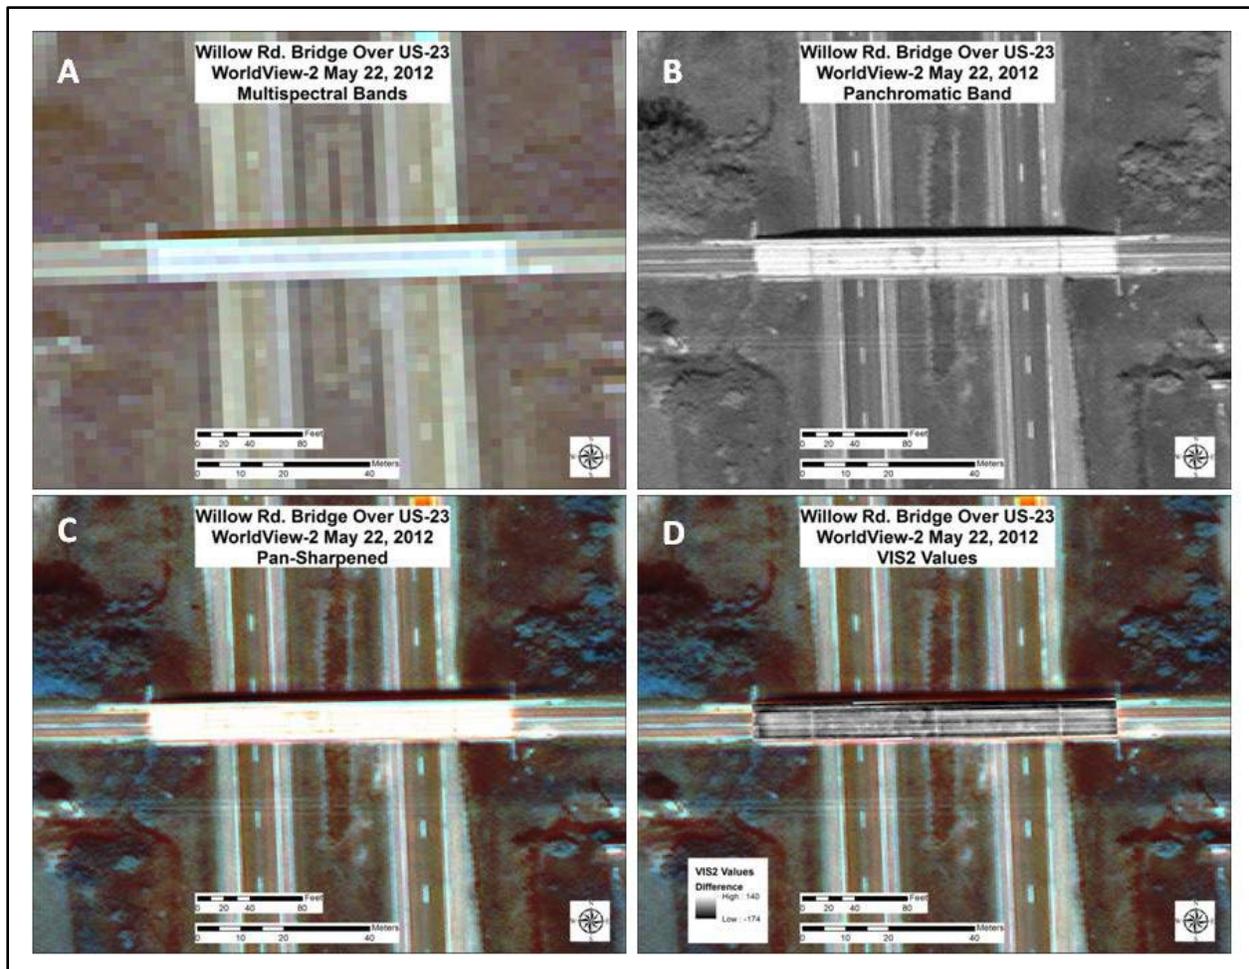
Figure 12-1: WorldView-2 image of Willow Road. Multispectral bands (A) have a resolution of 1.85 m while the panchromatic band (B) has a resolution of 0.5 m. The pan-sharpened (C) band has a resolution of 0.5 m. The derived VIS2 pixel values for Willow Road are shown in image D.

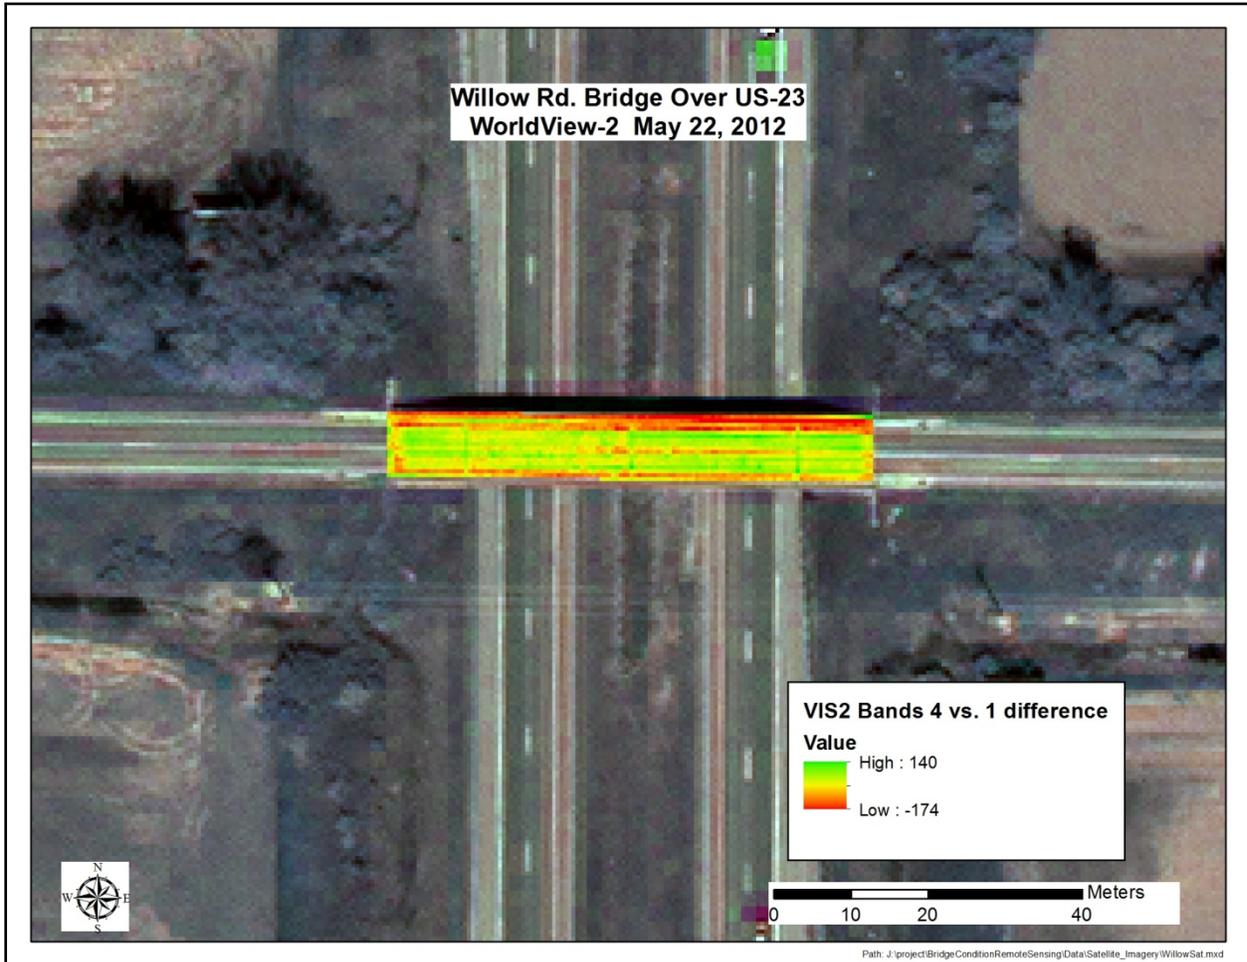
Figure 12-2: The VIS2 calculation displayed in color for the Willow Road bridge using WorldView-2 commercial high-resolution satellite imagery. Red and green areas (relatively low and high values) show high contrast between the blue and infrared spectral band information.

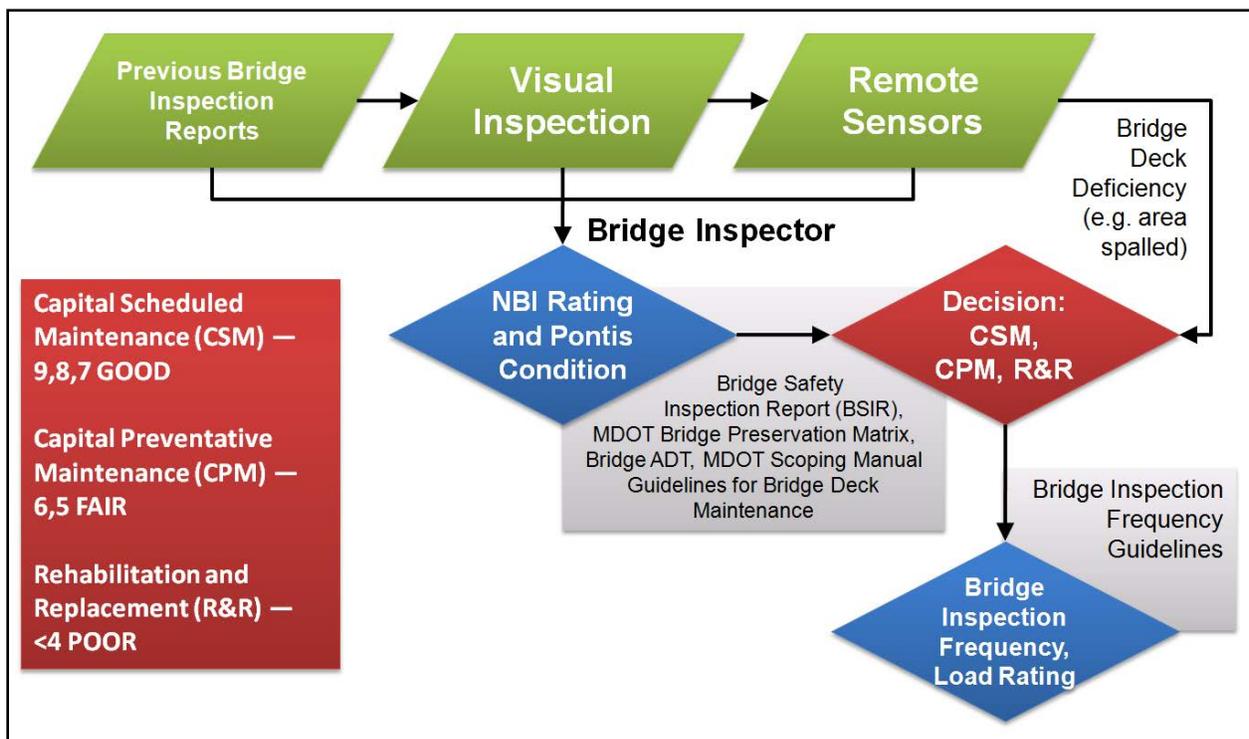
Figure 13-1: Example decision workflow for bridge managers and inspectors based on past NBI data, new NBI inspections, and remote sensing data.

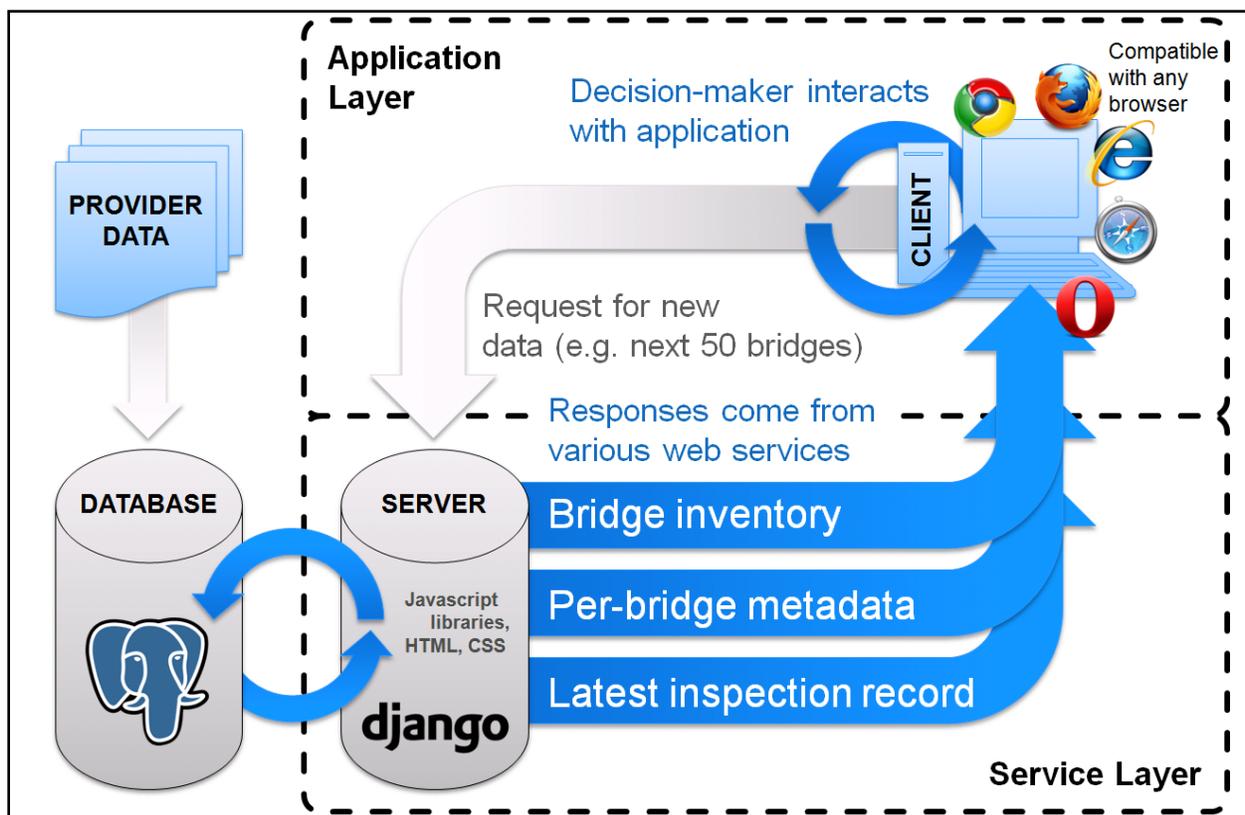
Figure 13-2: Concept diagram illustrating the components of the software architecture in the application and service layers, the location of the client and server within these, and how they communicate with each other.

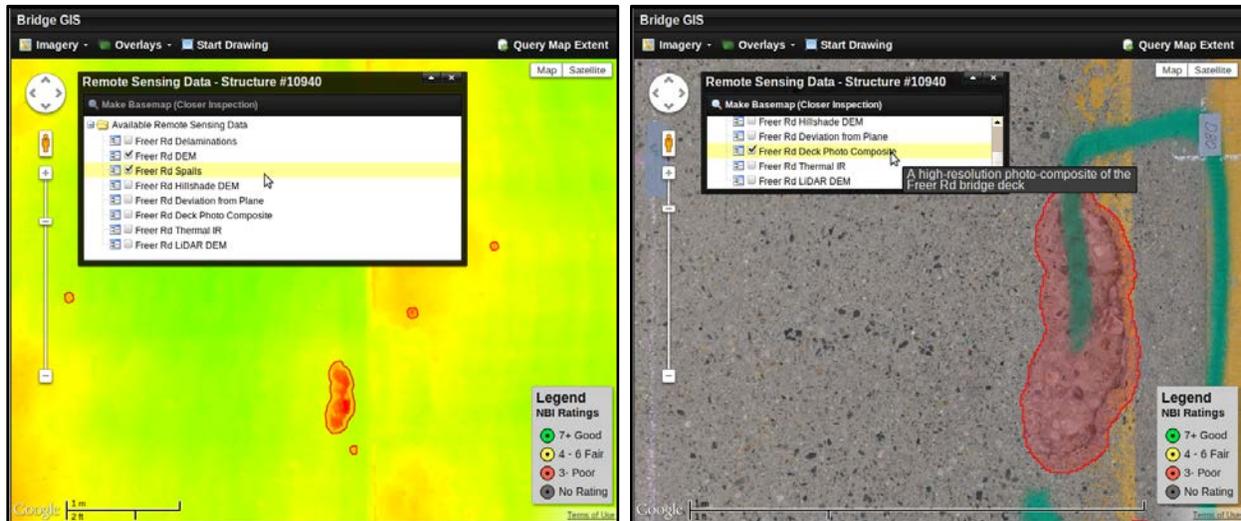
Figure 13-9: Screenshot from DSS of a digital elevation model (DEM) with a color-ramp and spalls outlined in red (left) and screenshot of a high-resolution photo composite showing the same, large spall as outline on the left; note the scale bar at the bottom of each, which is 1 meter in both (right).

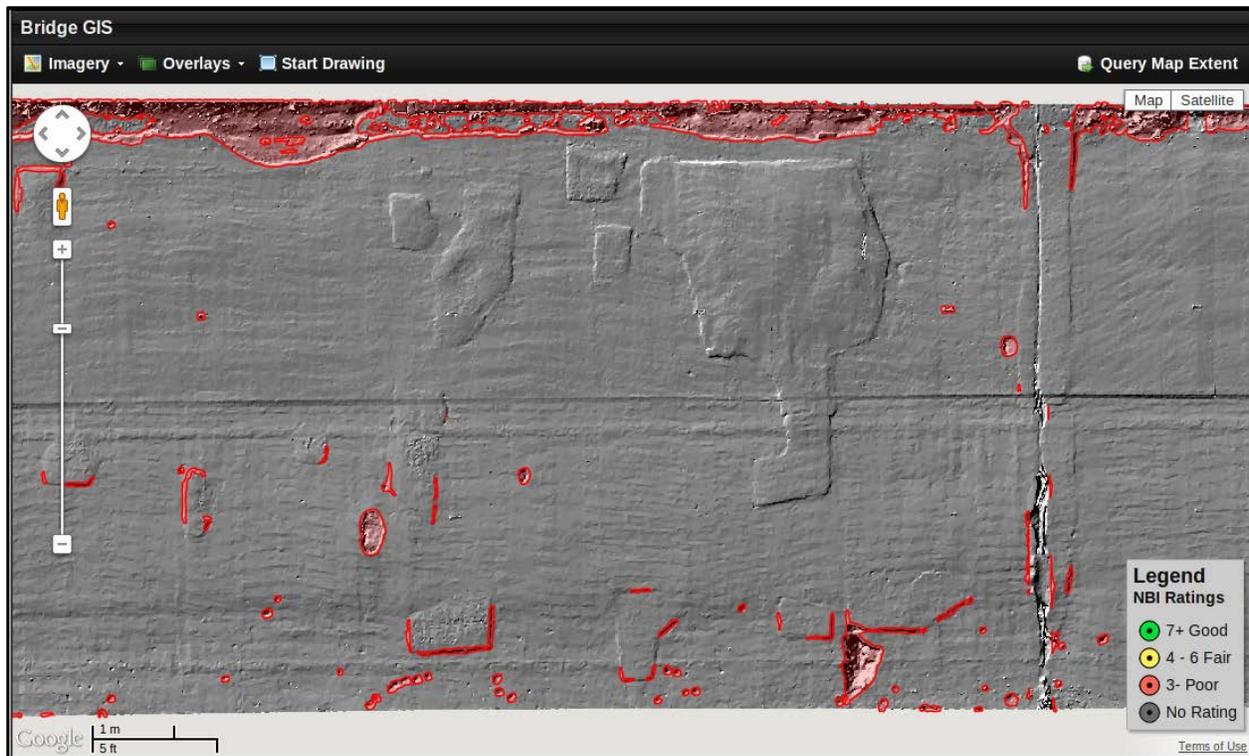
Figure 13-10: Screenshot from the DSS of the hillshade DEM layer for the Willow Road bridge with spalls outlined in red; note that bridge joints have been removed from the spalls layer and that the vertical accuracy is so fine that patches are clearly seen.

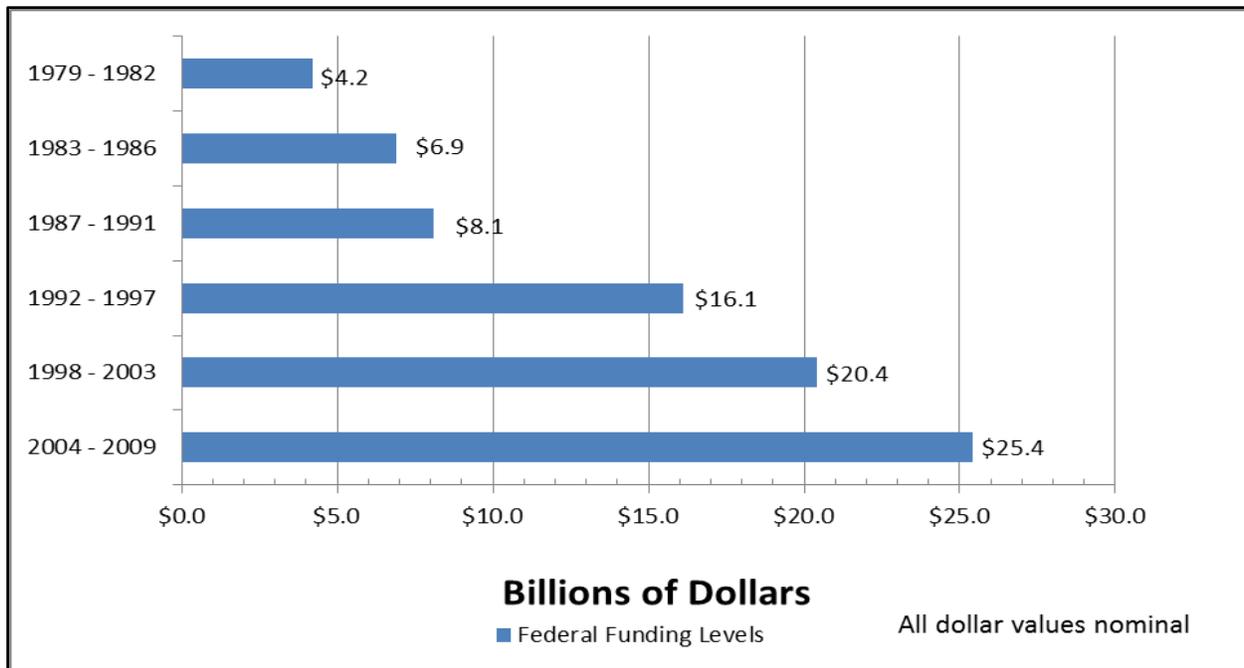
Figure 14-1: Funding levels of the HBP. Data source: 1979-03 data from Bridge Inspector’s Manual (FHWA 2006); 2004-2009 data from USDOT Office of Highway Policy Information website <www.fhwa.dot.gov/policyinformation/statistics.cfm>.

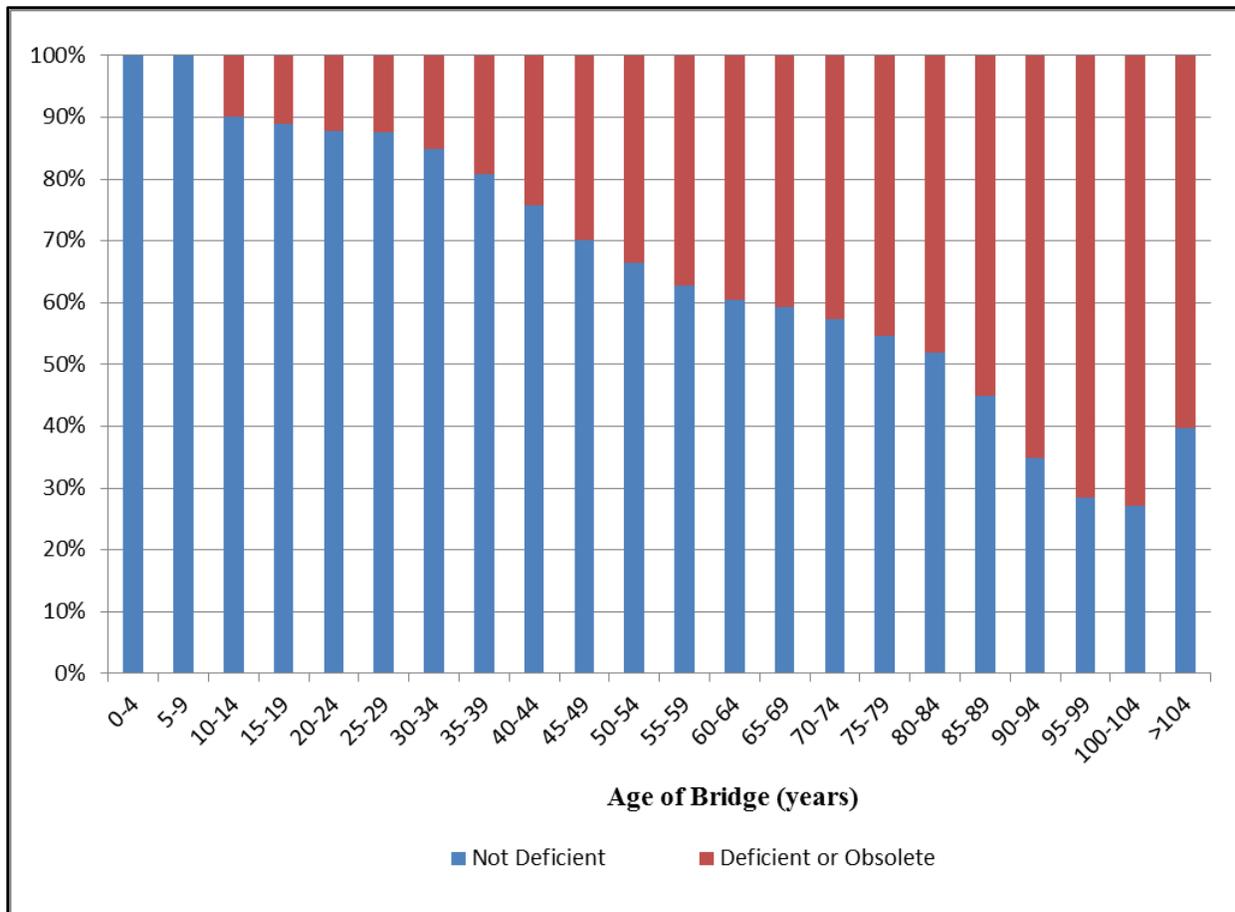
Figure 14-2: Age of bridge strongly correlated with condition (deficient or not). Data source: 2010 National Bridge Inventory (NBI) data.

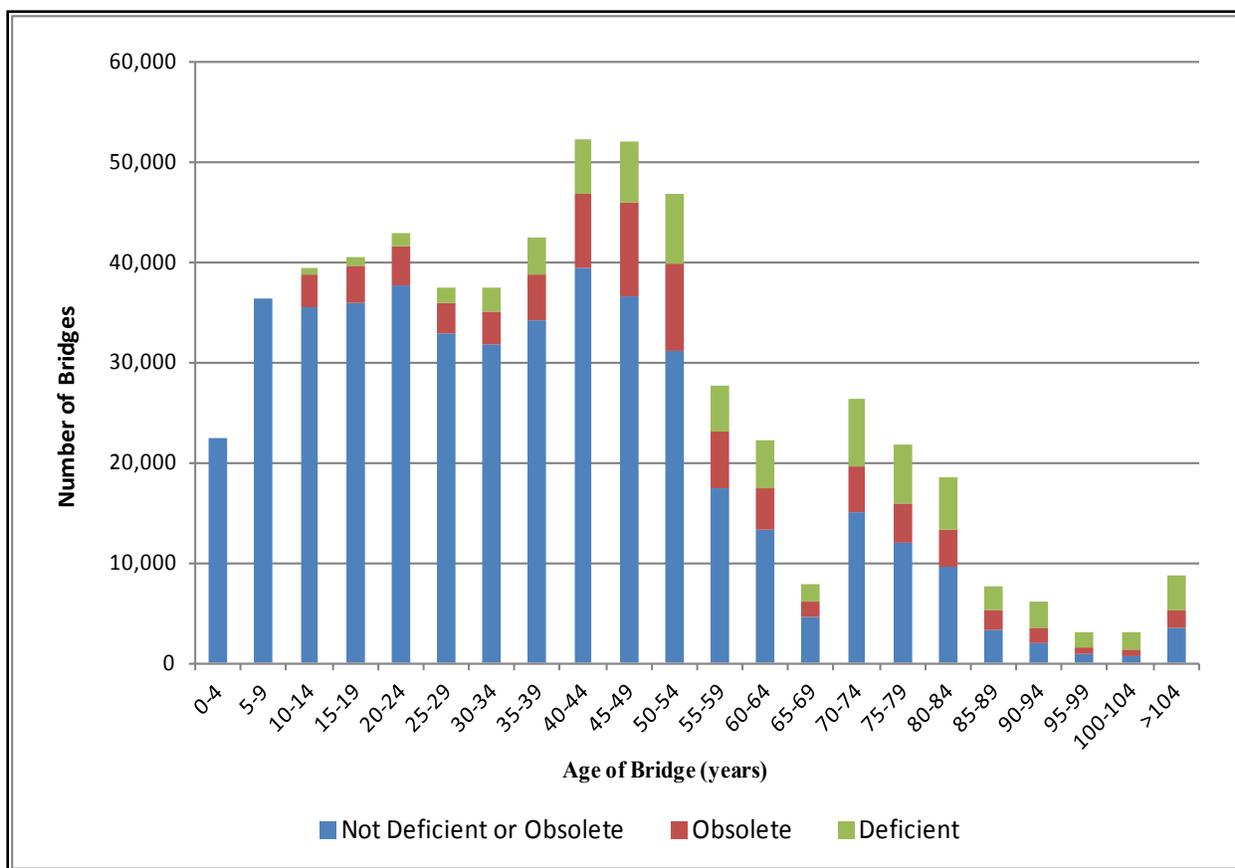
Figure 14-3: High percentage of older bridges are obsolete or deficient. Data source: 2010 National Bridge Inventory (NBI) data.
