# Memo

Number: 11

Re: Laboratory Study Progress Update

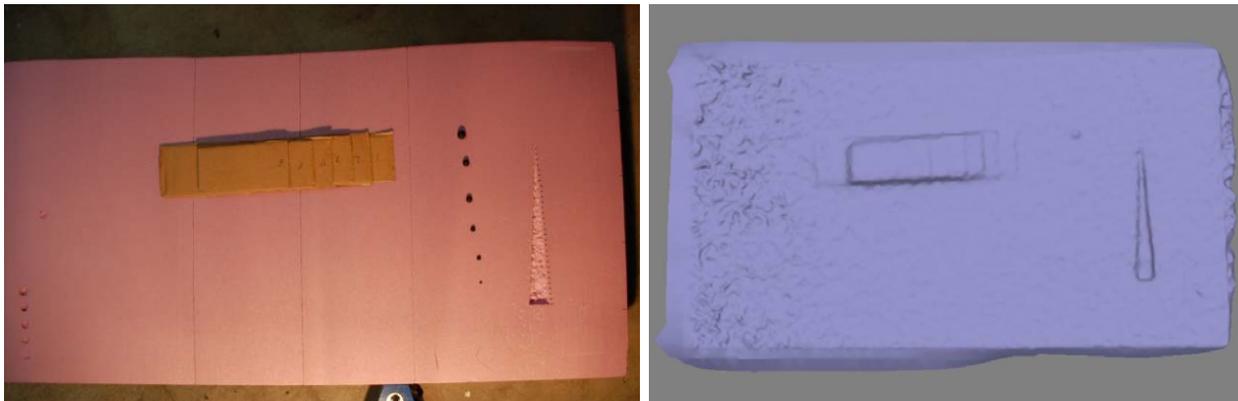
**Figures 1a & 2a: First experiment with foam board in the lab with original photo on the left and 3D model on the right.**

Various experiments were performed to test the cameras and software limitations using a piece of foam board, which was used for its ease to shape and attach extra pieces. A wedge shape was carved into the board that allowed us to determine the horizontal resolution of the program, which relates to the width of cracks on bridges. Pieces of cardboard were arranged in a stair-step fashion that shows the programs limit to resolve height or depth measurements. Finally, different colored spheres were added (see Figure 1a) to show if there would be problems with generating accurate models due to poor contrast and the different sizes show what the resolution is with respect to generating rounded features.

The camera was mounted directly above the board at a translation stage that allowed photos to be taken at precise intervals across the length of the board. This initial experiment showed that this program has a resolution of about 4mm in both the horizontal and vertical directions within this setup. Tests were also conducted with a single light source that illuminated the board from various angles to determine how the lighting and resulting shadows affected the model. All of the tests produced similar results and demonstrated that photos can be taken throughout daylight hours without concern over reducing resolution or accuracy.

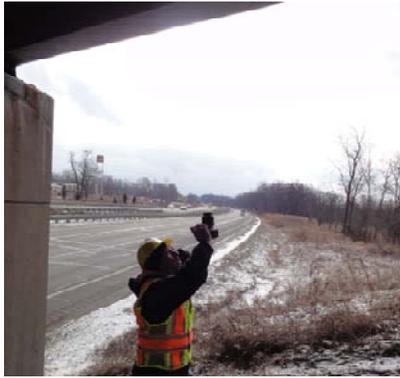
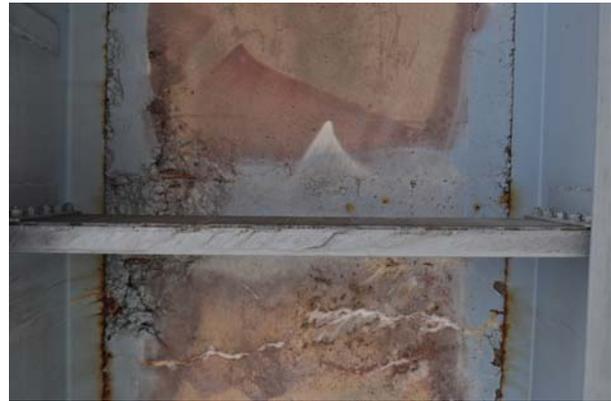
Figures 5a & 6a: Researcher taking photos of the underside of 6 Mile Bridge at US-23 near Brighton, MI. The distance from the camera to the spalls was approximately 2.5 meters (8 feet). Photo taken of spall on deck bottom surface from the field test shown above at 6 Mile/US-23 Bridge.

The first in-field test was conducted by taking the camera and capturing spalls on the underside of the 6 Mile Bridge over US-23 north of Ann Arbor, MI (see Figures 5a and 6a). 3D models of spalls were generated by taking four to six photos in a line, with the spalls being located approximately 2.5 meters above where the photo was taken (see Figures 7a & 8a). Spalls at a distance were of importance to demonstrate how a 3D setup could be deployed to measure the length, width, and depth of spalls that would otherwise require equipment to reach. Calculations of resolution attained by this camera, distance, and number of photos are currently being related that to desired measurement sensitivities.

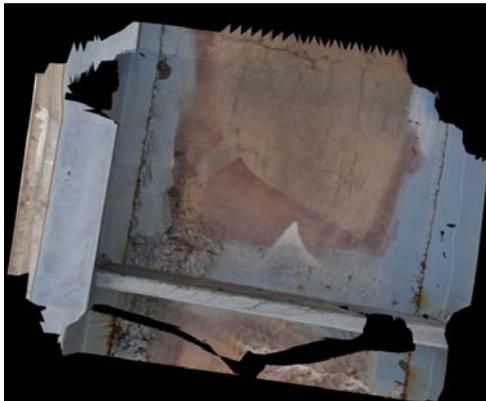
Figures 7a & 8a: Models generated from the infield photos with textured model on the left and shaded model output from PhotoScan on the right.

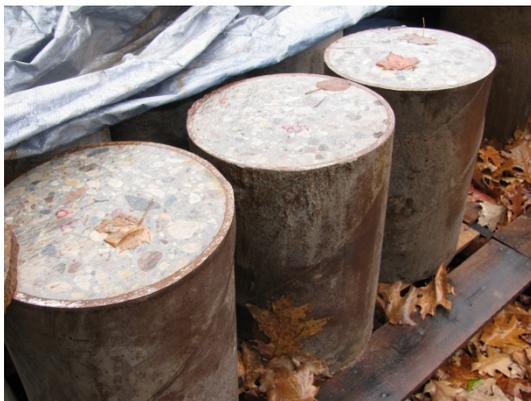
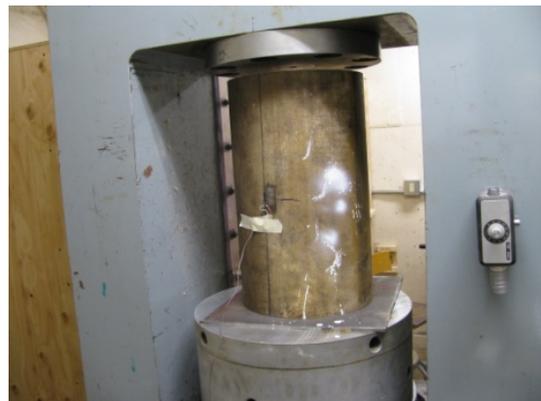
**Figures 1c & 2c: Bridge pylons on a pallet and pylon before a compression test.**

The overview plan involves laboratory testing of different structure samples such as W-shape structural steel members and concrete bridge pylons (concrete filled pipes) to determine static and dynamic behavior as emulated from bridge structures. Figure 1c below shows the pylons (note steel and concrete) and Figure 2c shows the sample bridge pylon during a compression test.
