Memo

Number: 20

Re: Field Deployment and Instrument Installation and Calibration Plan

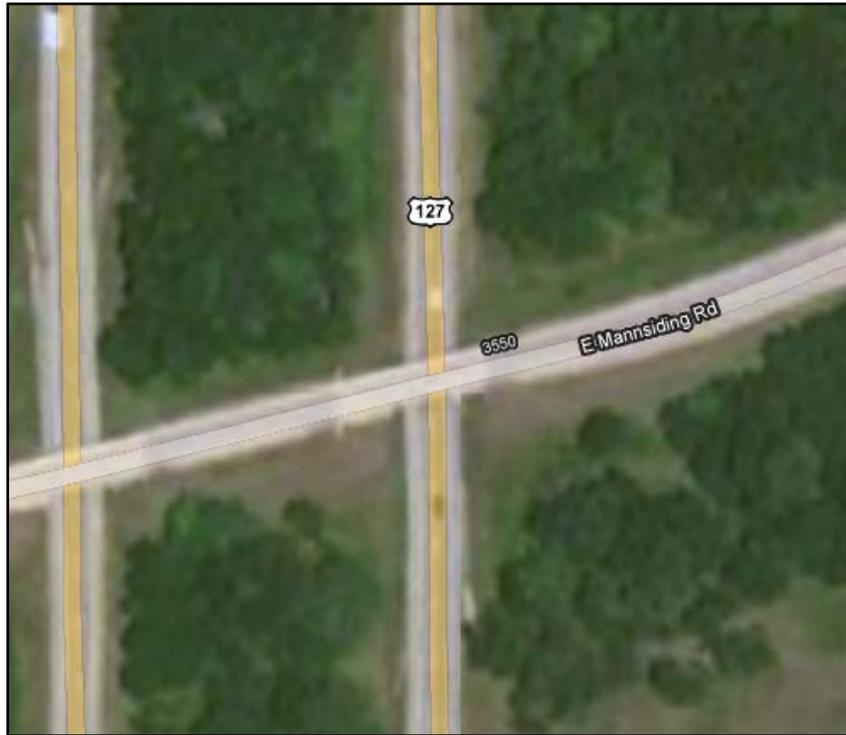
Figure 2: Aerial view of MDOT structure nº 1713 – Mannsiding Road over US-127 north bound.

MDOT structure n^o 1713 – Mannsiding Road over US-127 north bound; located in Clare County approximately 10 miles north of Clare, Michigan was determined to be the best candidate for field demonstration (see Figure 2).

The field demonstration candidate structure serves Mannsiding Road; a “Major Collector” road. The bridge was constructed in 1966 and is a 3-span pre-stressed concrete multi-I-beam composite structure. The structure is 130'-6” in length, 31'-5” in width, which translate into 26' of open roadway riding surface. During 1996 the average daily traffic (ADT) over the structure was found to be 1,000 with 3 % being commercial.

The current condition of the deck surface is an area of major focus and concern; it's rated at a "4" on the NBI scale. In 2008, a detailed inspection and scoping were completed of the top and bottom of the deck surface (project team has access to this report from MDOT). The scoping revealed that on the top surface of the concrete deck 176 ft² or 4.4 % of the deck was delaminated. Additional testing on the bottom surface revealed that 623 ft² or 15 % of the deck was in distress. The deck also possesses light scaling throughout and numerous transverse, longitudinal and diagonal cracks are present. In concern with the superstructure several high-load hits have resulted in scrapes and spalls but currently there is no sign of exposed reinforcing steel or pre-stressing strands. The bridge is scheduled for complete replacement in 2012/13.

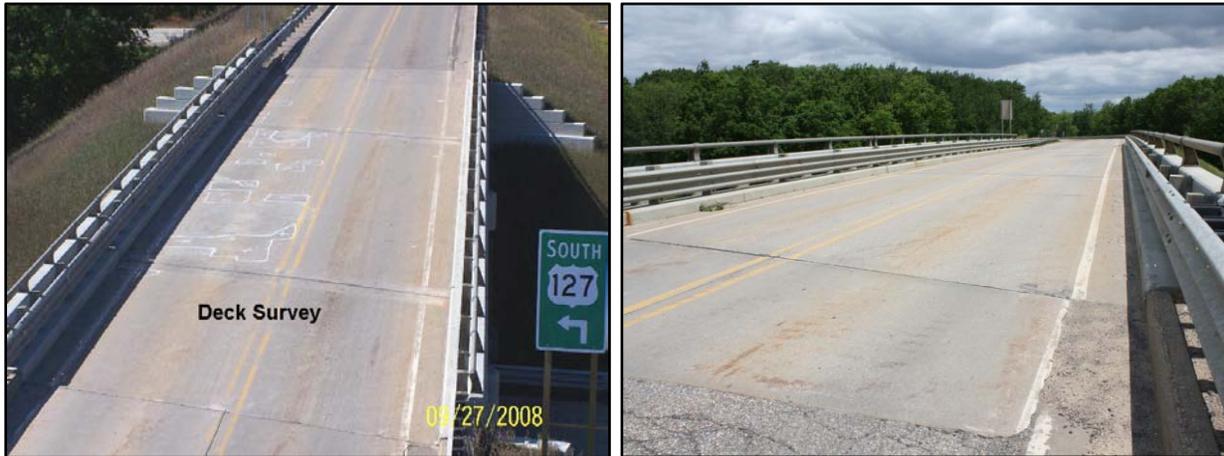
Figures 3 & 4: Photos of the Mannsiding Road bridge, from a 2008 MDOT scoping report (left), and from a June 2011 site visit (right).

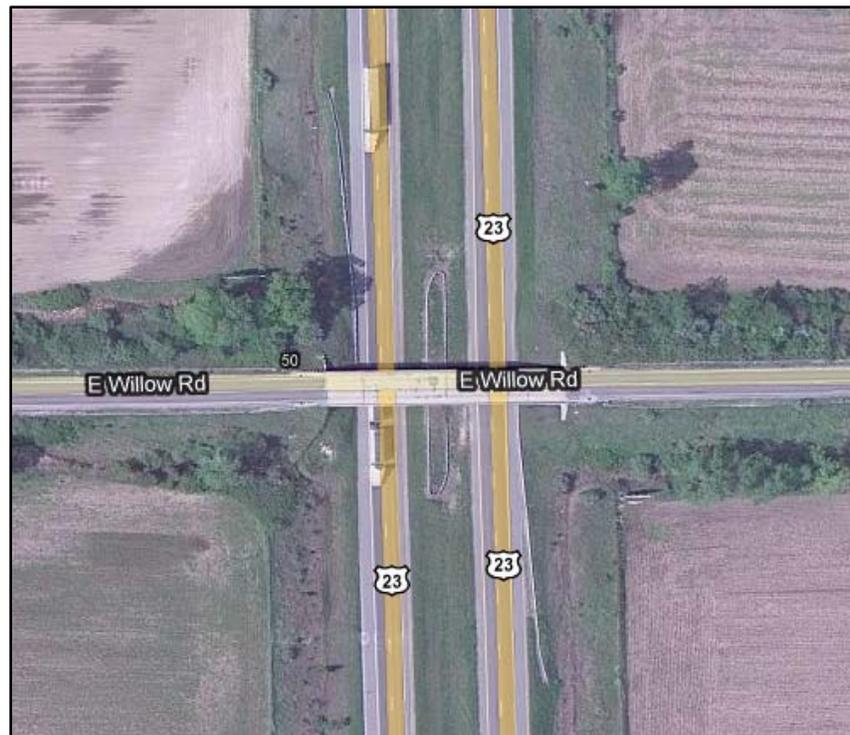
Figure 5: Aerial view of MDOT structure n° 10892 - Willow Road over US-23.

MDOT structure n^o 10892 – Willow Road over US-23; located in Washtenaw County approximately 3 miles north of Milan, Michigan was determined to be the best candidate for field demonstration (see Figure 5).

Currently the bridge has no posted speed limit restriction. The crossing spans both north and south bound US-23; a NHS route that is not within any federal-aid urban boundary. The bridge does not meet the desired minimum vertical clearance for NHS routes. The structure is located in York Township within Washtenaw County.

The current condition of the deck surface is rated at a “5” on the NBI scale. In 2010, the inspection report indicates that open transverse cracks, diagonal cracks and areas of delamination are present throughout the deck. Concrete patching has been done to help minimize deterioration and prolong the service life of the bridge. Additionally areas on the bridge superstructure display desired sensing deficiencies over both the north and south bound lanes. This is attributed to several high-load hits which have resulted in scrapes and spalls but currently there is no sign of exposed reinforcing steel or pre-stressing strands. Figure 6 shows a photo of the bridge deck.

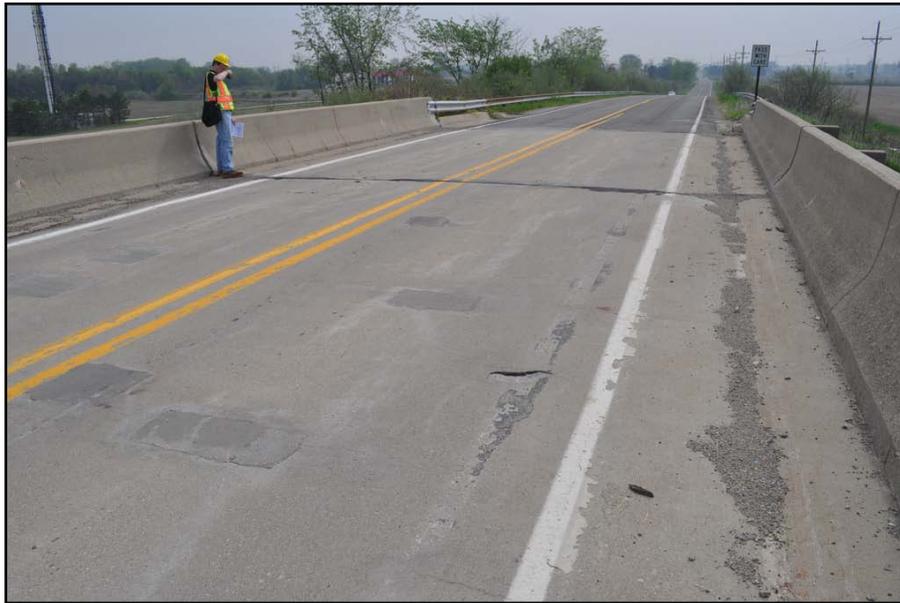
Figure 6: An example photo of the bridge deck of the Willow Road bridge taken on May 13, 2011 (note the variety of visible deck surface defects).

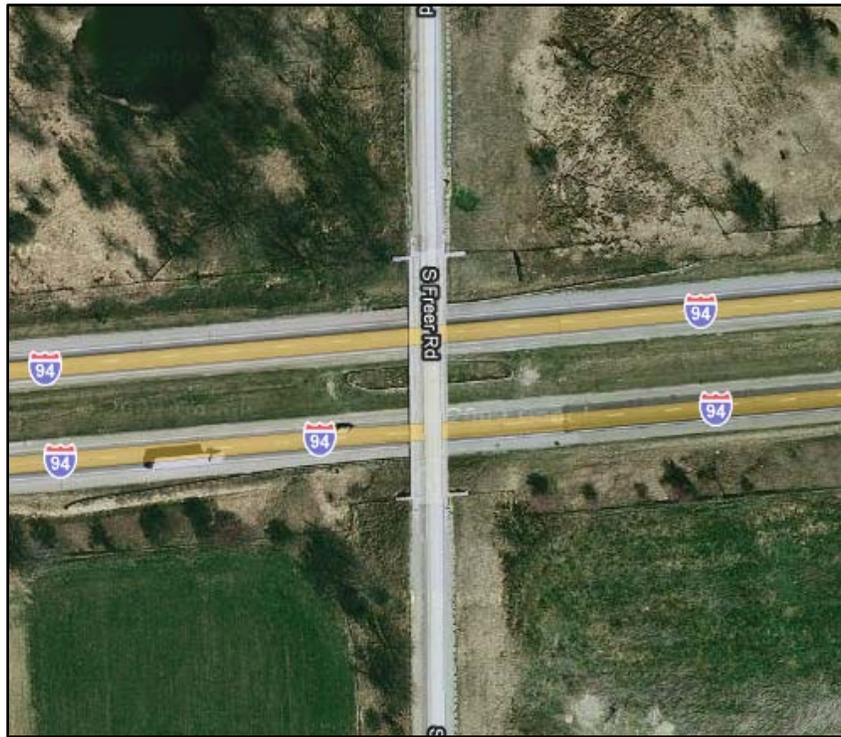
Figure 7: Aerial view of MDOT structure n° 10940 - Freer Road over I-94.

MDOT structure n^o 10940 – Freer Road over I-94; located in Washtenaw County approximately 1 mile east of M-52 in Chelsea, Michigan was determined to be the best candidate for field demonstration (see Figure 7).

The field demonstration candidate structure serves Freer Road; a “Major Collector” road. The bridge was constructed in 1960 and is a 4-span pre-stressed concrete multi-I-beam composite

structure. The structure possesses dimensions of 209' in length, 30'-10" in width, which translate into 26' of open roadway riding surface with no available for shoulder room. During 1997 the ADT over the structure was found to be 150 with 3 % being commercial.

The current condition of the deck surface is rated at a "6" on NBI scale. In 2010, the inspection report indicates that there were several areas of concrete patching accompanied by few tight transverse and diagonal cracks present on the deck. Concrete patches have been applied to help minimize deterioration and prolong the service life of the bridge. The report indicates that

there are also areas of interest on the superstructure where the concrete material has spalled and cracked. These areas of interest are located at the beam-end locations on the bottom flange. None of the spalled sections are currently deep enough to expose any reinforcing steel or pre-stressing strands (Figures 8 and 9 show two sample photos of the bridge).

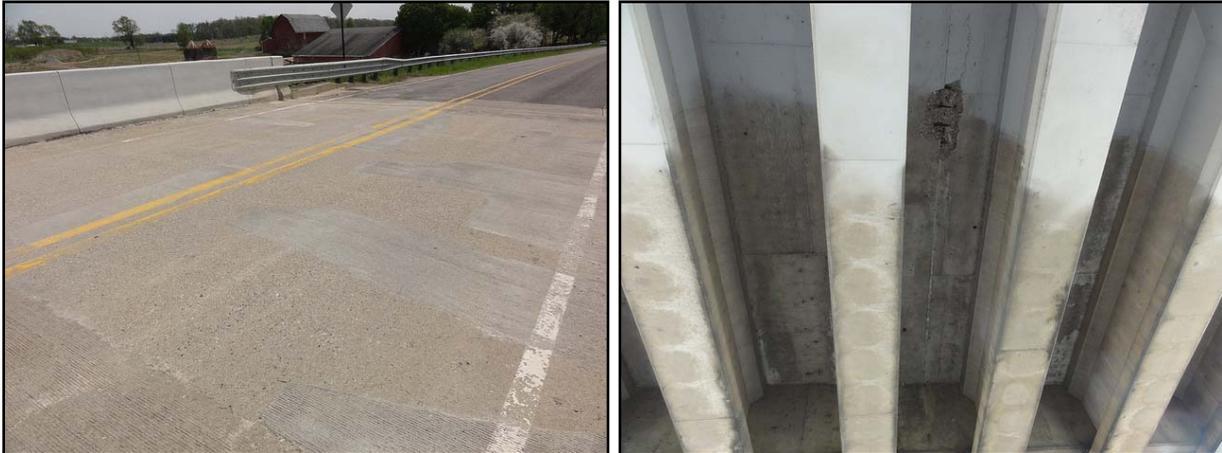
Figures 8 & 9: Two sample photos taken of the Freer Road bridge over I-94 on May 13, 2011.

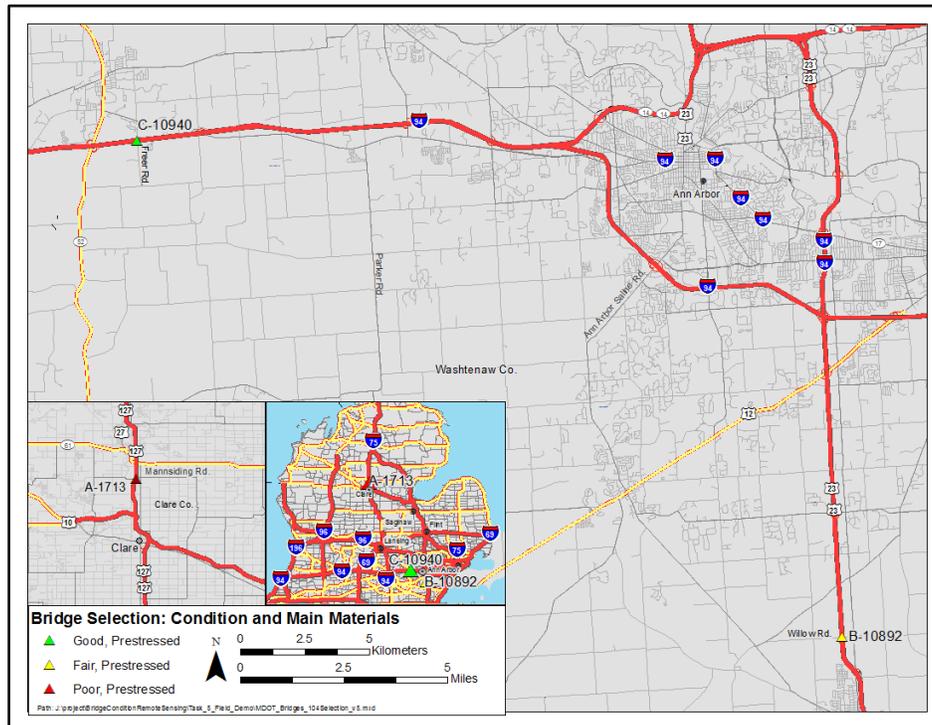
The proposed field demonstration time has been narrowed down to the first two weeks of August; actual days are pending weather and closure timing and availability. The first structure to be tested is planned to be the “satisfactory” condition bridge (MDOT n^o 10940), followed the “fair” condition bridge (MDOT n^o 10892), and the “poor” condition bridge (MDOT n^o 1713) respectively (see Figure 10).

Figure 10: Close up of the locations of all three bridges shown in the Decision Support System (DSS) interface in relationship to Ann Arbor and the State of Michigan.

Both systems can be deployed during the field demonstrations and finished with data collection in less than 30 minutes each. Data will be processed in the MTRI GIS lab into a geo-tagged photo inventory of each bridge for inclusion in the Decision Support System (DSS) (see Figure 10).

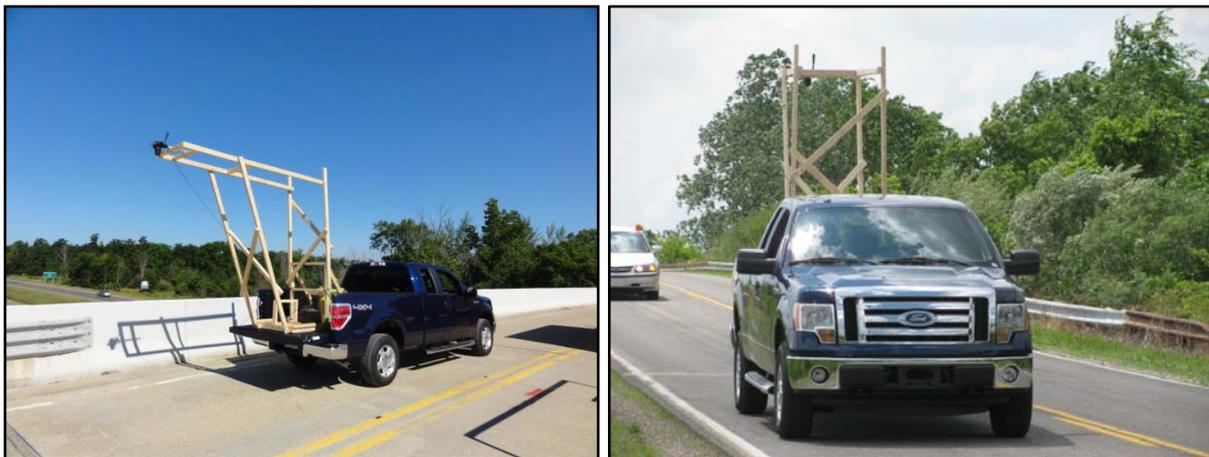
Once at the site, the vehicle mount for the 3D system is put together, the camera is mounted and the vehicle mount is strapped down to the bed of a truck. The camera is then connected to the computer and then tested to make sure there is a good connection and everything is working properly. Once everything is ready, the truck drives along the bridge at a slow speed (currently 1-to-3 mph); this has been achieved by putting the truck into 4x4 low and letting it idle across (see Figures 11 and 12). Note that potential future systems would be able to cross at higher speeds if more advanced digital cameras are used.

Figures 11 & 12: 3D Optics (3DO) data collection system deployed for pre-field demonstrations trials.

- Assemble the vehicle mount (see Figures 11 and 12)
- Attach the Nikon D5000 camera being used for the field test
- Drive across the bridge at a speed around 2 mph (4x4 low at idle speed)
- As the truck drives across bridge, camera will take photos at 1 fps
- Repeat pass on the other lane of the bridge

The camera is set to take photos once per second (1 fps) during the collects. The combination of the vehicle speed and the camera's continuous shooting allows for at least a 60 % overlap in the photos (which is necessary for 3D photogrammetry) and due to the height of the camera we are able to cover one full lane width on a bridge. On the selected bridges, we would need two passes to cover the entire bridge.

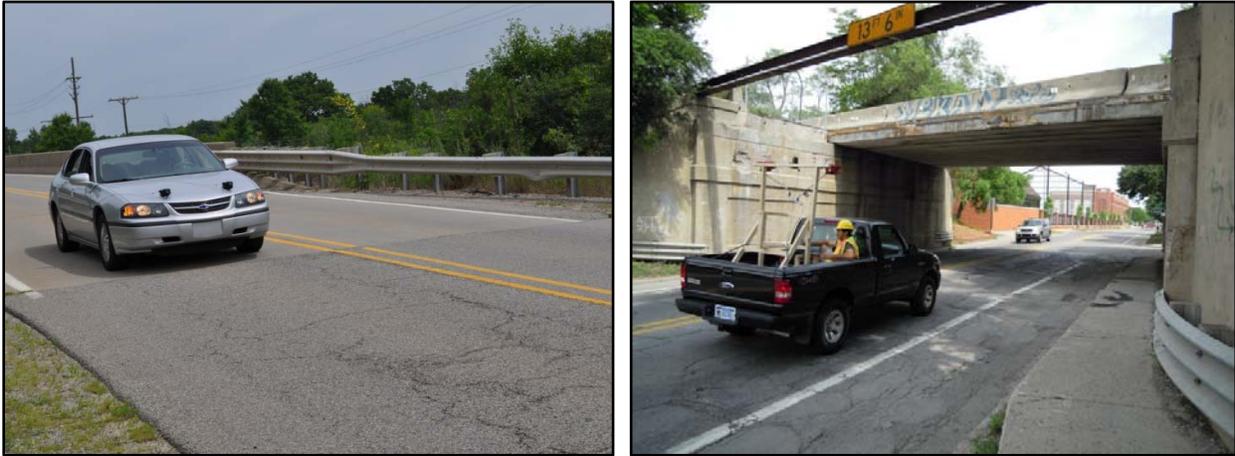
Figures 13 & 14: Example deployments of the “Bridge Deck” (left) and “Bridge Underside” (right) versions of the BridgeViewer Remote Camera System (RCS).

- Take a picture of Garmin GPS unit being used to geo-tag the photos later
- Mount the cameras to the hood of the car (see Figure 13)
- Align the cameras so that their field of views overlap in the center of the lane
- Drive over bridge at 5 mph while capturing images once every four seconds

- Take a picture of Garmin GPS unit being used to geo-tag the photos later
- Assemble vehicle mount with camera and lights (see Figure 14)
- When approaching the bridge, turn on the lights and start taking photos at 1 fps
- Drive along both lanes to collect full coverage under the bridge

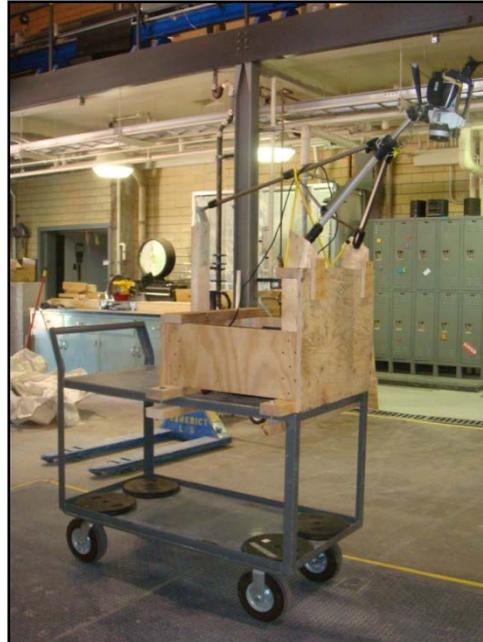
be calculated by comparing the boxed area to a reference area on the bridge deck. Figure 15 shows the cart with fabricated wooden frame for collecting the ThIR images. The height of the camera lens to the deck surface should be ~ 6.2 ft giving about a 2.67 ft by 1.98 ft FOV (5.29 ft^2), allowing for the ThIR camera to take images 1 fps while the cart rolls along at ~ 1.3 mph.

Figure 15: FLIR SC640 ThIR camera mounted on the cart for field demo.

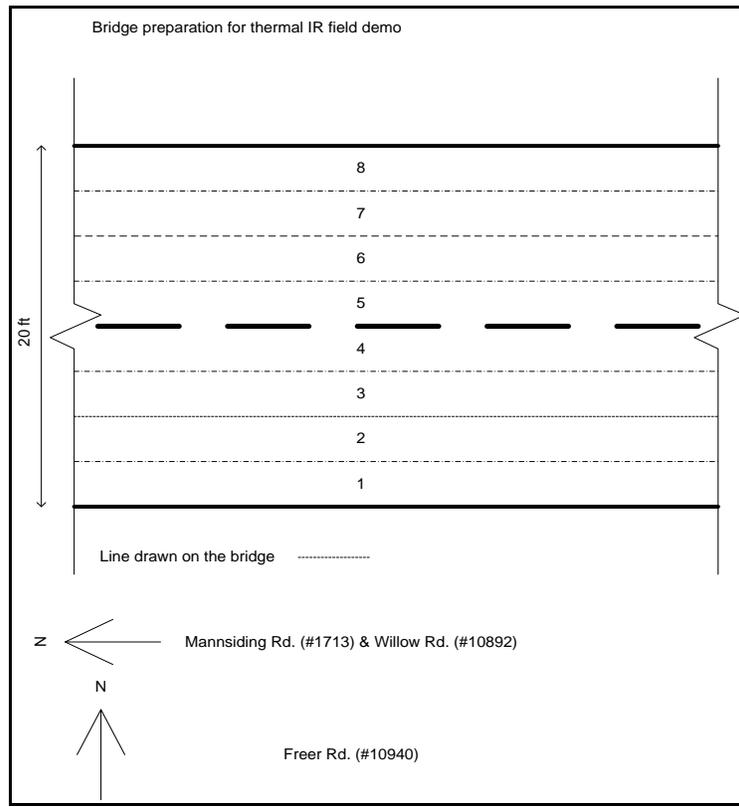
Chalk lines will be drawn on the deck top surface to facilitate the data collection procedure. Figure 16 shows a diagram of the deck. As it can be seen in this figure, data collection of the whole bridge requires 8 passes. Duration of data collection will be approximately 20 minutes for Freer Road and Willow Road and 15 minutes for Mannsiding Road. This excludes the time duration between each pass.

Figure 16: Diagram of the deck surface showing lanes which ThIR camera-equipped cart will travel on.

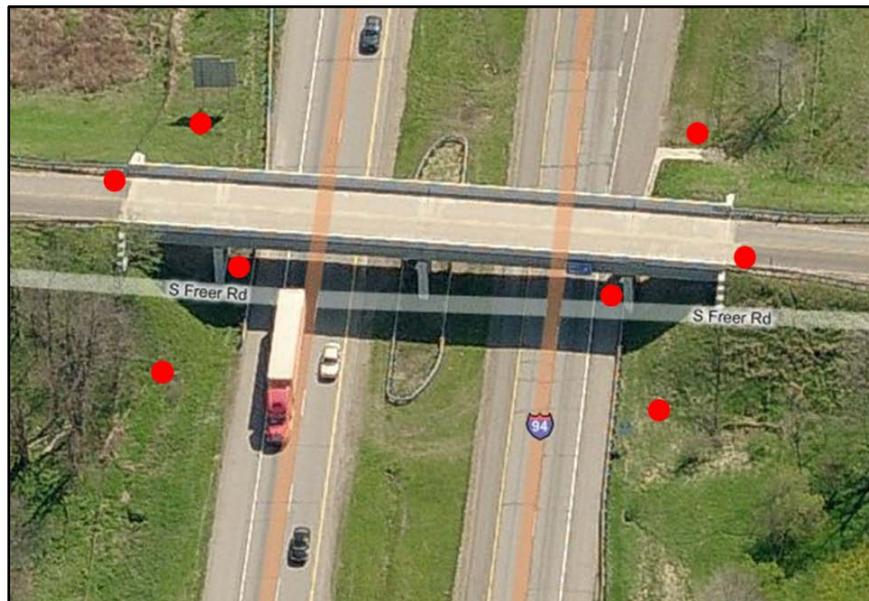
Testing should last roughly four hours, which includes setup, six to eight separate scan locations and demobilization. A simple survey location map has been constructed to help accelerate the actual selection during data collection (see Figure 17). To be more precise, once the crew is on-site it will 30 minutes to assemble, and position the Riegl LMS-Z210ii LiDAR unit (see Figure 18) in the first scanning location along with the six retro reflective prisms for the points of commonality. Note the opportunity to gain access to MDOT's terrestrial Leica LiDAR system for deployment at the three bridge sites, in coordination with MDOT LiDAR experts is being investigated.

Figure 17: Possible survey points for Freer Road bridge.

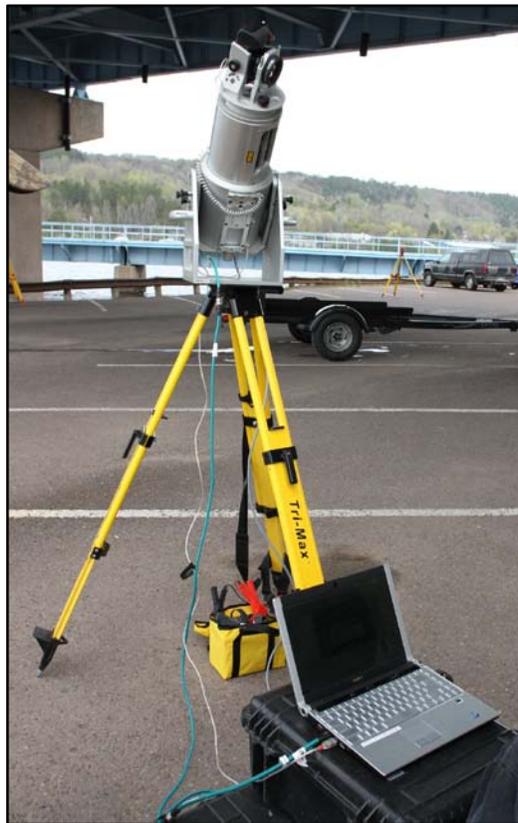
Figure 18: Typical Reigl LiDAR unit setup.

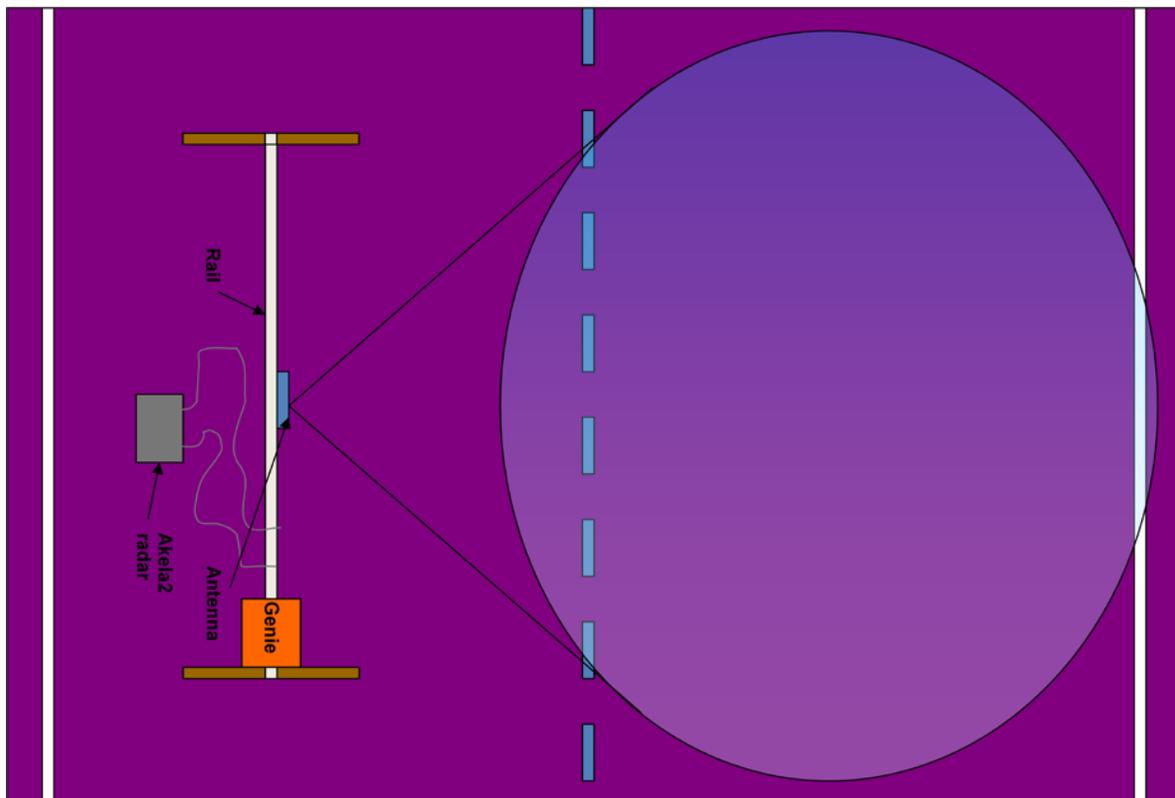
MTRI's 2D Radar will look at bridge deck top surface to detect sub-surface delaminations. The radar will be setup in one lane and image the other lane, requiring blocking of two lanes (see Figure 19). No vehicle or pedestrian traffic should be present on the bridge during data collection.

Figure 19: The setup of the project's 2D radar sensing system for detecting bridge delaminations.

Initial translator setup and radar calibration is anticipated to take approximately one hour. These steps include assembling translator fixture with radar antenna, cabling radar to the antenna, cable power from a generator, and setting up fiducials. This will be at a minimum a two person job.

Data collection for three 5 m by 10 m (50 m²) scenes will take approximately two hours. Multiple passes at two heights will be done. Moving to a new patch will require minimal time (about 15 minutes). The translator can be moved without breaking down the unit. The radar itself is disconnected, moved, and re-connected at the next patch to be scanned.
