# Memo

**To:** T. Ahlborn, D. Harris, L. Sutter, R. Shuchman, J. Burns  
**From:** H. de Melo e Silva, C. Brooks  
**CC:** A. Endsley, R. Oats, K. Vaghefi, R. Hoensheid, R. Dobson, J. Ebling, D. Dean  
**Date:** October 13, 2011  
**Number:** 21  
**Re:** Summary of Field Demonstration Including Sensor Evaluation and Update of the DSS.

## 3D OPTICAL BRIDGE-EVALUATION SYSTEM (3DOBS)

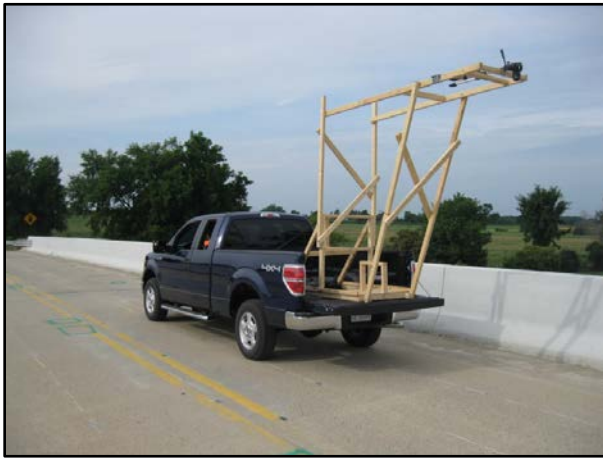
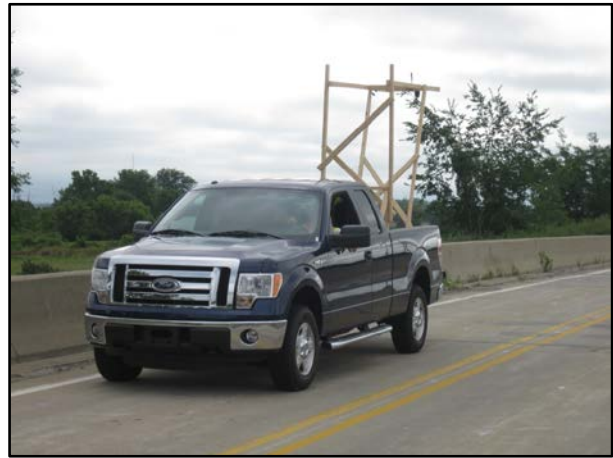
**Figures 1 & 2: The 3DOBS being deployed on Willow Road bridge over US-23 during August, 2011 field demonstrations.**

Easily transported in the bed of a light duty pickup truck the 3DOBS took 15 minutes to setup. For collecting the imagery, the truck was geared down to “4x4 low” and idled across the bridges at a speed of about 1 mph (see Figures 1 and 2 for the system in data collection mode). This allowed for at least 60% overlap of the resulting photos with the camera mounted 9 ft above the bridge deck surface, needed for photogrammetric image collection. The total time needed to make a full collect (two passes, one pass per lane) of the bridge was about 10 minutes. Breakdown of the system took another 10 minutes which translates to total collect time of 35 minutes per bridge (see Figure 3 for an example of the 3DOBS when broken down into its parts). With a faster camera that could take more frequent images, the speed of data collection could be increased and the data collection time could be decreased to less than 10 minutes per bridge for a full collection.

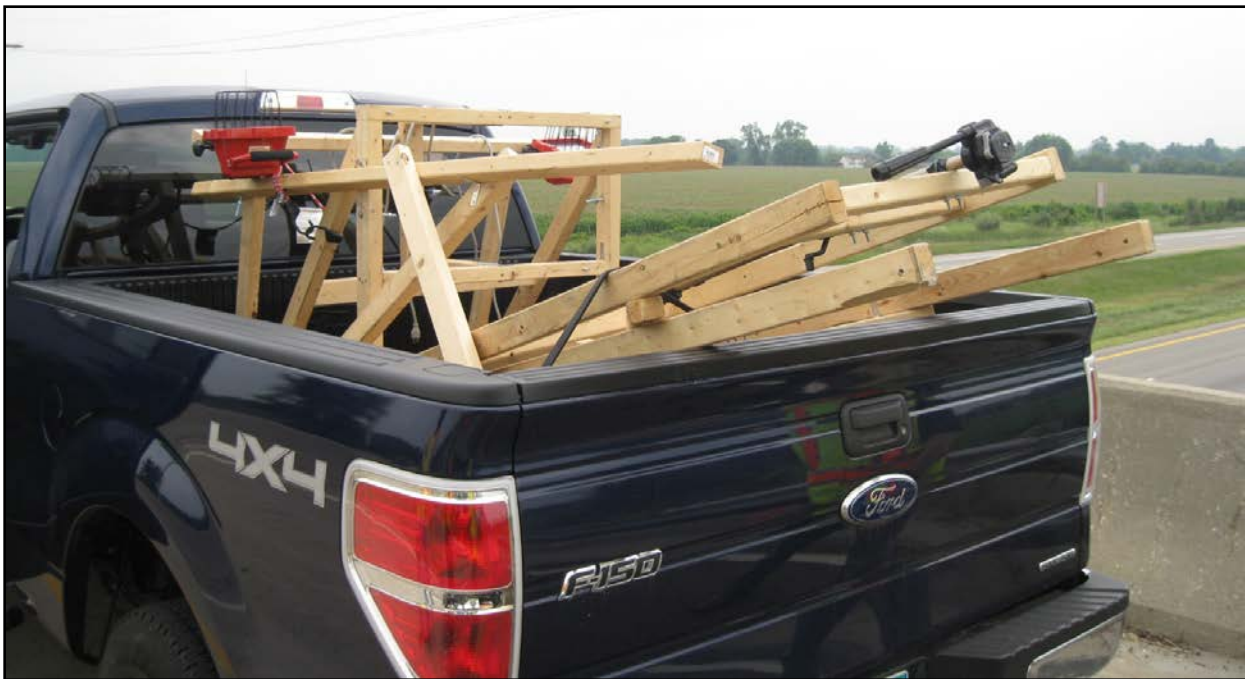
**Figure 3: The disassembled 3DOBS being transported to bridge field demonstration sites.**

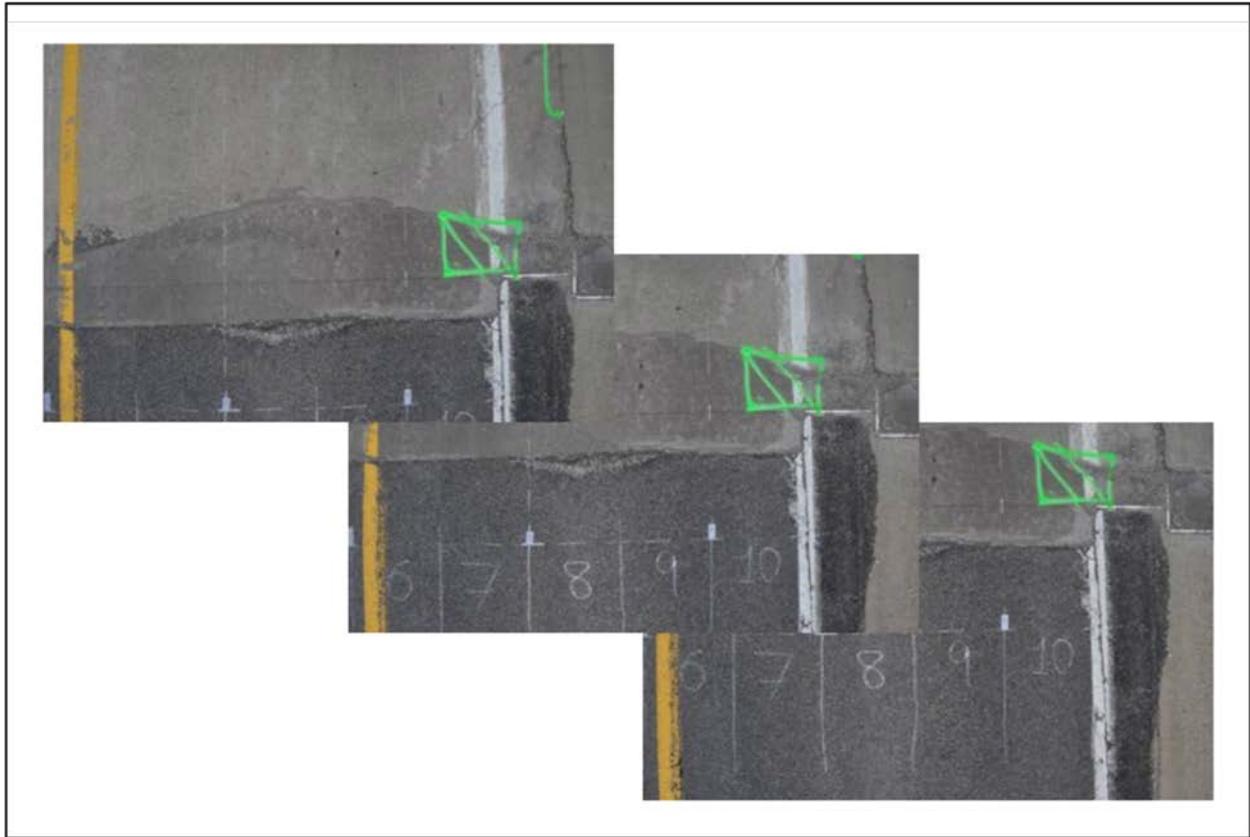
**Figure 4: Photos of Willow Road bridge taken with the 3DOBS showing a 60% picture overlap for photogrammetric image creation.**

The resulting photos from the Willow Road bridge (see Figure 4) were processed in the commercial software package Agisoft PhotoScan Professional to generate 3D models of the bridge deck surface. Using the labeled bridge locations from the team's onsite bridge grid system, the models were given a coordinate system and were then exported out of PhotoScan Professional as a Digital Elevation Models (DEM) seen in Figure 5. The bridge DEM is being used

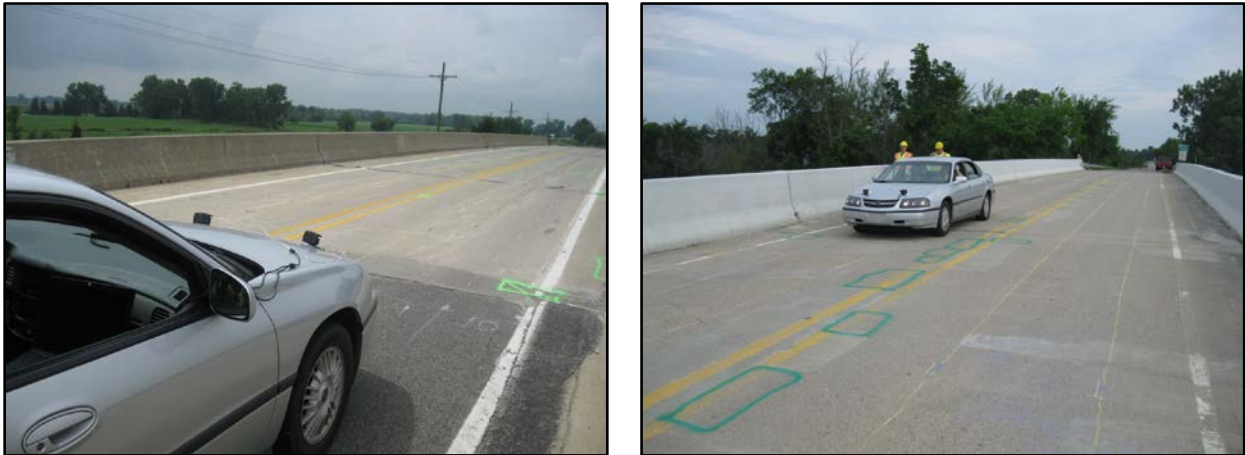
Figures 9 & 10: The BVRCS being deployed on Freer Road bridge to capture a photo inventory.

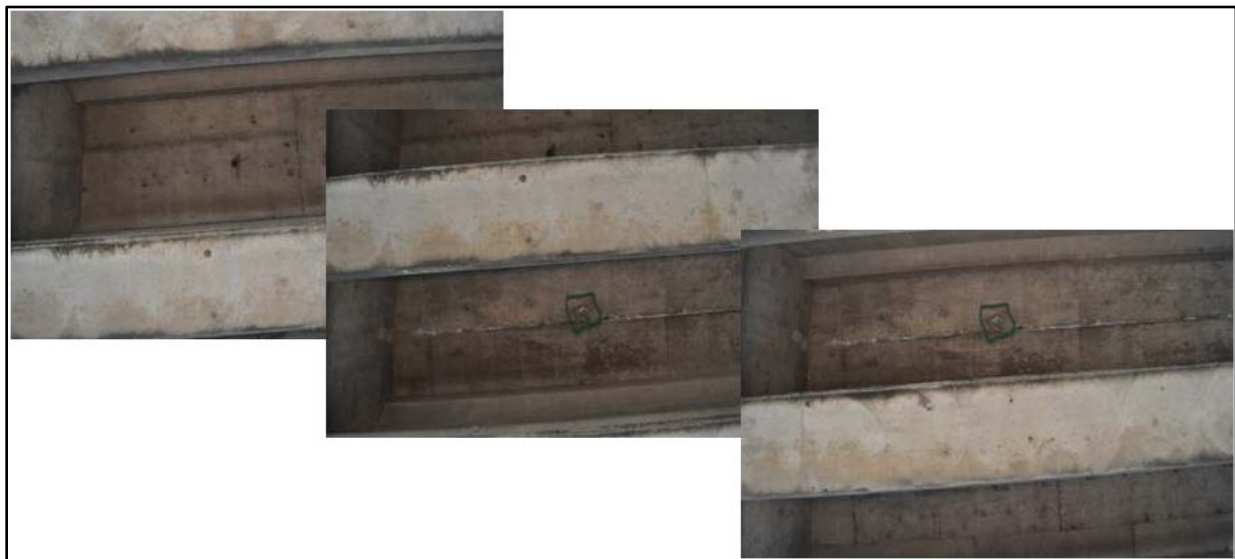
**Figure 14: Example photos taken with the BVRCS-Underside of Willow Road bridge.**

The project team also developed an additional version of the BVRCS that could capture a photo inventory of the underside of a bridge. In order to accomplish this task, the BVRCS was modified so that a camera faced straight-up, and a lighting source was added to address potential shadow areas. The BVRCS-Underside was developed by the project team and deployed at all bridges. This system was mounted in the bed of a truck and used the same base as the 3DOBS. An attachment was added that had two 500 watt work-lights with one of the D5000 cameras mounted to it. Due to being underneath a bridge with the sky blocked, collection of exact location-data with a GPS was not practical with the BVRCS-Underside. The same 3DOBS camera triggering device was also used. Again the truck drove at a speed of about one mph and captured photos at a rate of one fps (see Figure 14). Similar to that system, a faster camera would enable increased driving speeds. This system was easily transported and was set up, deployed and broken down within 25 minutes.

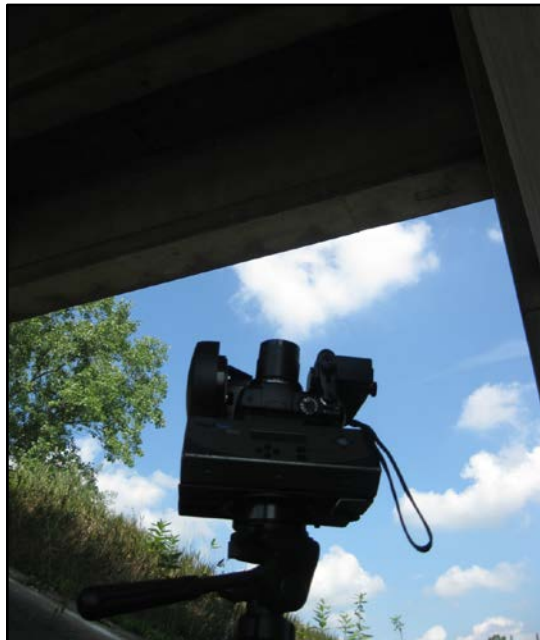
**Figure 15: An example of the GigaPan being used to collect high-resolution bridge inventory photos during August, 2011 field demonstrations at Willow Road bridge.**

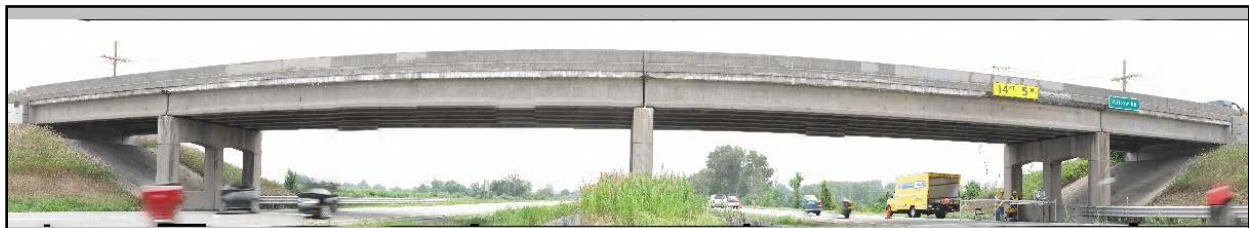
**Figure 16: Profile view of Willow Road bridge looking south along US-23 from a GigaPan image. The full resolution version of this photo captures the entire side of the bridge at very high resolution in a gigapixel image.**

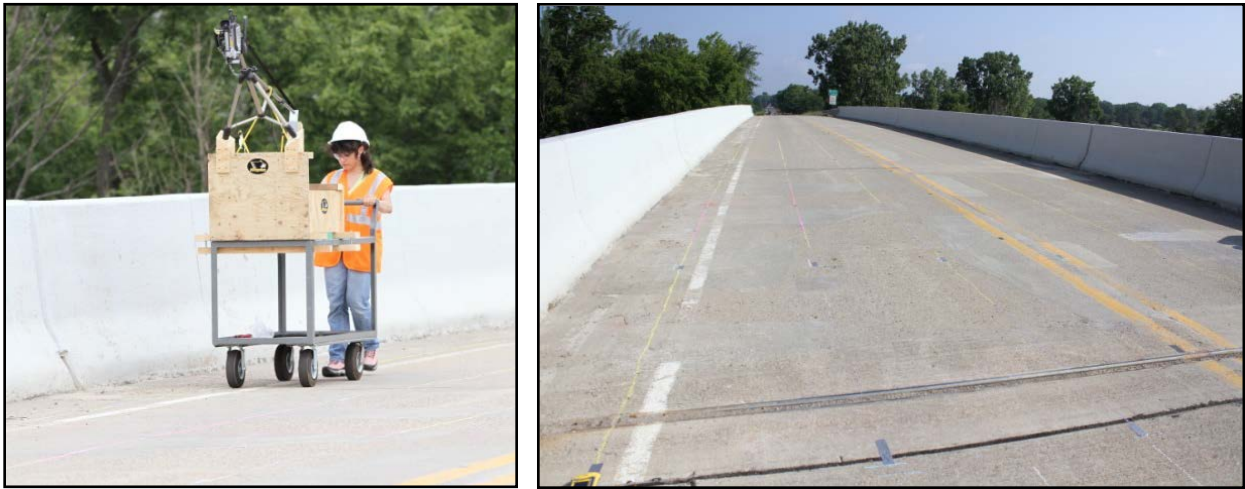
Figures 17 & 18: ThIR camera mounted on the cart with “homemade tripod” system and chalk and duct tape grid layout on Freer Road bridge.

Field demonstration of ThIR imagery was conducted on the selected pre-stressed concrete bridges using the data collection procedure based on the proposed method in technical memorandum n<sup>o</sup> 20. ThIR images were collected on the top of the bridge deck by pulling the cart with a "homemade tripod" over the bridge (see Figure 17) on the specific grid pattern (see Figures 18 and 19) that was drawn on each bridge prior to data collection. This cart system can be adapted to a vehicle-based mount.

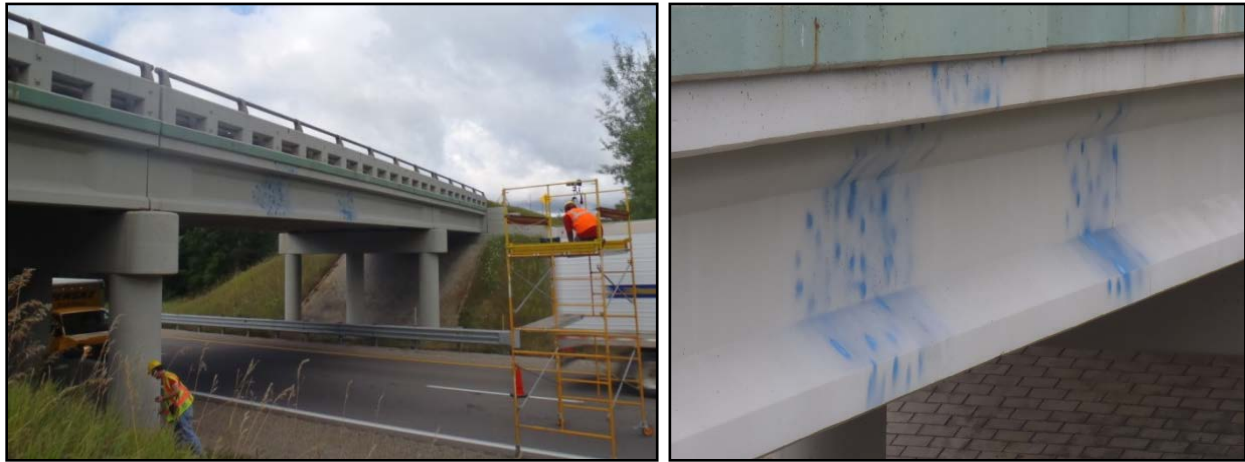
**Figures 23 & 24: DIC setup at Mannsiding Road bridge and detail of girder with speckle patterns.**

The camera was placed at a 20 ft standoff distance from the target surface on a rigid tripod (4.25 ft) located on a scaffolding platform (10 ft). The overall height of 14.25 ft placed the camera perpendicular with the exterior girder (see Figures 23, 25, and 26).

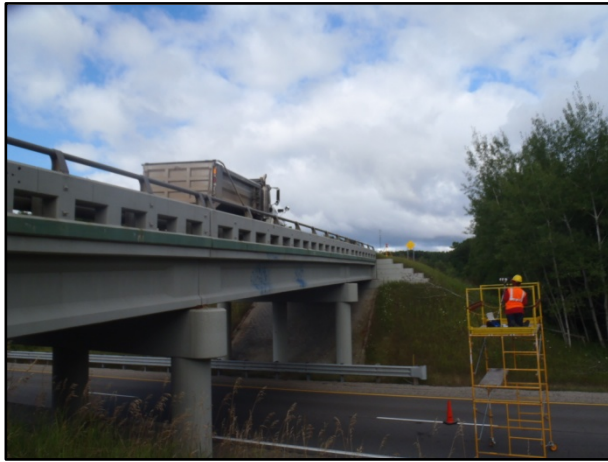
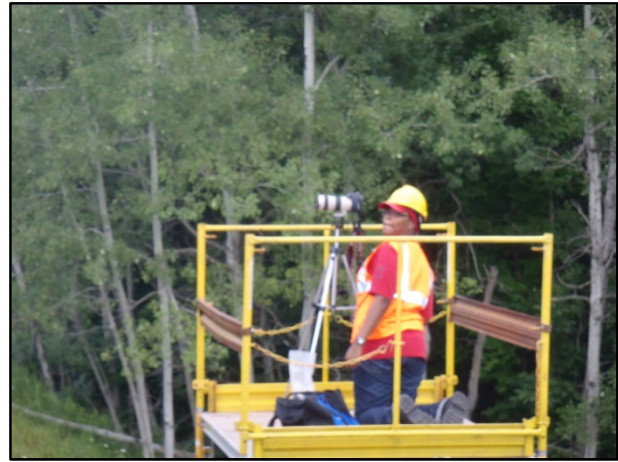
**Figures 25 & 26: Load truck going over bridge and close-up of camera and tripod setup on scaffolding.**

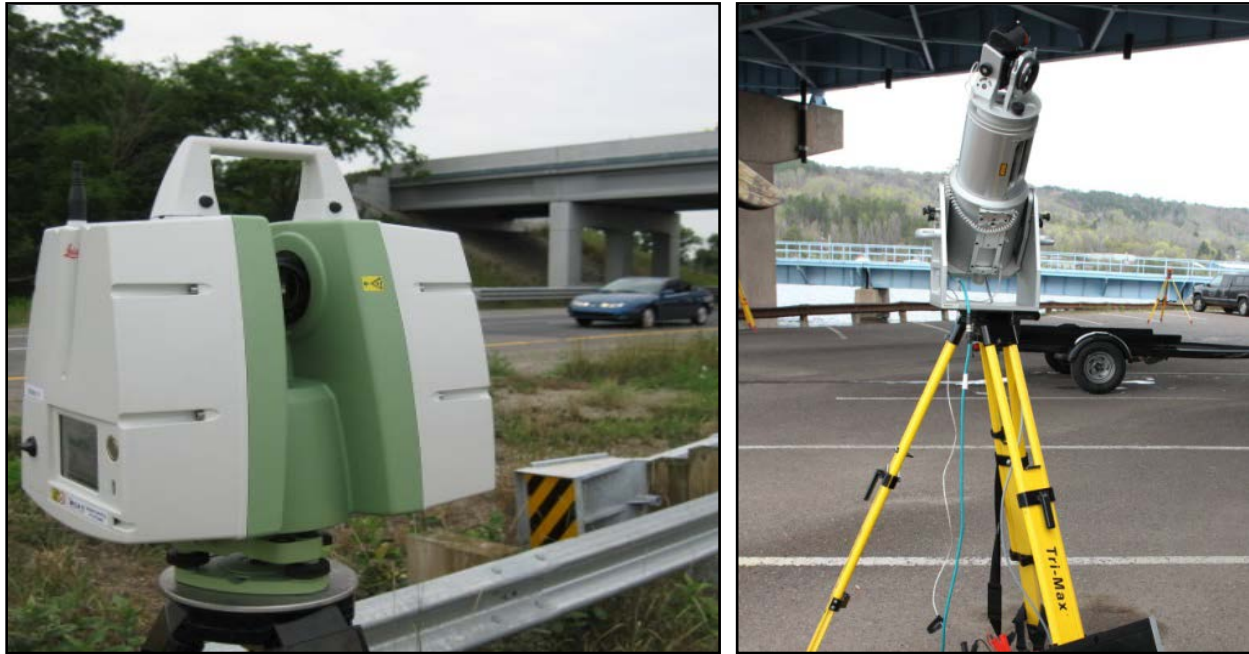
**Figures 33 & 34: MDOT's Leica ScanStation C10 and MTU's RIEGL LMS-Z210ii.**

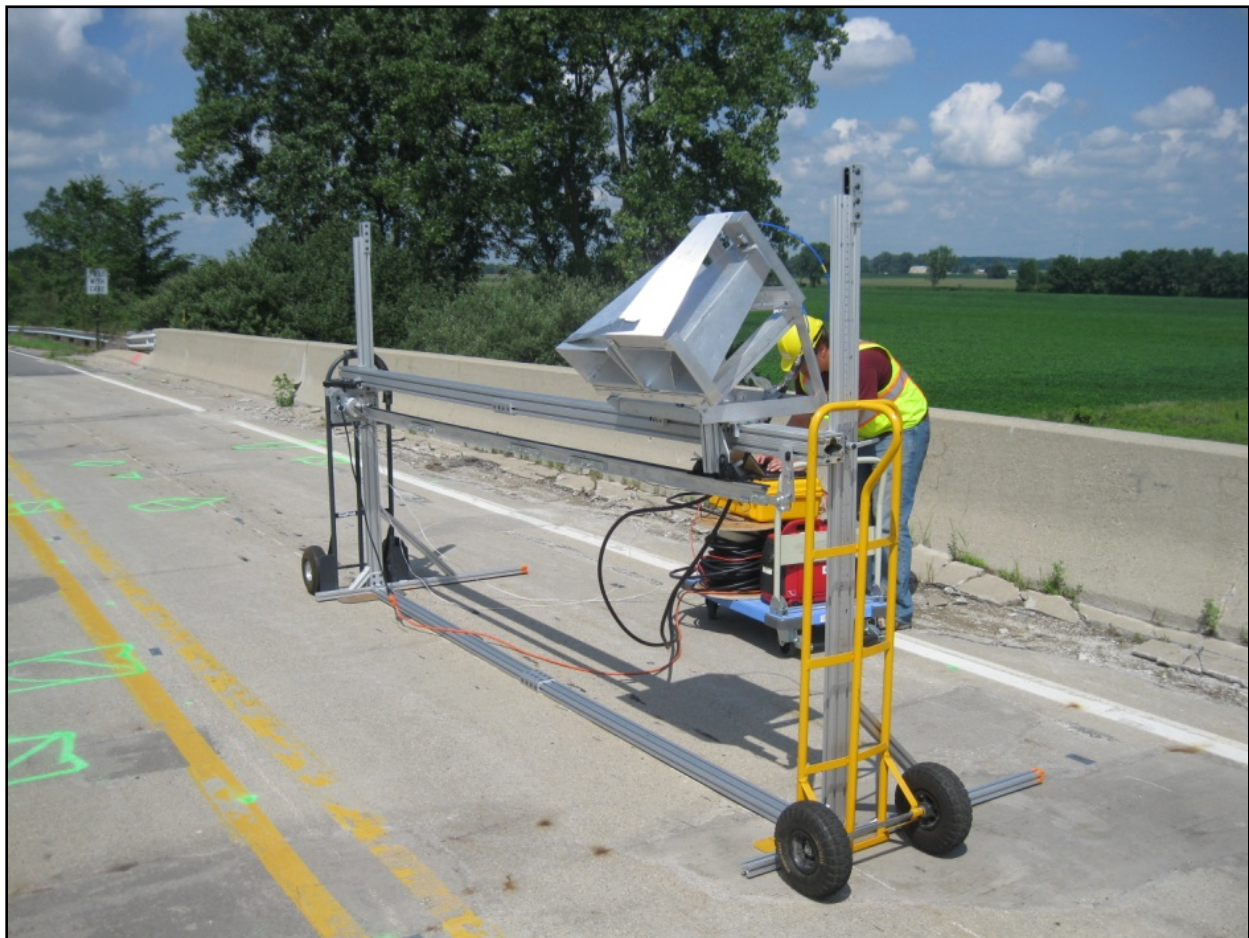
**Figure 46: More "mobile" translator apparatus and radar equipment. It is easy to view how such a system could be adapted for use on a moving vehicle.**
