Implementation Assessment of Unpaved Road Condition with High-Resolution Aerial Remote Sensing

Colin N. Brooks, Michigan Tech Research Institute (MTRI)

Characterization of Unpaved Road Conditions through the Use of Remote Sensing

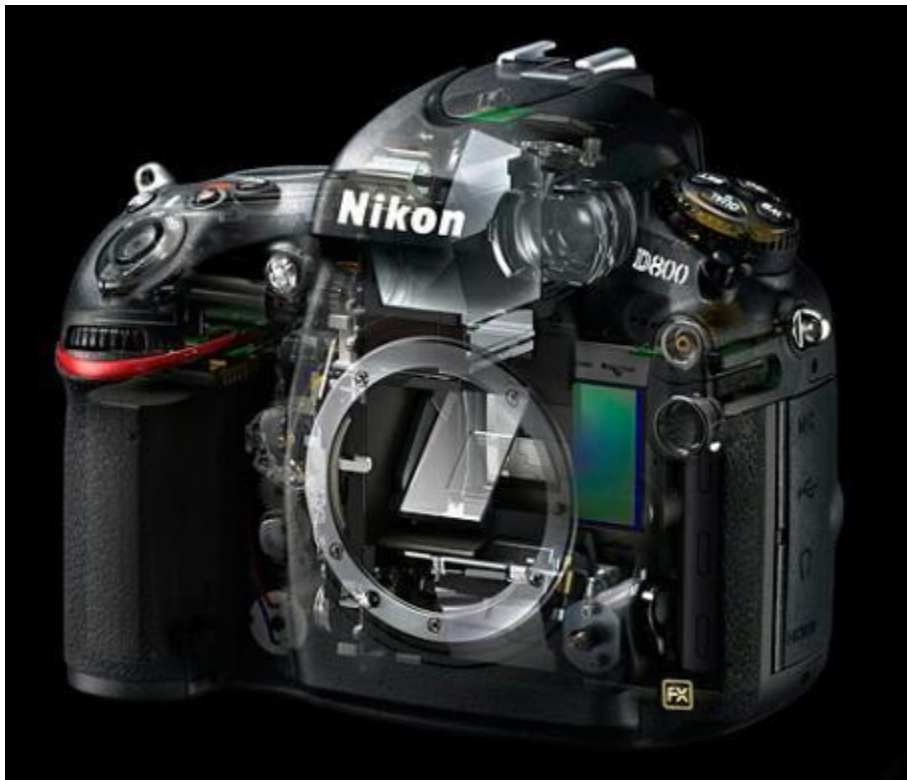
Selected sensor: Nikon D800

- Nikon D800 – full-sized (FX) sensor, 36.3 Mp, 4 fps - \$3,000
- More than meets all our requirements
- Weight prime lens, weights ~1.5 kg

Body type	
Body type	Mid-size SLR
Body material	Magnesium alloy
Sensor	
Max resolution (px)	7360 x 4912
Effective pixels	36.3 megapixels
Sensor photo detectors	36.8 megapixels
Other resolutions	6144 x 4912, 6144 x 4080, 5520 x 3680, 4800 x 3200, 4608 x 3680, 4608 x 3056, 3680 x 2456, 3600 x 2400, 3072 x 2456, 3072 x 2040, 2400 x 1600
Image ratio w:h	5:4, 3:2
Sensor size	Full frame (35.9 x 24 mm)
Sensor type	CMOS
Processor	Expeed 3
Color space	sRGB, Adobe RGB
Color filter array	Primary Color Filter
Image	
ISO	100 - 6400 in 1, 1/2 or 1/3 EV steps (50 - 25600 with boost)
White balance presets	12
Custom white balance	Yes (5)
Image stabilization	No
Uncompressed format	.NEF (RAW)
JPEG quality levels	Fine, Normal, Basic
File format	<ul style="list-style-type: none"> • NEF (RAW): 12 or 14 bit, lossless compressed, compressed or uncompressed • TIFF (RGB) • JPEG
Optics & Focus	
Autofocus	<ul style="list-style-type: none"> • Phase Detect • Multi-area • Selective single-point • Tracking • Single • Continuous • Face Detection • Live View

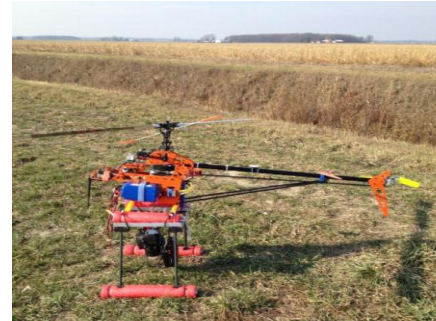
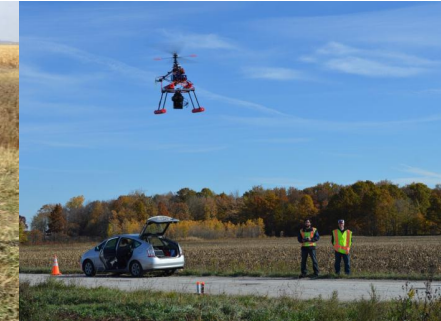
■ Bergen Helicopter

- Total flight time: 16 minutes (not including 2 minute reserve); flight time for a 200 meter section ~ 4 minutes.
- Flown at 2 m/s at 25 and 30 meters
- 50mm prime lens

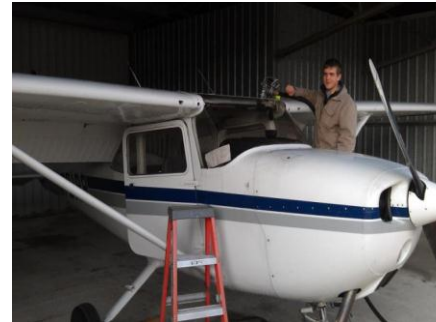
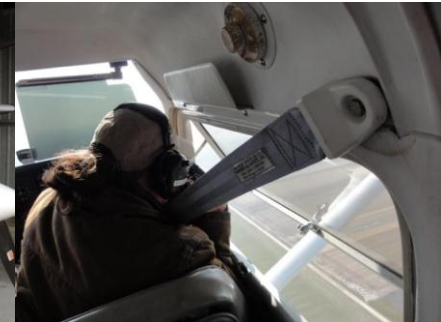
■ Cessna 172 and 152 Aircraft

- Average air speed: 65 knots (~ 75 mph)
- Flown at altitudes of 500 and 1000 feet
- 105 mm prime lens (2012), 70-200mm zoom (2013)

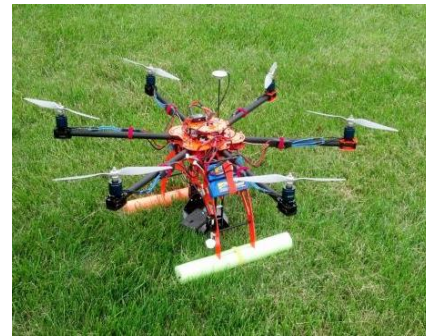
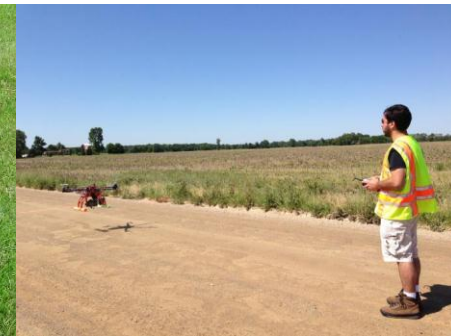
■ Bergen Hexacopter

- Total flight time: up to 30 minutes with small payloads
- Weight: 4kg unloaded
- Maximum Payload: 5kg
- Includes autopilot system, stabilized mount that is independent of platform movement, and first person viewer system (altitude, speed, battery life, etc.)

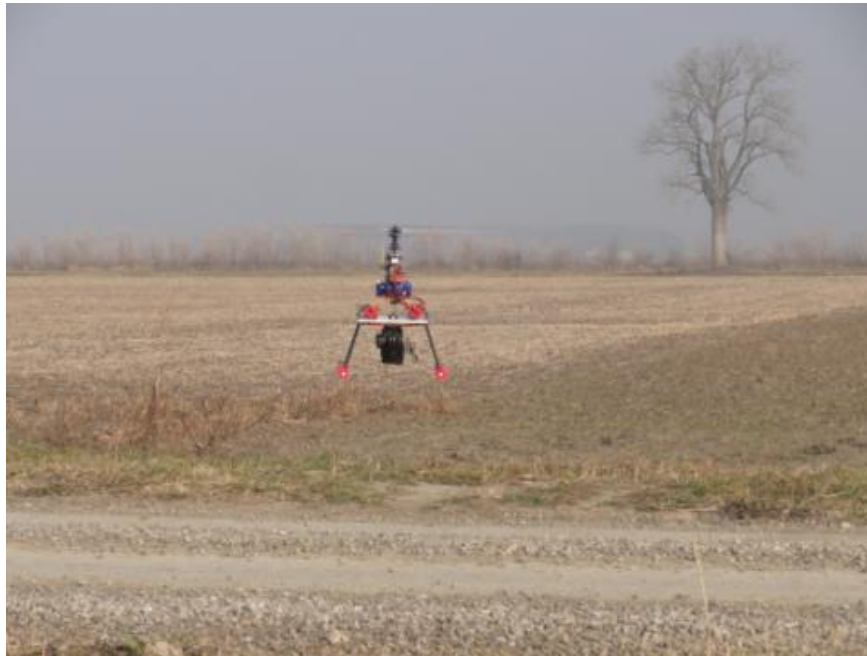
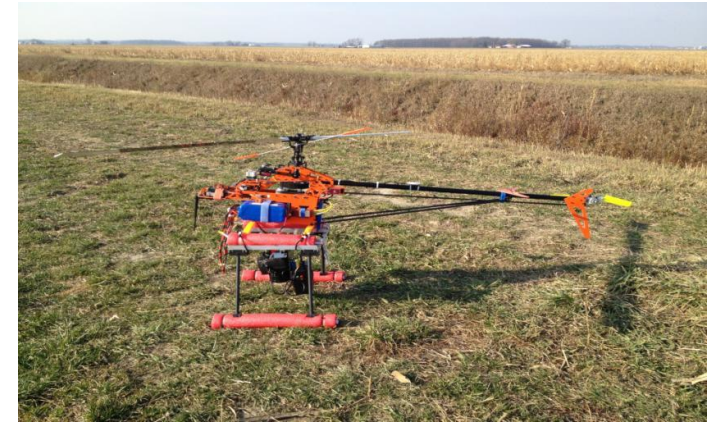
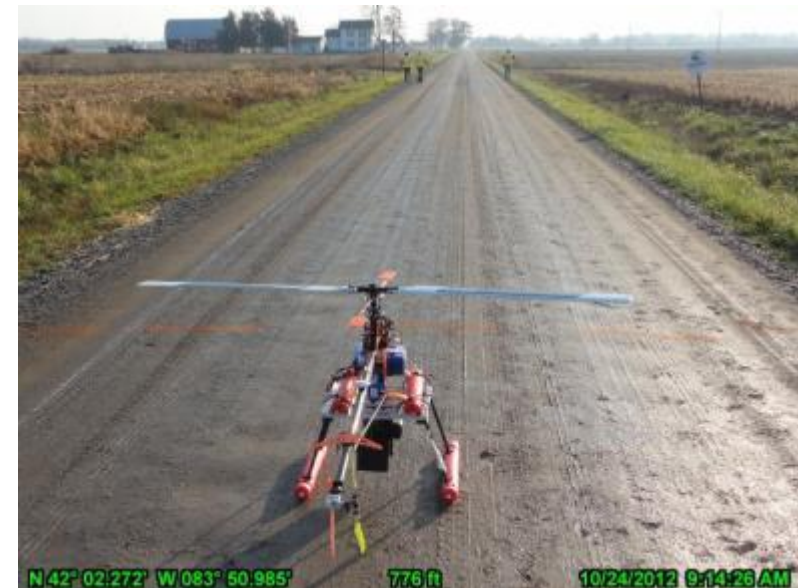
Initial UAV Collect

- Flight time for a 200 m section: 4 minutes
- During collects helicopter is flown at 2 m/s and at an altitude of 25 m (82') and 30 m (98')

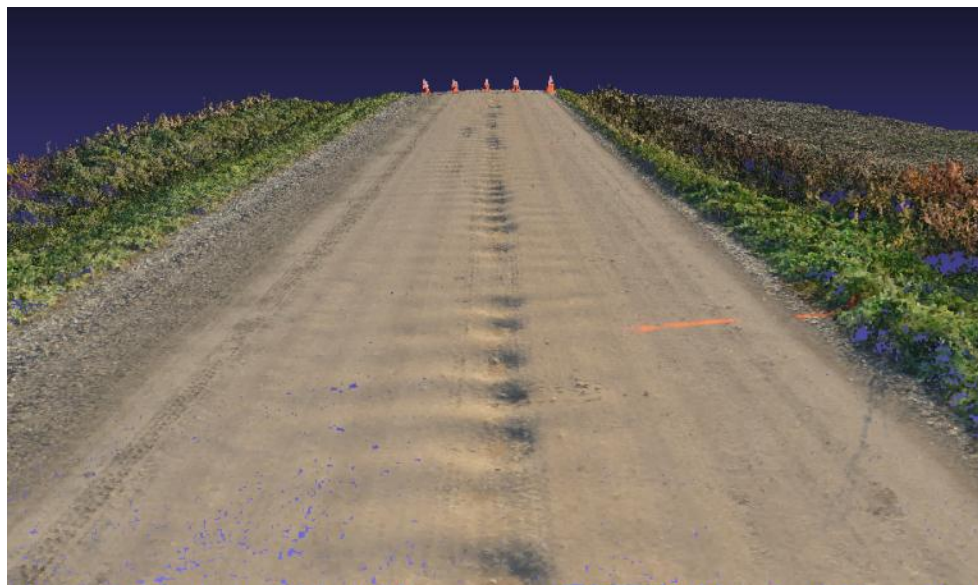
3D surface from point cloud
